GROUP	MODEL
ELE	2016-2018MY Sorento (UMa)
NUMBER	DATE
297 (Rev 2, 06/16/2026)	May 2023

TECHNICAL SERVICE BULLETIN

MULTIFUNCTION SWITCH REPAIR (WTY031)

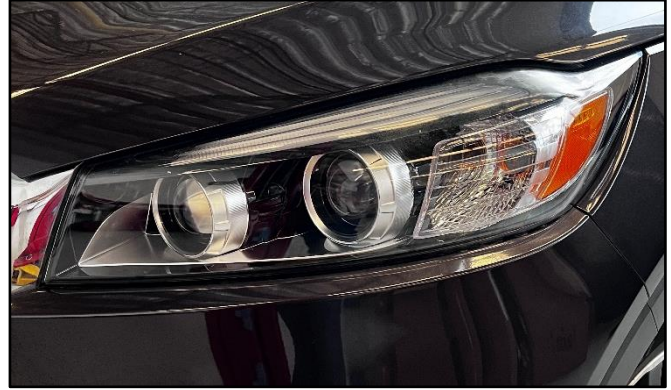
- Perform a visual inspection of the bulb.
 - If the bulb is **(OK)**, continue to step 2.
 - If the bulb is **(NG)**, this TSB does not apply. **Claim Diagnosis Op Code 232A1010.**

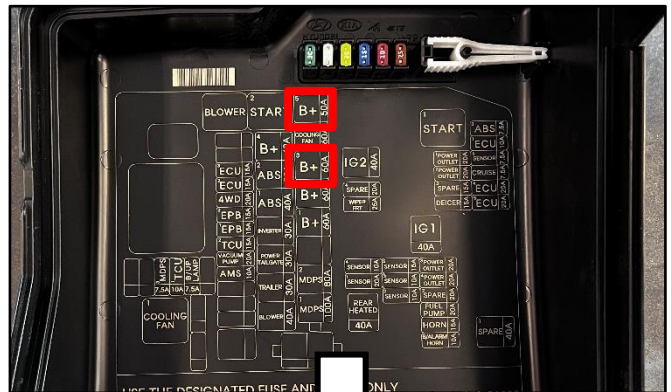
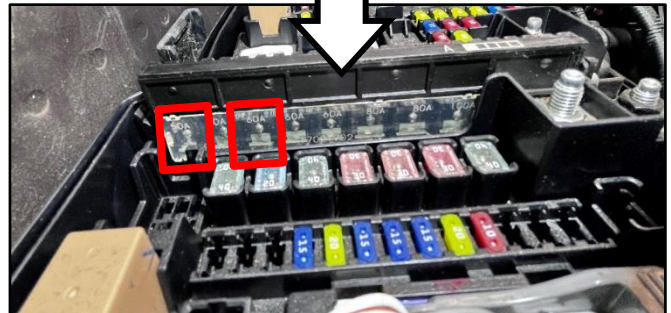
- Ensure the **50A B+5** and **60A B+3** headlamp fuses are not blown.
 - If the fuses are **NOT** blown **(OK)**, proceed to step 3.
 - If the fuses are blown **(NG)**, this TSB does not apply. **Claim Diagnosis Op Code 232A1010.**

Note: The multi-fuse does **NOT** need to be removed to inspect the **50A B+5** and **60A B+3** fuses.

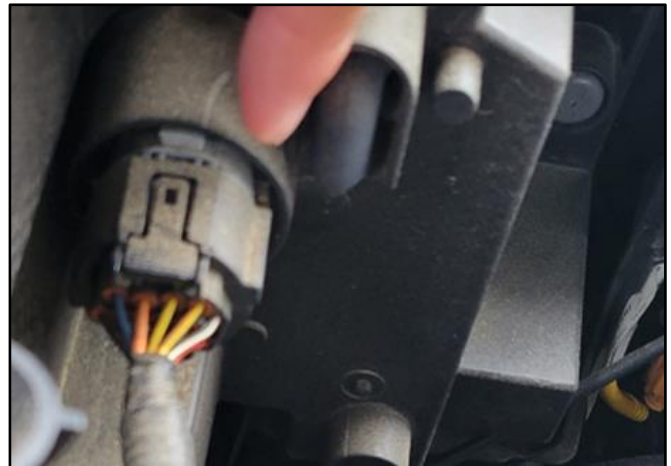
- Ensure the headlamp connector is properly seated.
 - If the connector is properly seated **(OK)**, proceed to the 'Repair Procedure'.
 - If the connector is **not** properly seated **(NG)**, remove connector and properly install. **No further action is required.** **Claim Diagnosis Op Code 232A1010.**
