223 S63e - Popping Sound From Rear When Driving

Topic number	LI35.31-P-080609
Version	3
Function group	35.31 - Rear axle center assembly
Date	6/12/26
Validity	S63e (223.182) and rear subframe manufacture date after December 2025.
Reason for change	Remedy update

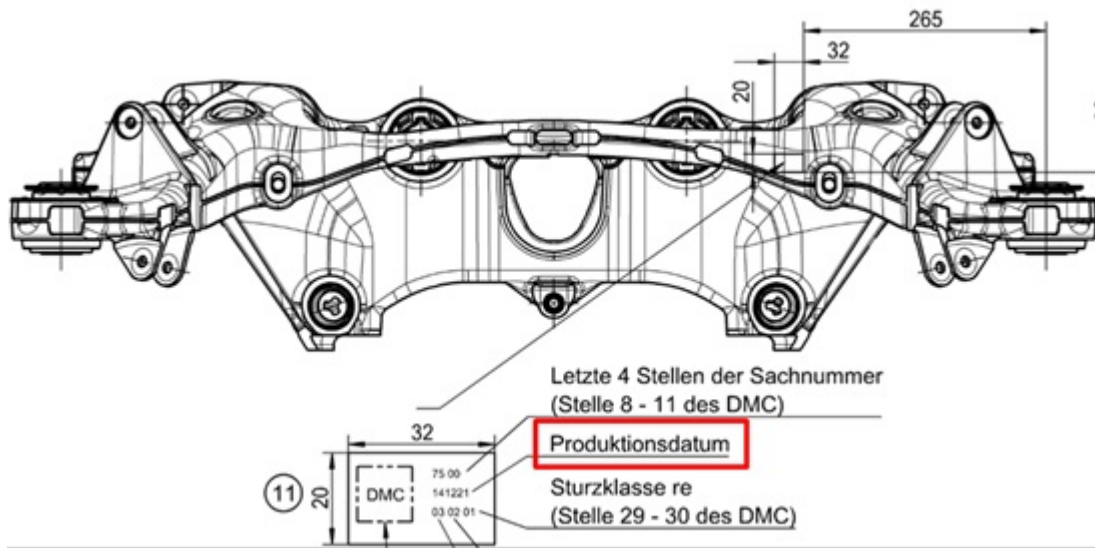
Consistent popping sound from rear of vehicle.

Rear subframe manufactured on or after November 2025.
