# HYUNDAI

## Technical Service Bulletin

GROUP	NUMBER
<b>ENGINE ELECTRICAL</b>	<b>26-EE-007H</b>
DATE	MODEL(S)
<b>JUNE 2026</b>	<b>SEE BELOW</b>

**SUBJECT:** BATTERY DRAIN FROM CONTINUOUS OPERATION OF COOLING FAN – ENGINE ROOM PCB BLOCK REPLACEMENT

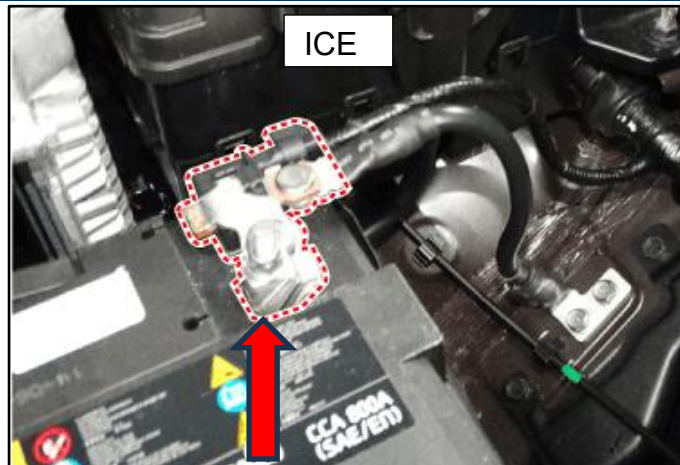
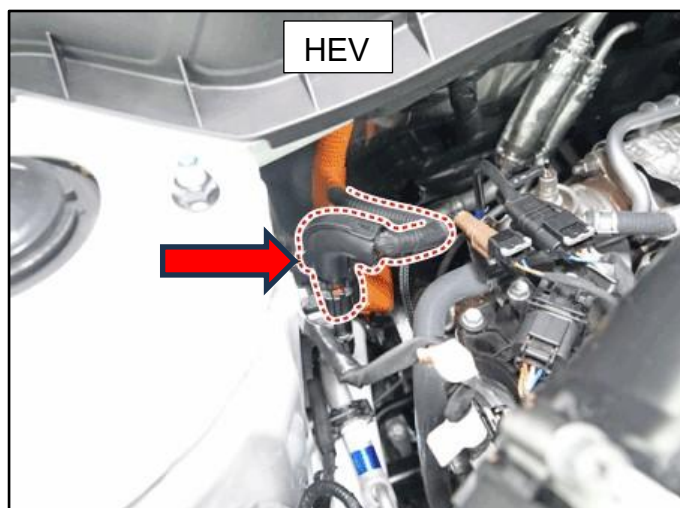
1. Turn **OFF** the vehicle by pushing the START/STOP Button (SSB), then disconnect the battery.

Model	Remove Part	Location
ICE	- Terminal	Engine bay
HEV	+ Connector	Upper engine bay near passenger strut mount

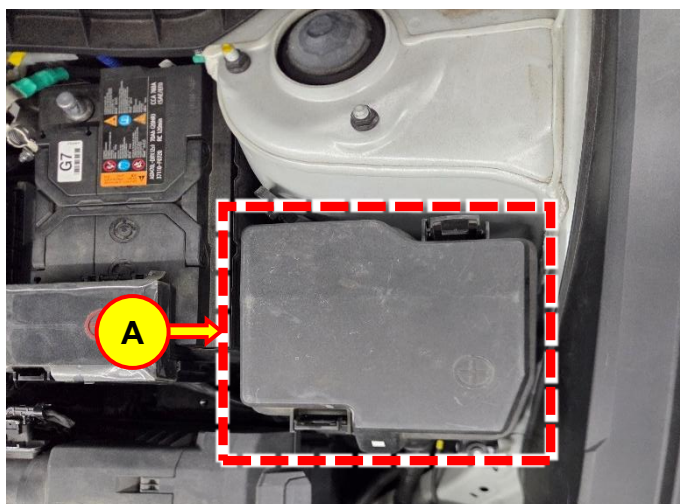
2. Remove the engine room relay box cover (A).

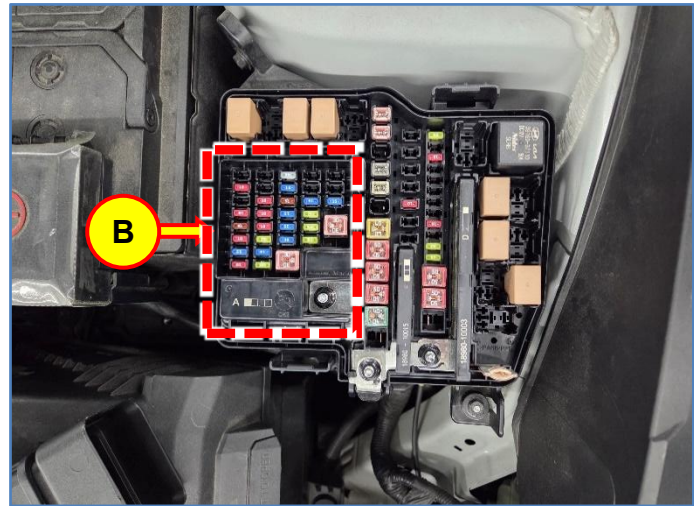
3. Remove the engine room PCB block (B) by referring to one of the following sections of the shop manual:

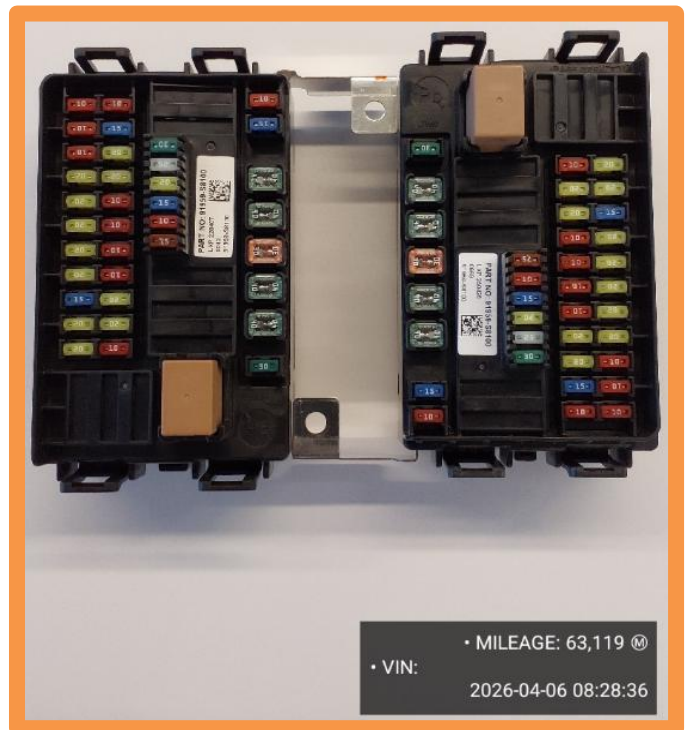
Using the STUI camera function, take a photo of the old engine room PCB block next to the new engine room PCB block.
