HYUNDAI
Technical Service Bulletin

GROUP BODY ELECTRICAL	NUMBER 26-BE-012H
DATE JUNE 2026	MODEL(S) PALISADE (LX2)

SUBJECT: CHECK FORWARD SAFETY SYSTEMS WARNING – FRONT VIEW CAMERA REPLACEMENT DTC C272246

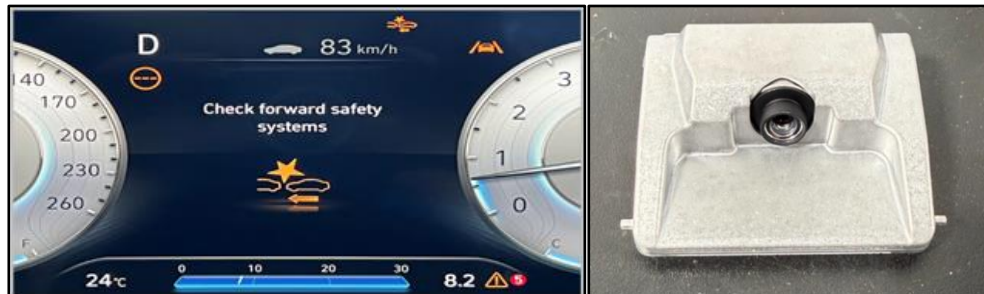
Description: Some Palisade (LX2) vehicles may display a “Check forward safety systems” warning message on the cluster along with DTC C272246, due to the front view camera calibration range being exceeded. This bulletin provides instructions to replace the front view camera when this DTC is active.
