Technical Service Bulletin

Circulate To:	Service Manager	x	Parts Manager		Series:	Momentum
	Warranty Admin	x	Technician	x	Model:	Line 12 built TT's only
	Sales Manager				Build Date	*10/2025

Concern: It has been identified that certain Line 12 Momentum TT's may have the Happijac top bunk L-brackets installed in an inverted (upside-down) orientation. The reduced clearance condition can cause mechanical interference at the top of travel, preventing the bunk from properly disengaging from the locking mechanism.

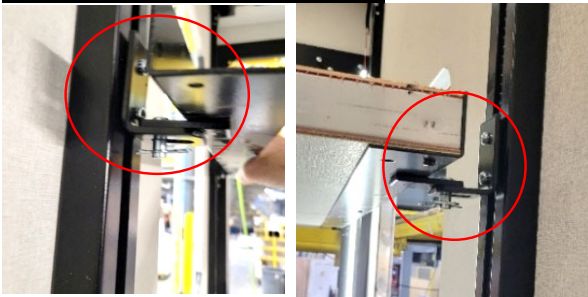
Incorrect install examples:

Remedy: Inspect the orientation of the Happijac top bunk L-brackets. If brackets are found to be inverted, remove and reinstall in the correct orientation per manufacturer specifications to restore proper clearance and ensure normal disengagement of the locking mechanism at full upward travel.

- Step 1:** To correct this, you will need to pull the cotter pin out of the clevis pin
- Step 2:** Lift the bed decking rail to get to the mounting screws on the bracket and back out the screws.
- Step 3:** Flip the bracket to its correct position, making sure to keep the spacer block in place, reinstall both screws.
- Step 4:** Lower bed decking back into place and reinstall washer and cotter pin into the clevis pin. Repeat process on all 4 brackets.

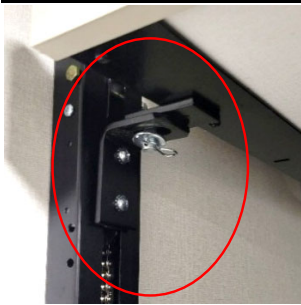
Correct install:

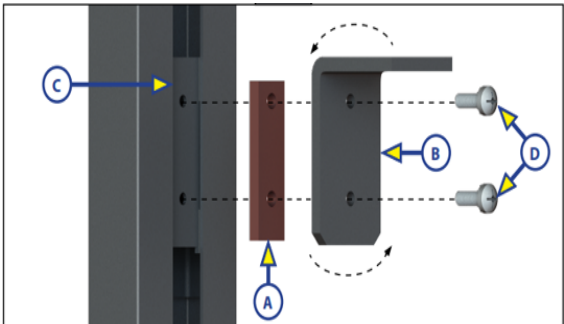
LCI / Lippert example install:
