TSB:	26-003: M920029	Product:	Lineage M-Series 25FW
Date:	5/13/2026	Repair Time:	0.5h

Purpose

This bulletin describes the procedure to relocate the LP solenoid power source from the chassis battery to the house battery on Lineage M-Series 25FW units equipped with an LP solenoid. The relocation uses retrofit harness EL-0189.

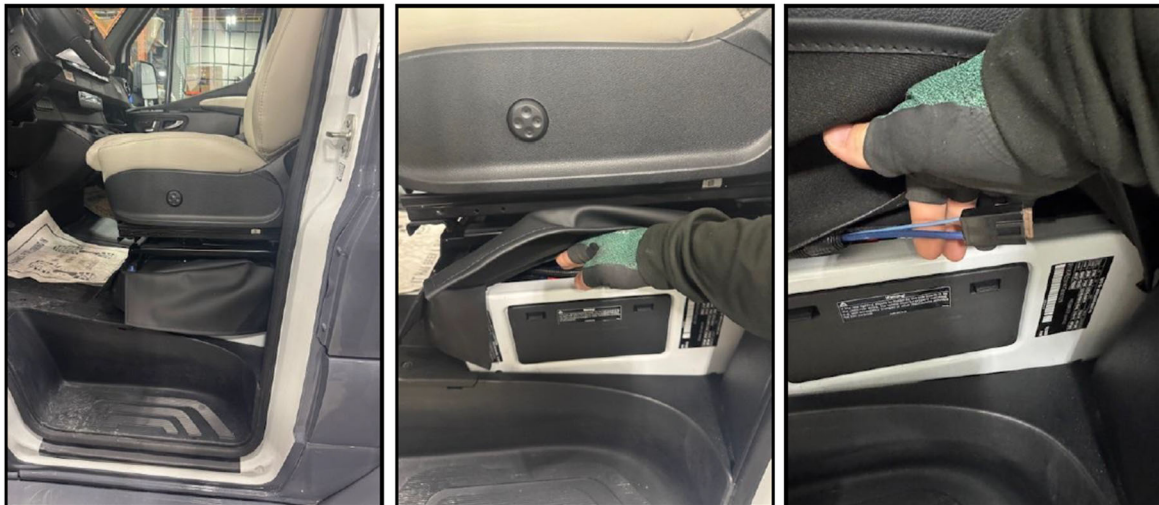
Fig. 1-3 — Location of the 5A fuse

Step 1 — At the driver's seat, locate the existing 5A fuse and fuse holder for the LP solenoid, located just inside the driver's seat base.

Step 2 — Pull the fuse holder out from beneath the driver's seat as far as possible to gain working access.

Step 3 — Cut the fuse holder wires just behind the fuse holder.

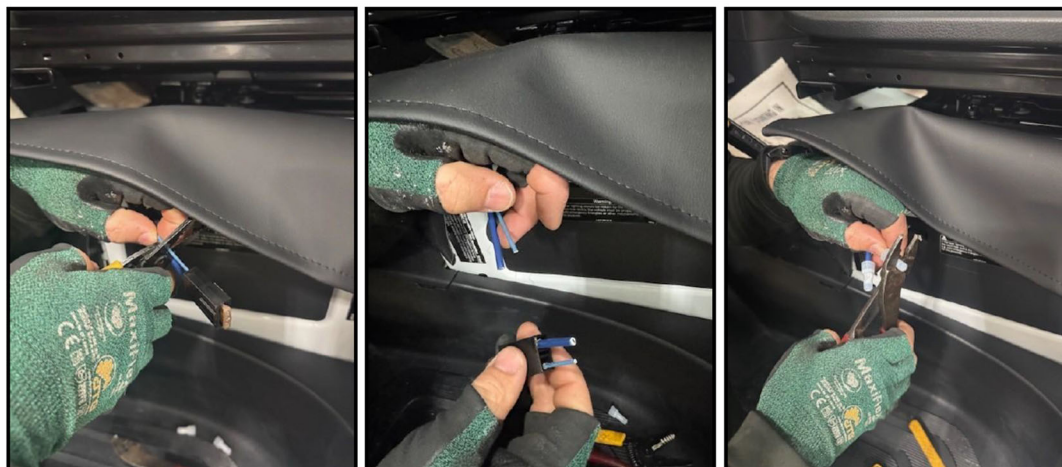
Fig. 4-6 — Cap off both wires separately and discard the fuse.

Step 5 — Cap the wires that remain in the harness using approved wire end caps.

Note: Both abandoned wires must be individually capped and secured. Do not leave any conductor exposed.

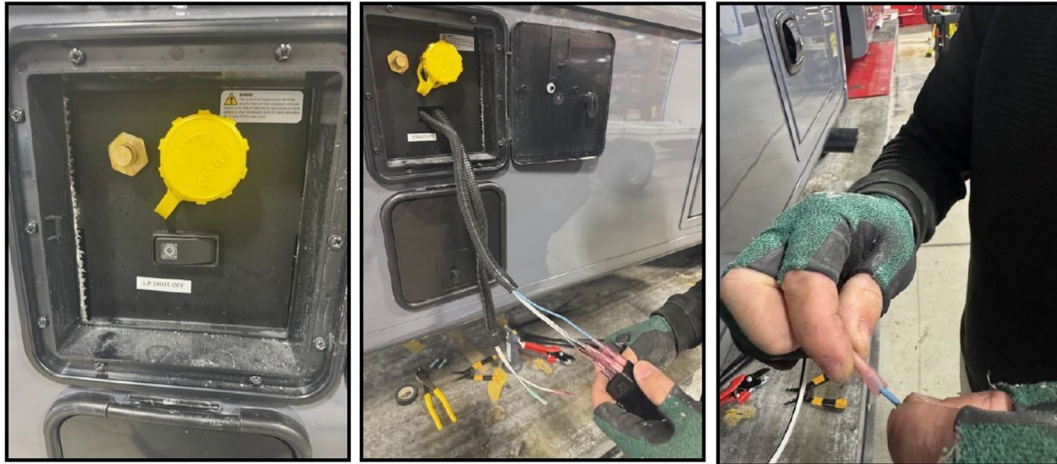
Fig. 3 — LP shut-off switch removed from access panel.

Fig. 4 — Pull existing wire and the new harness through the switch hole.

Fig. 5 — Butt-connect splice between EL-0189 harness and the cut light blue wire.

Step 3 — Locate the light blue wire on the existing switch harness. Cut this wire several inches after the QD (quick-disconnect) female connector.

Step 4 — Butt-connect the two leads of the new EL-0189 harness to the two cut ends of the light blue wire.

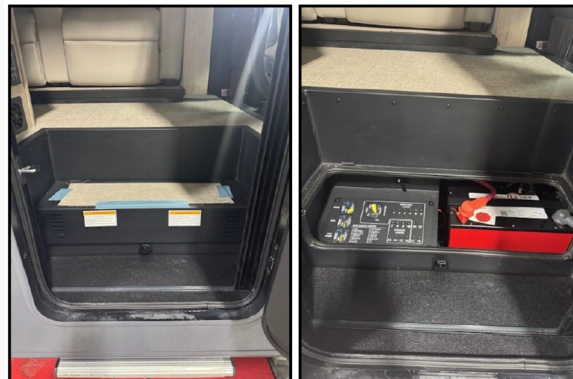
Fig. 6 — Entry step cover removed for access to the DCD panel.

Step 1 — Remove the entry step cover to access the under-step compartment.

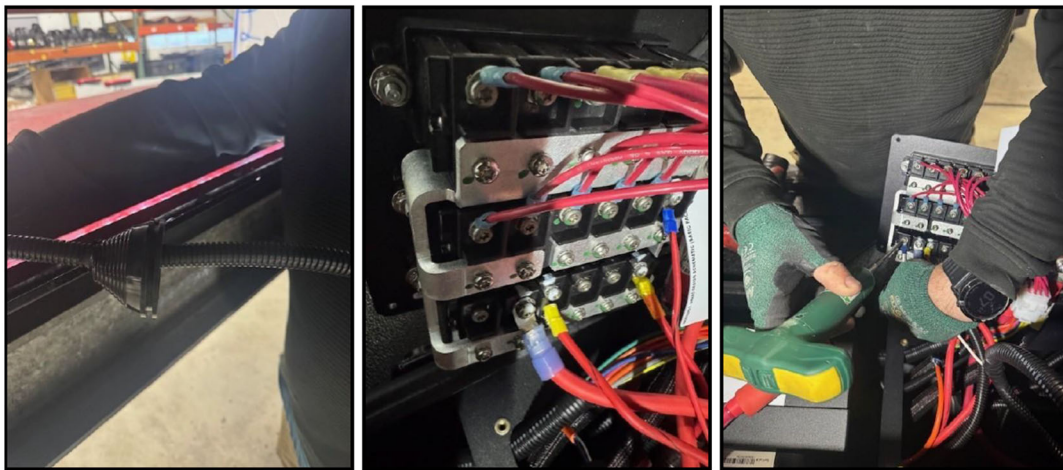
Fig. 7 – Harness routed through spare rubber grommet in step box wall.

Fig. 8 – Route & secure as necessary up to DCD

Fig. 9 – Ring terminal connected to AUX breaker, torqued to 15 in-lbs.

Step 3 – Route the new harness down the passenger side of the frame and into the step box, passing through the spare rubber grommet in the side of the step box.

Step 5 – Attach the harness ring terminal to the AUX breaker on the DCD panel.

Step 6 – Torque the AUX breaker terminal screw to 15 in-lbs using a calibrated torque screwdriver.

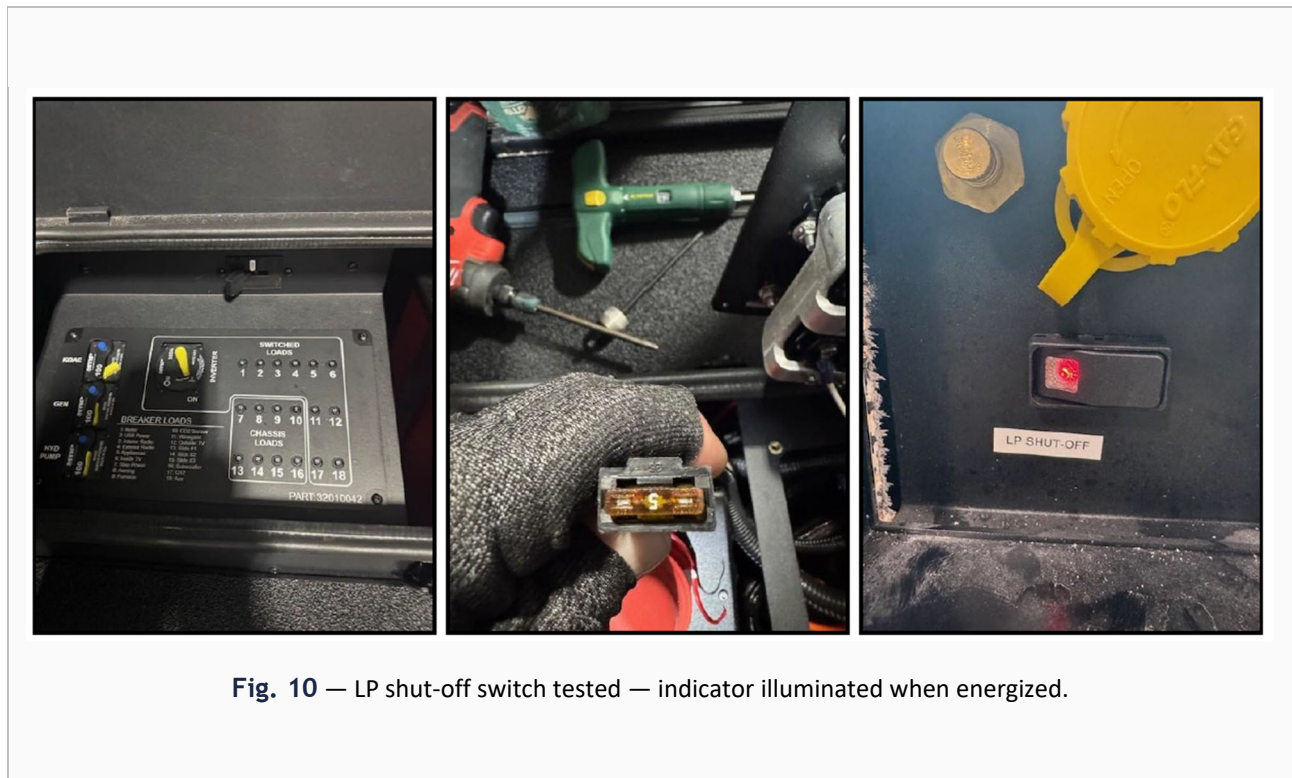
Fig. 10 — LP shut-off switch tested — indicator illuminated when energized.

Step 5 — Test the LP shut-off switch. Confirm the LP solenoid energizes and de-energizes as the switch is cycled.
