Job Code:	M920032 – 26-005	Product:	Lineage LVT1
Date:	5/20/2026	Repair Time:	0.50

This bulletin describes the procedure to replace the plastic threaded pivot fitting on the rain shower head with a metal threaded pivot fitting on affected Lineage LVT1 units. The metal fitting addresses a failure of the plastic threaded pivot fitting as supplied by the shower head manufacturer.

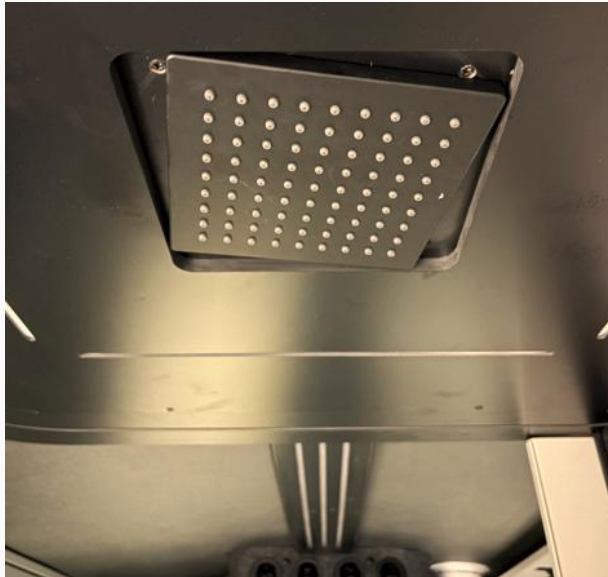
Fig. 1.1 – Shower head turned by hand to expose mounting screws.

Step 1 – Rotate the shower head to expose the four #6 x 1" black flat head screws.

Step 2 – Remove each of the four screws by turning counterclockwise. These screws may be reused if desired; extra screws are included in case a screw is lost or damaged.

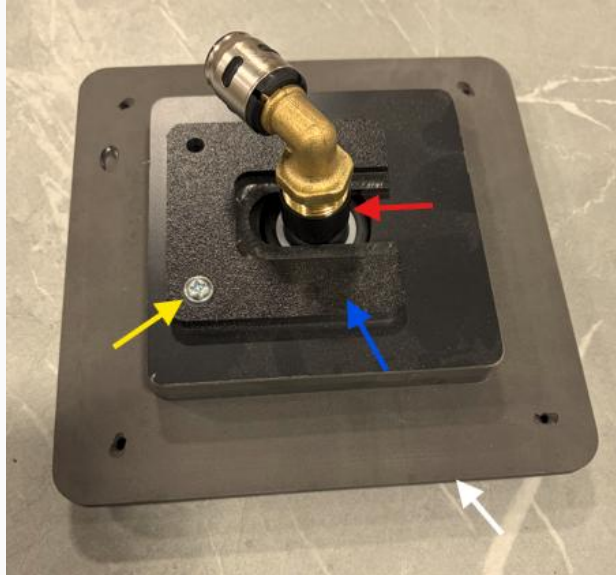
Fig. 1.2 — Service panel with shower head installed — service panel, pivot fitting, keeper, and mounting screw locations.

Step 4 – Disconnect the shower head from the supply line: support the supply line with one hand and twist the plastic threaded pivot fitting counterclockwise.

Step 5 – Note the machined black plastic keeper that holds the shower head in place. It may be held by one or two #8 x 5/8" silver washer head screws. Remove the screw(s) by turning counterclockwise.

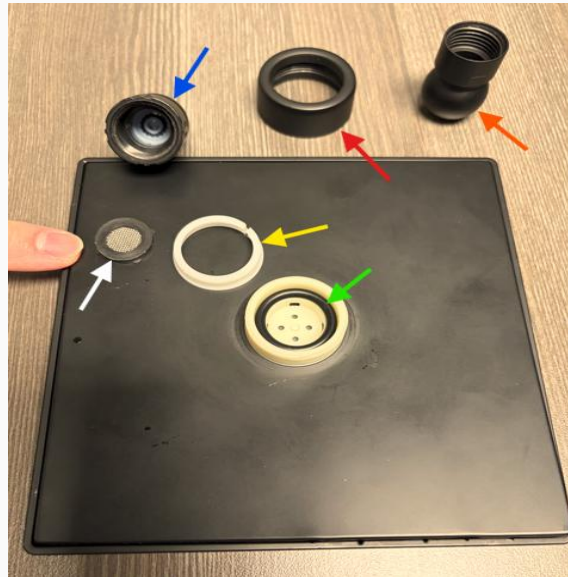
Fig. 2.1 — Shower head disassembled — sediment screen, boss nut, split ring, plastic fitting, metal fitting, and O-ring.

Step 2 — Twist off the plastic boss nut on the back of the shower head: hold the square part of the shower head and rotate the boss nut counterclockwise.

Step 3 — Note the position of the white plastic split ring on the plastic threaded pivot fitting, then remove the ring.

Step 4 — Install the split ring onto the metal threaded pivot fitting in the same orientation it had on the plastic fitting.

Step 5 — Position the metal threaded pivot fitting inside the opening on the shower head, seated against the rubber O-ring.

Step 6 — Reposition and hand-tighten the plastic boss nut until it is snugly in place.

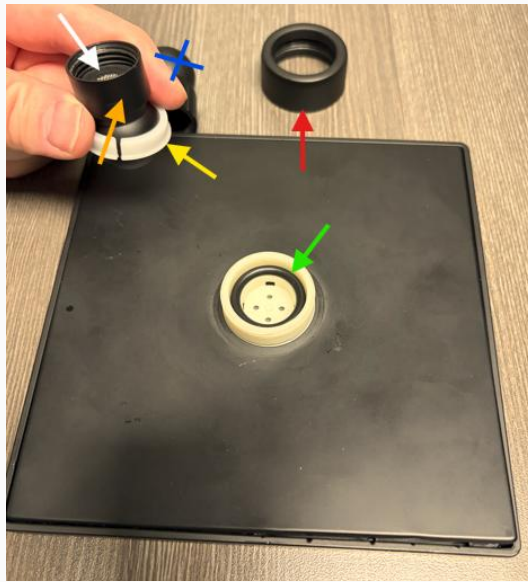
Fig. 3.1 – Shower head reassembly order – sediment screen into metal fitting.

Step 1 – Insert the rubber washer sediment screen into the metal fitting.

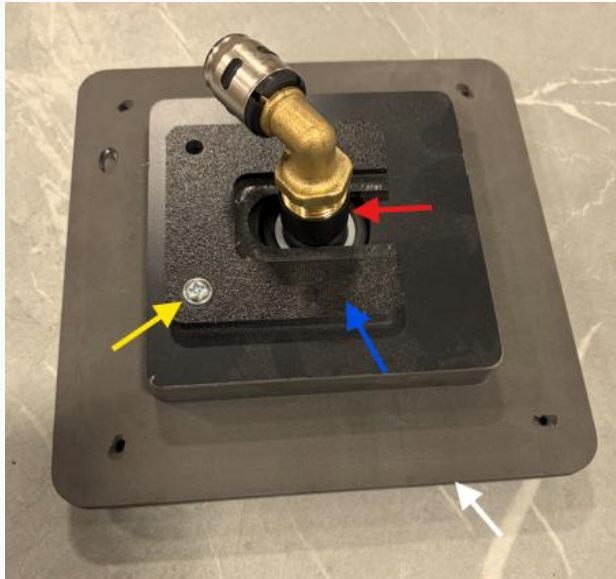
Fig. 3.2 — Shower head reassembled — service panel, supply line connection, keeper, and mounting screws.

Step 3 – Connect the metal threaded pivot fitting to the supply hose: support the supply line with one hand and hand-tighten the metal fitting until it is snug.

Step 4 – Re-install the machined plastic keeper around the metal threaded pivot fitting. Hand-tighten one #8 x 5/8" silver washer head screw with a clockwise motion.

Step 5 – Reposition the shower head service panel and hand-tighten the four #6 x 1" black flat head screws with a clockwise motion.
