Job Code:	M920035 – 26-008	Product:	Lineage LVT1
Date:	5/20/2026	Repair Time:	0.05 h

This bulletin describes the procedure to install the Compressor Power Relay Upgrade on affected Lineage units. The upgrade routes the A/C compressor positive power feed through a dedicated 120-amp relay, removing the compressor load from the control board. The upgrade is supplied as SDG kit 5000041 (GDRV PN 710676).

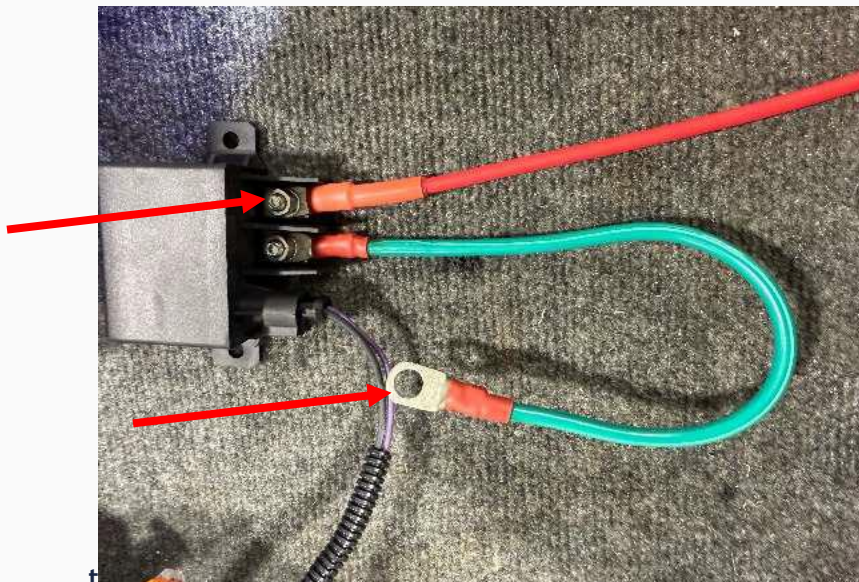
Fig. 1 — New 120-amp relay — compressor positive power wire and 12" power wire connections.

Step 1 — Access the chassis power strip or breaker where the compressor positive power wire is connected. Disconnect the wire and reconnect it to the new relay as shown.

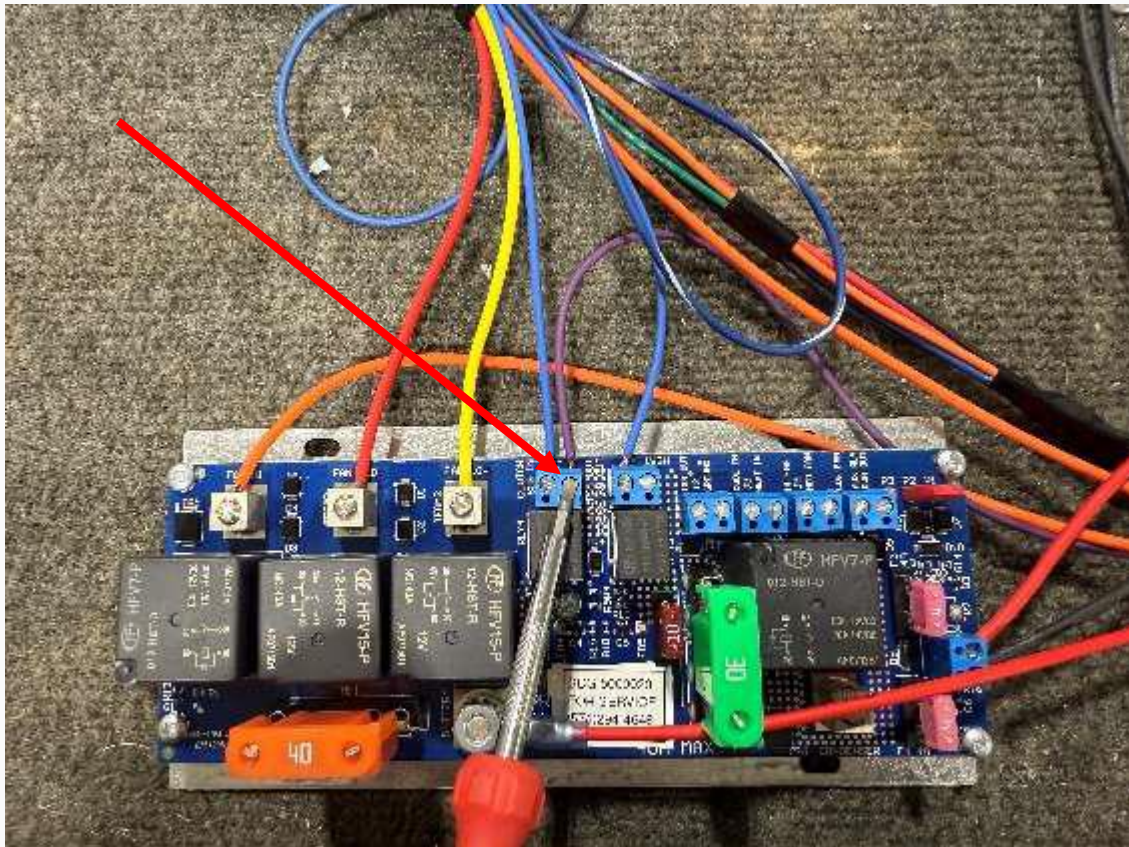
Fig. 2 – Control board — purple wire terminal location.

Step 3 – Remove the purple wire from the control board using a 1/8" screwdriver tip as shown.

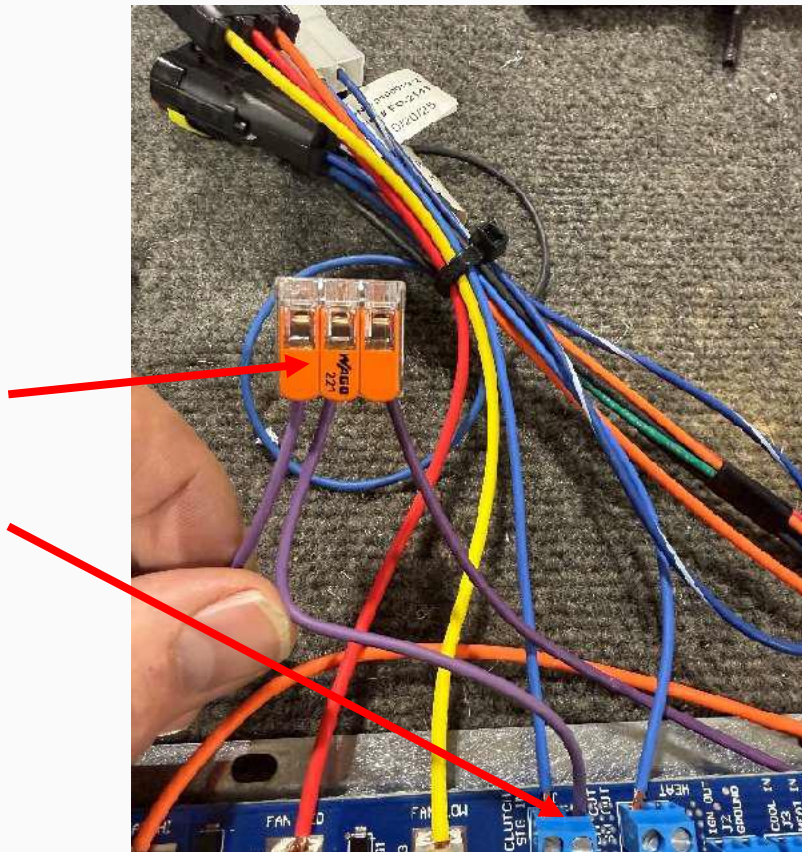
Fig. 3 — WAGO connector splice — removed purple wire and short purple wire to control board.

Step 4 – Connect the removed purple wire to the supplied WAGO connector as shown.

Step 5 – Connect the short purple wire on the WAGO connector back onto the control board in the same position the original purple wire was removed from.

Note: The replacement purple wire must go into the exact same control board position as the wire removed in Step 3.
