TECHNICAL SERVICE BULLETIN

TECHNICAL SERVICE BULLETIN: 53-2073
SERVICE CAMPAIGN: 001302

TECHNICAL SERVICE BULLETIN 53-2073 REMEDY INSTRUCTIONS

FOREST RIVER	Make(s): SHASTA Model(s): SST18FQ, SST28BHS, SST521CK Model Year(s): 2026-2027	Repair Code: SB-741-09-00-004840 Allotted Time: .40 HRS. Inspection Code: N/A Allotted Time: N/A
	Concern: The direct vent furnace was inconsistently installed with excessive gap to the cabinet.	Photo(s) Required: NO Prior Authorization Required: YES Part(s) Number: N/A Part(s) Return: NO

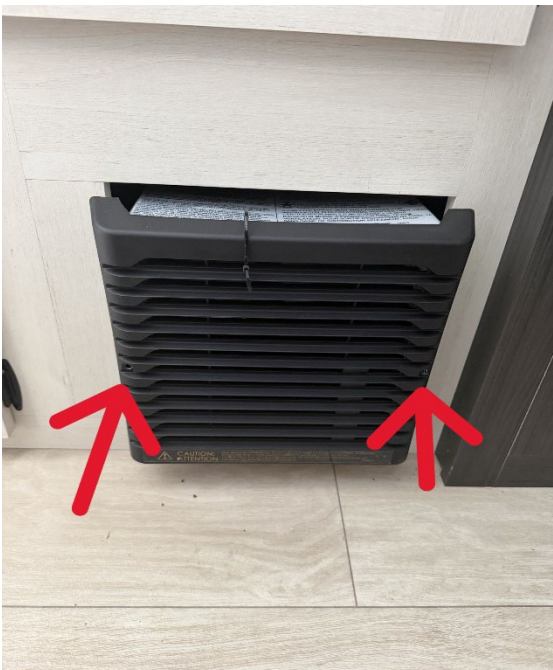
FIGURE 1

The furnace was inconsistently installed with excessive gap to the cabinet.

1. REMOVE SCREWS FROM FURNACE FLUE ON THE EXTERIOR OF THE UNIT AND LOOSEN SEAL
2. REMOVE THE 2 SCREWS FROM THE FRONT OF THE FURNACE GRILL ON THE INTERIOR OF THE UNIT (SEE FIGURE 1)
