Preview Solution CBR-2568-5

Contact Workshop; Communication Lost With Ultracapacitor Message With Associated CCIOM DTC U100687 And A Startability Issue.

Published 12 June 2026

Model Year - 2024 to Current

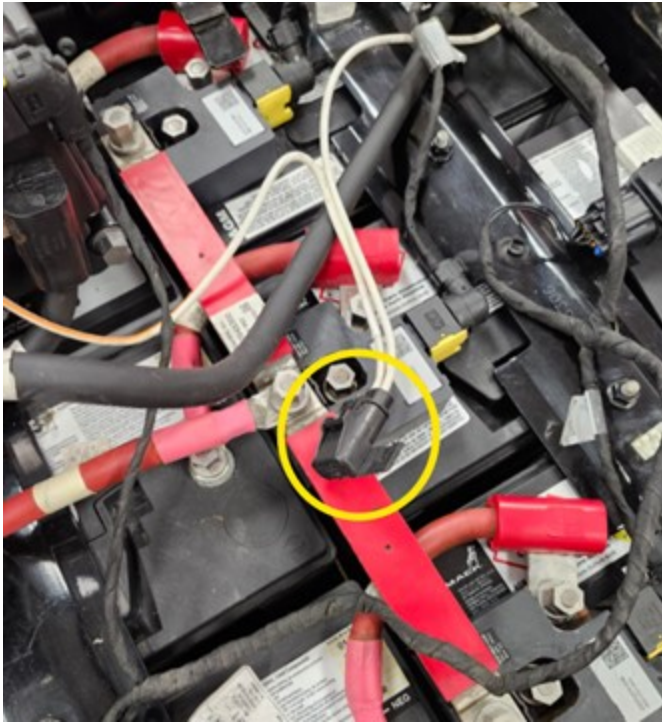
40 amp ground fuse:

1. Check the 40A ground fuse for the Ultracapacitor (UC) and the F38 40A positive fuse for the UC

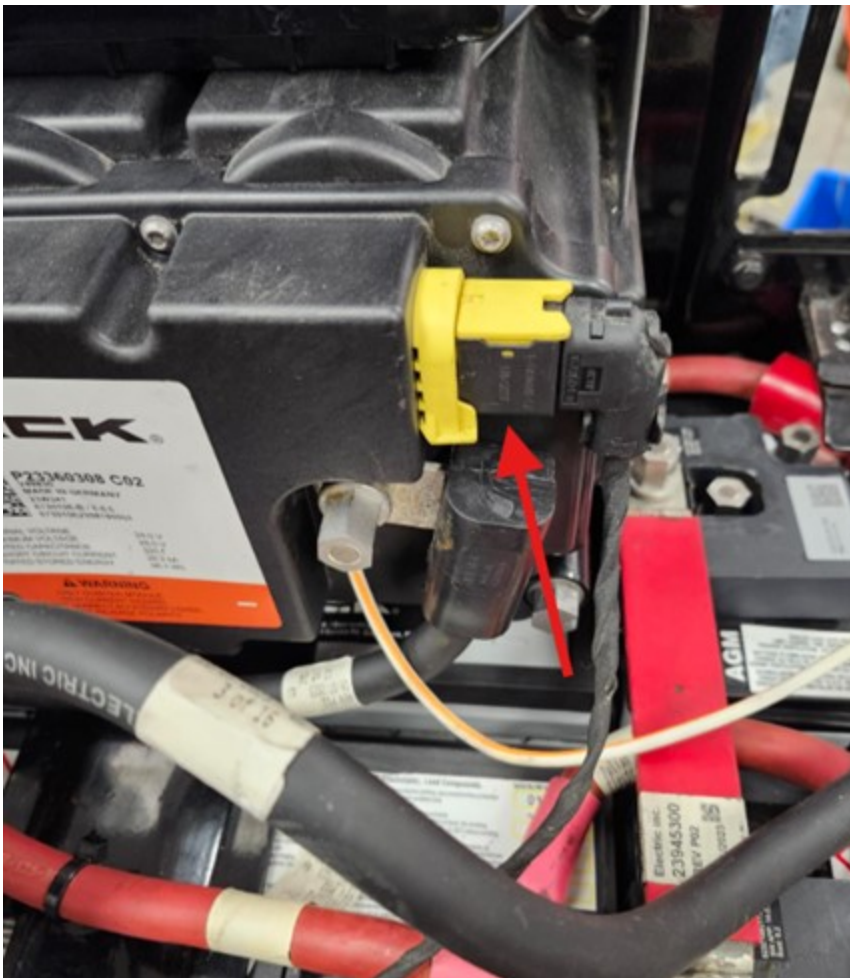
UC LIN connector:

2. Verify all power, ground, and LIN connectors into the UC and BPMU. Ensure all are connected and verify there is no damage

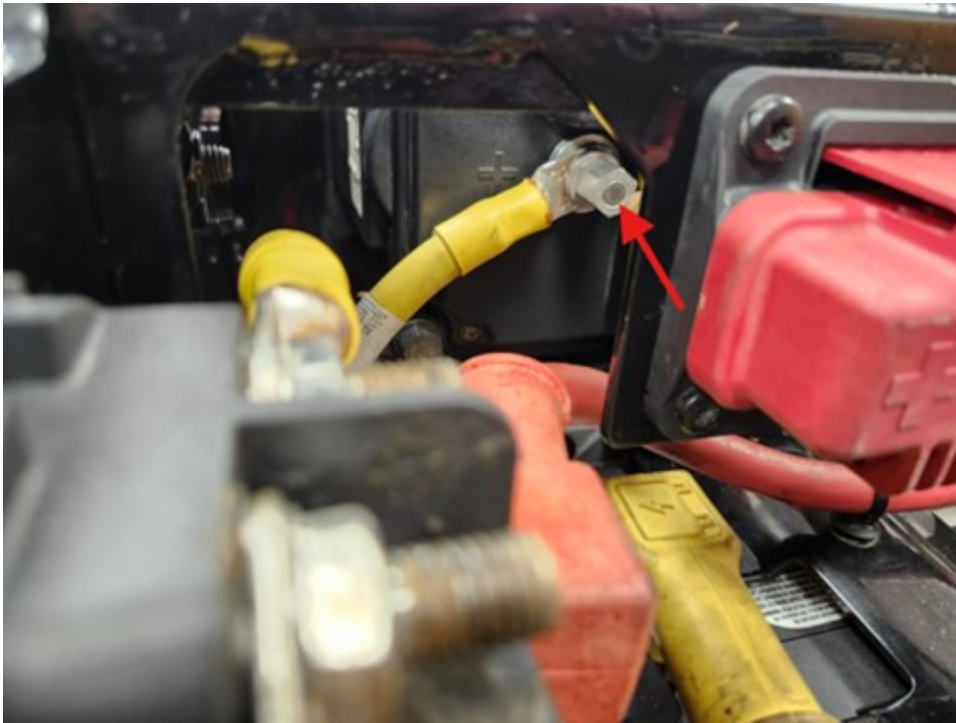
On the UC side:

4. Verify the voltage out of the BPMU into the UC

- If the voltage is less than 10V, attempt a "forced charge" of the UC by turning the key to position 2 (or ON with a green light on a push-button start vehicle) for a minimum of 5 minutes. Attempt a start cycling following this procedure.

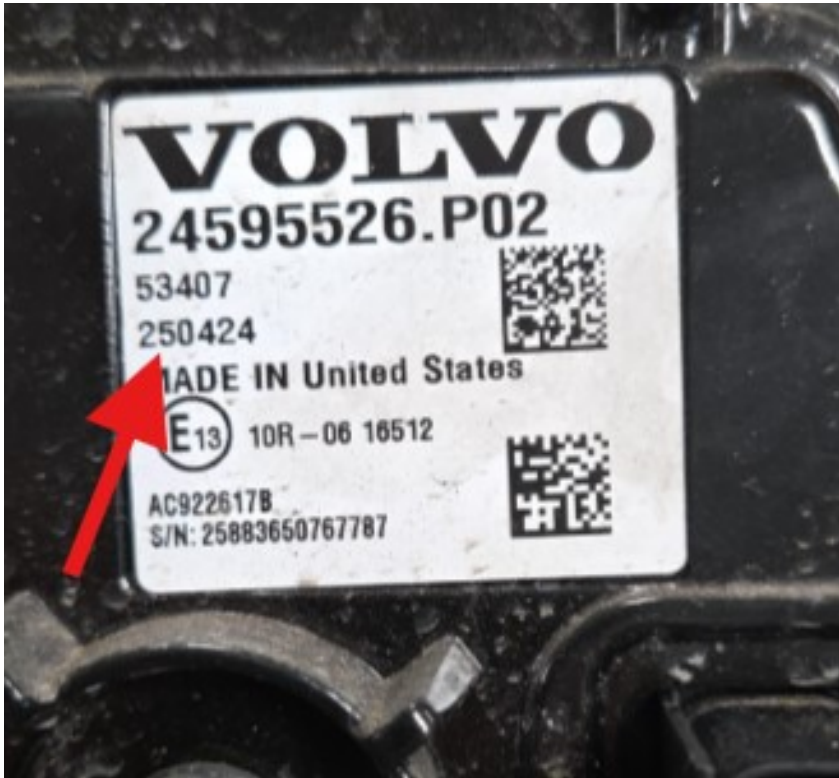
5. Record date code (YYMMDD) on BPMU and verify if there is/is not a green dot on the BPMU (see examples below).

Example of BPMU built prior to 6/4/2025:

If the date code is prior to 6/4/2025 (250604) and there is no green dot, the BPMU may be replaced.

ONLY Replace the BPMU if the Date Code is Within the Effective Range

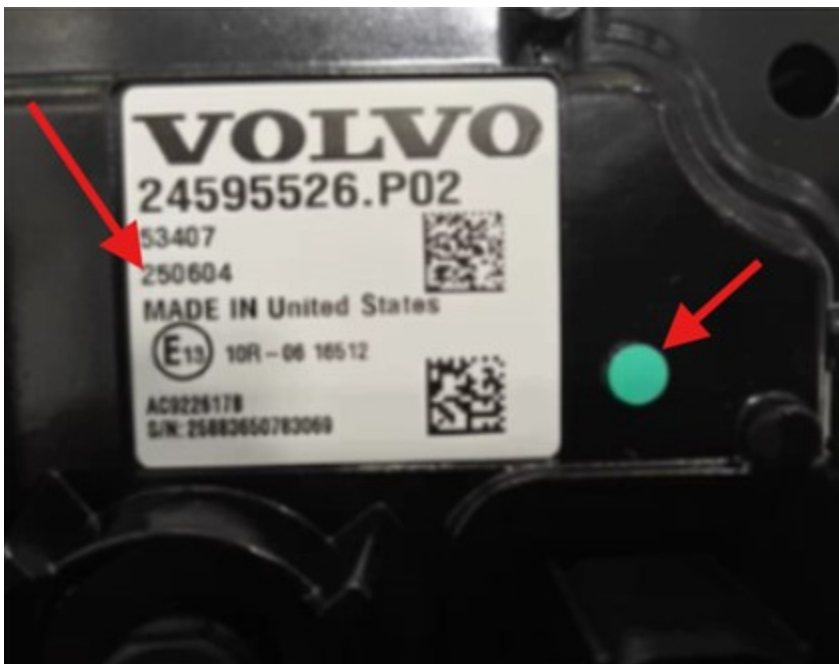
Example of BPMU built after 6/4/2025:
