Preview Solution CBR-2588-2

## **VMCU B1524-49 – Rain Sensor Internal Electronic Failure (Rain Sensor Will Not Calibrate) - AN (4) - PR - VN (4)**

Published 01 June 2026

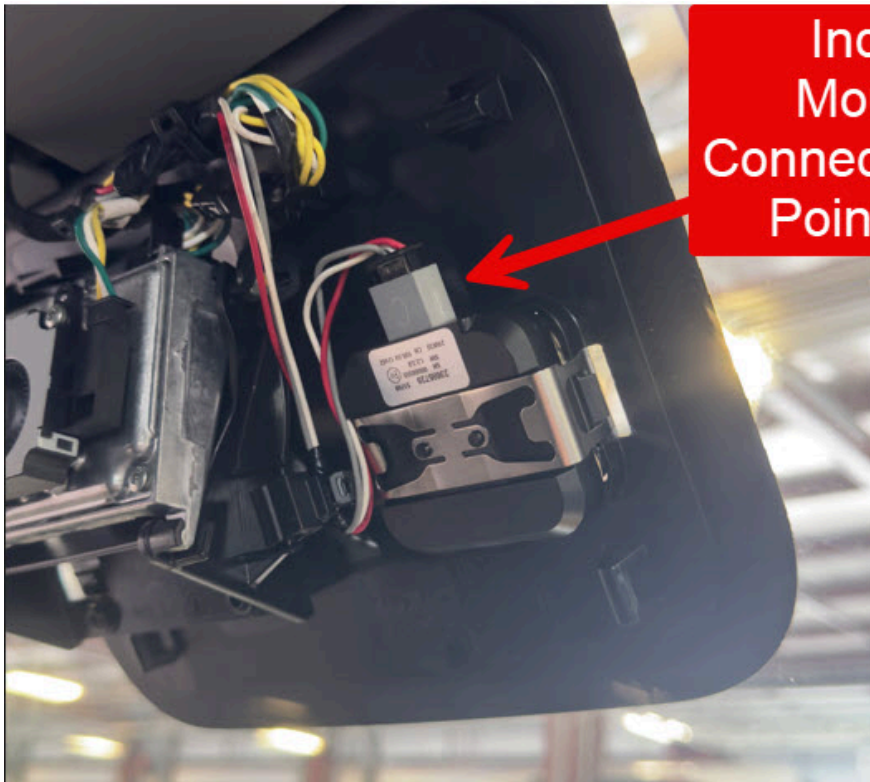
**Incorrect Mounting!  
Connector Should Point Down!**

If VMCU fault B1524-49 – Rain Sensor Internal Electronic Failure is encountered ensure the rain sensor is mounted correctly. This will be referenced in IMPACT operation ID 3639-03-02-12. The rain sensor electrical connection should be pointed down. If correct mounting is encountered with the fault code refer to PTT (Premium Tech Tool) and or WSTB (Workshop Toolbox) for further troubleshooting.
