Subject: Improvements in Trunk Lid Closing Bulletin Type: Field Fix Conditional

Bulletin No: TS35-FC-2602

Vehicle Model and Number of Vehicle:
TS35 - 83

Explain technical summary of the modification implemented:	The ventilation vents inside the vehicle have been removed. New ventilation vents have been added to the floorboard assembly.
Under what conditions is this service bulletin applicable?:	This procedure will be implemented if complaints are received regarding trunk lids not closing.

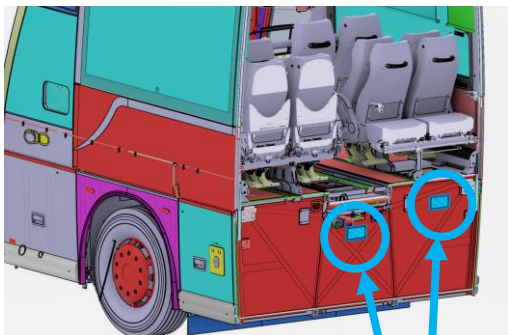
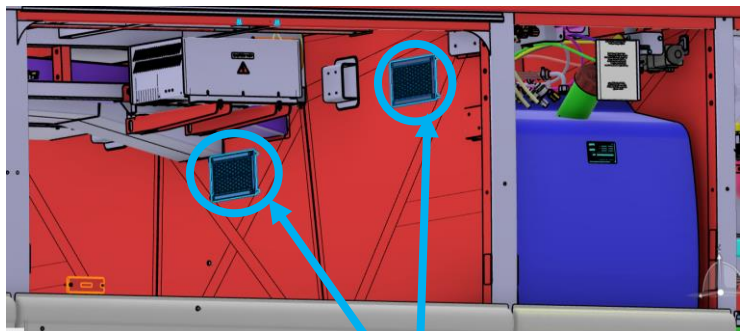
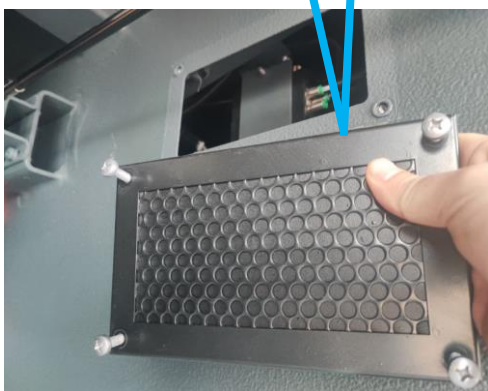
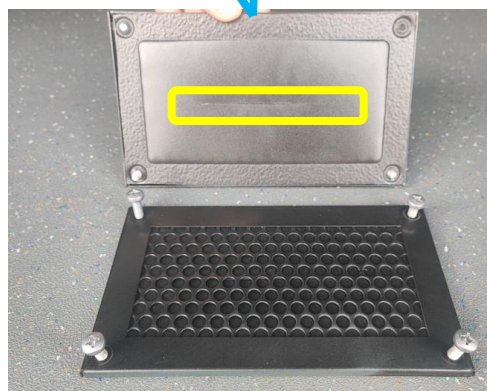
View from the vehicle for ventilation

1. The two air vents on the vehicle will be removed. The gap will be sealed by applying sealant to the area marked in yellow in the image below. The vents will then be reinstalled.

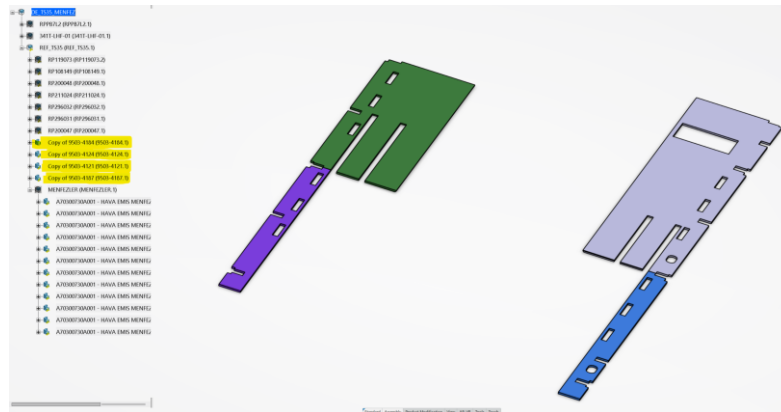
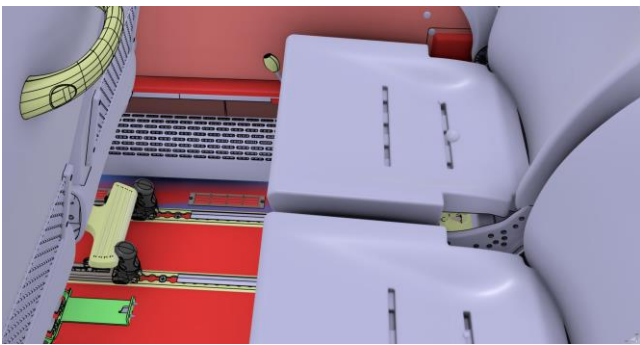
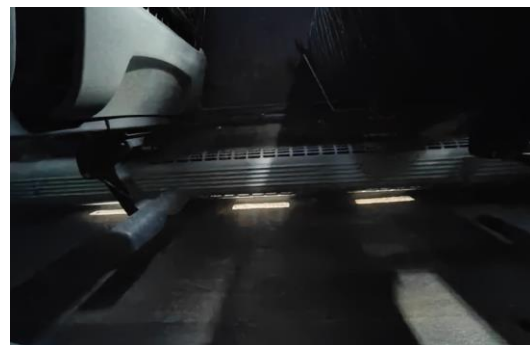
View from inside the vehicle

- New vents are required to be added, positioned on the inner side of the luggage compartment covers, mounted on the floor panels. Inside the vehicle, they will be located at floor level beneath the convector. Three vents will be added to each cover, resulting in a total of 12 new vents across the vehicle. The locations of these ventilation openings can be observed in both the technical drawings and the corresponding vehicle views provided in the following figures.

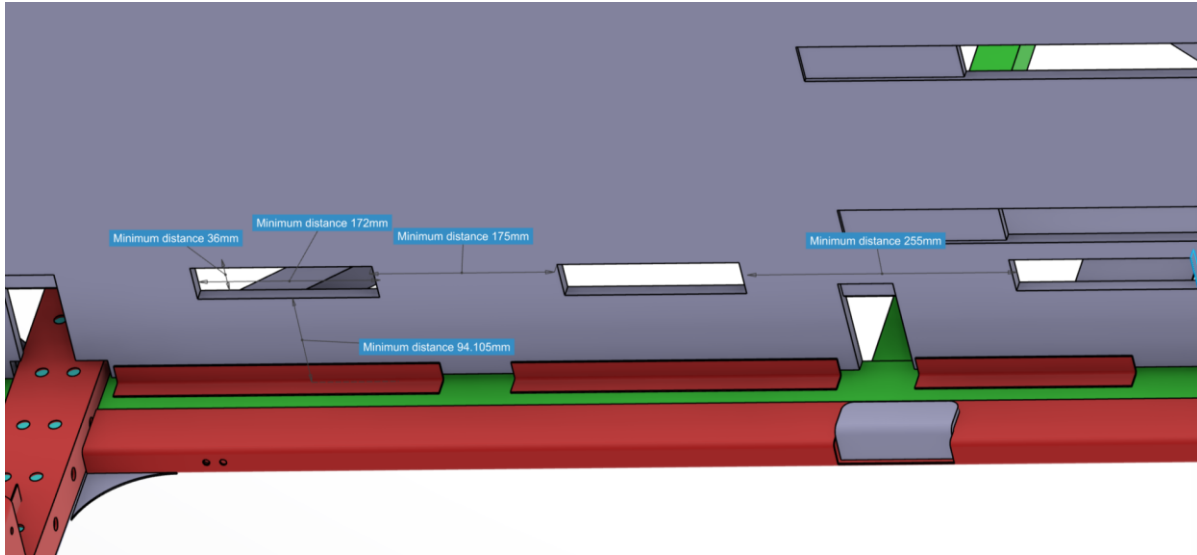
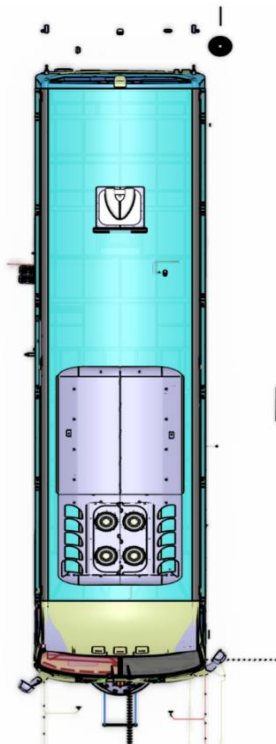
Top View of the Vehicle

3. The dimensional specifications for creating the vent openings on the floor board assembly, corresponding to parts (9503-4121, 9503-4124, 9503-4184 and 9503-4187) are indicated in the provided visual reference.

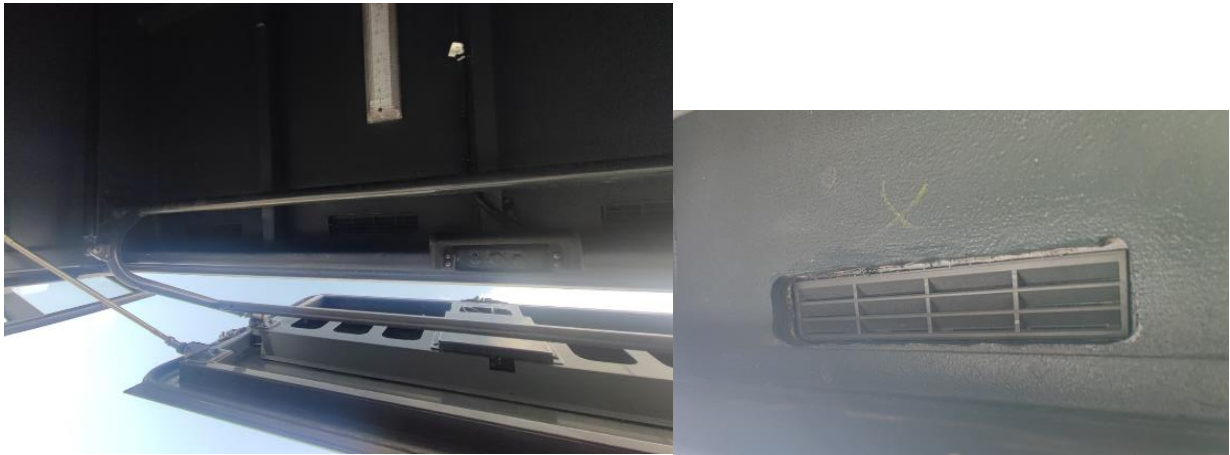
View of the vents from luggage compartment

4. Cut wooden bases to the specified dimensions for the ventilation holes in the luggage compartment. Do the same for the tarpaulin. Place the vents into the ventilation holes created inside the vehicle and secure them with screws.
