INSTRUCTION TO SERVICE

ITS: 61817		June 24, 2026
SECTION:	260-BATTERY COMPARTMENT	
SUBJECT:	ABS Batteries Software update procedure to version 8.6.3.3.51.13	
ISSUE	Software updates and improvements	
SUMMARY:	Software update to address isolation faults, HV contactor faults, and thermistor issues

ITS61817

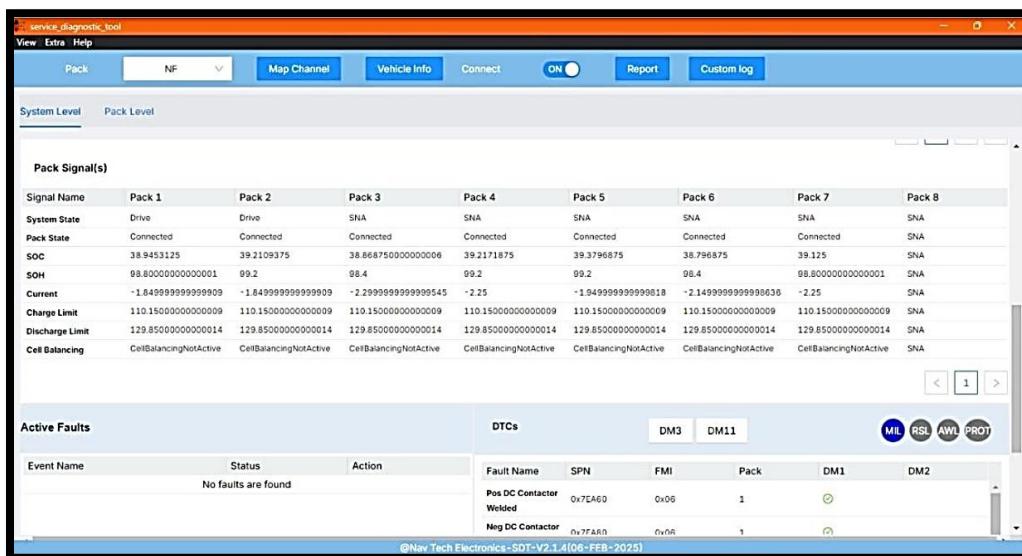
Figure 6 - System Level view

4.9. Verify that all packs (number will vary by contract) are online and healthy, and that there are no active faults or DTCs.

- 4.10. If a DTCs do exist, you can attempt running the “DM3” and “DM11” clear functions. Click the DM3 button, wait 30 seconds, click the DM11 button, wait 30 seconds, cycle the MRS to the OFF position. Make sure all VMM’s power down to sleep. close and reopen the diagnostic software and repeat steps 4.4 - 4.10.
- 4.11. If the issue persists, contact ABS service or NFI engineering support.
- 4.12. Once the vehicle is confirmed to be in a healthy state, toggle the Connect option to “OFF” and begin the flashing process.

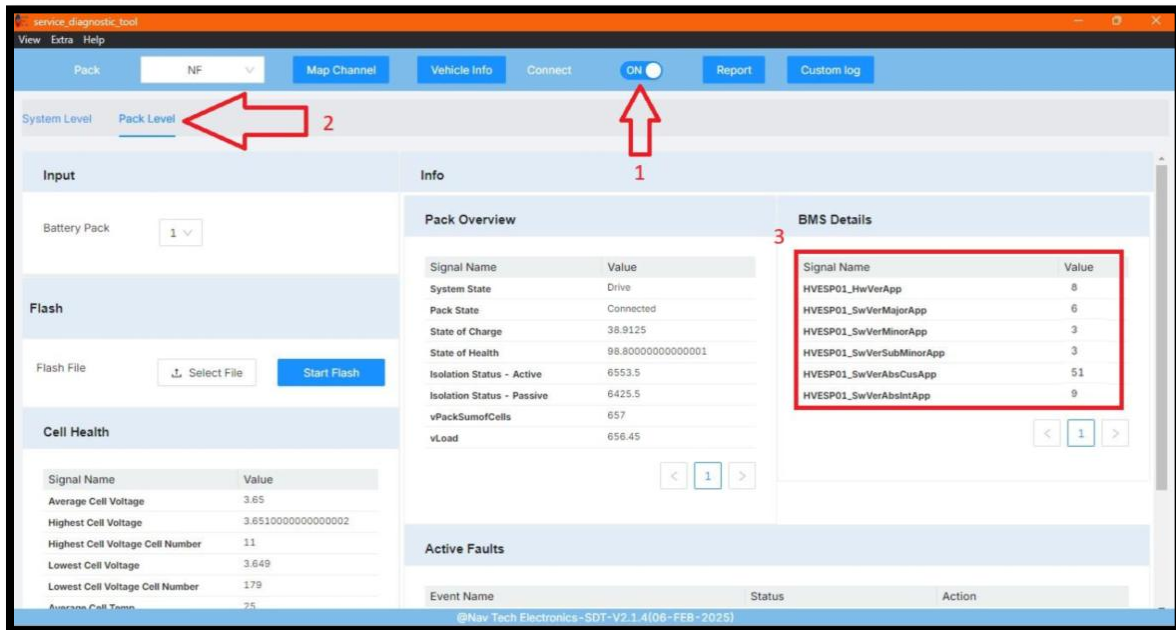
Figure 9 - BMS Details

- 6.1. Connect the PEAK tool to the port on the vehicle that monitors the ESS.
- 6.2. Turn MRS (T15) to the ON position.
- 6.3. Wait approximately 5 minutes, to ensure the ESS has time to fully wake up.
- 6.4. Open the SDT and navigate to the **pack level** screen. Verify that there are no active faults and the correct revision is listed under the “BMS Details” - **v8.6.3.3.51.13**

Verify no active faults
