PERSONAL SERVICE LAB

# MC20 Seat Strap Button Repair Procedure

DATE: JUNE 24, 2026

**MODELS:** MC20 (Coupè and Cielo) ALL MY.

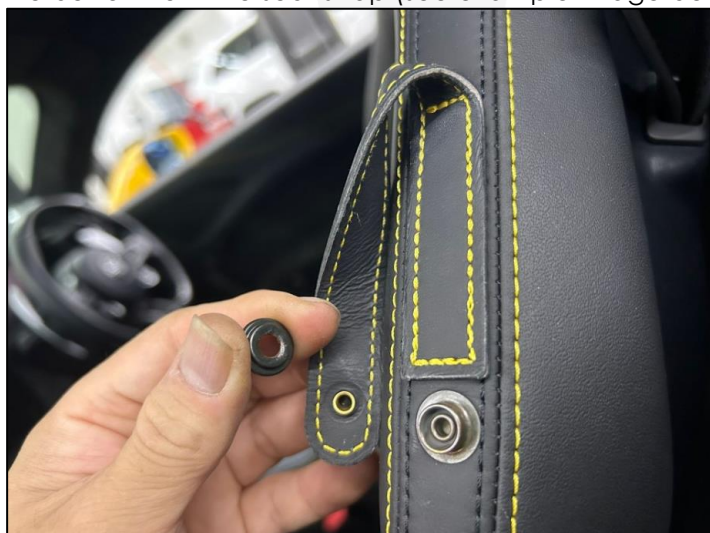
Detachment of the button from the seat strap (see example image below).

1. Open a Blue On Line (BOL) as "Mandatory & Support Request" and provide the address where the button is to be shipped; the Product Support Team will send it directly from the factory.
2. Once the button has been received, and before carrying out the restoration procedure, please follow the procedure indicated for interior protection:
