RAPID UPDATE

Rapid Update 825 Maserati GranTurismo – Oil Sensor Wiring Check

DATE: June 30, 2026

VEHICLES INVOLVED: (M189) GranTurismo, (M190) GranCabrio MY24 – MY26

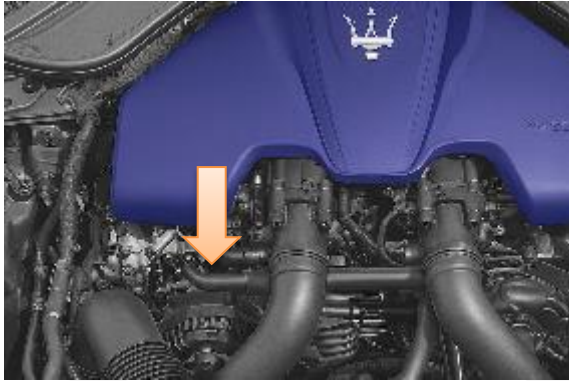
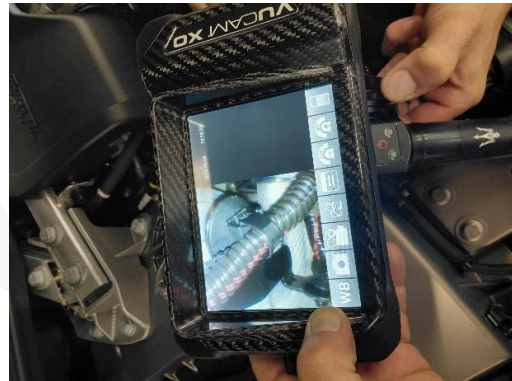
1. Always check ModisCS+ to see if the vehicle is involved in this action and if it has not been previously performed.
2. Before performing any operation, disconnect the battery following the workshop manual procedure:
 - a. **8.20.001 - BATTERY - Power supply Connecting/disconnecting**
3. Open the front hood and locate the alternator. **Note:** An endoscope is required for this inspection.
4. Insert the endoscope probe behind the alternator to identify the wiring harness and its retaining clip.

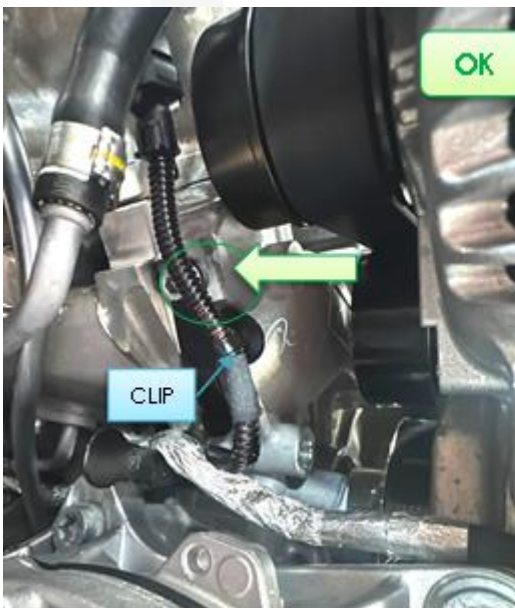
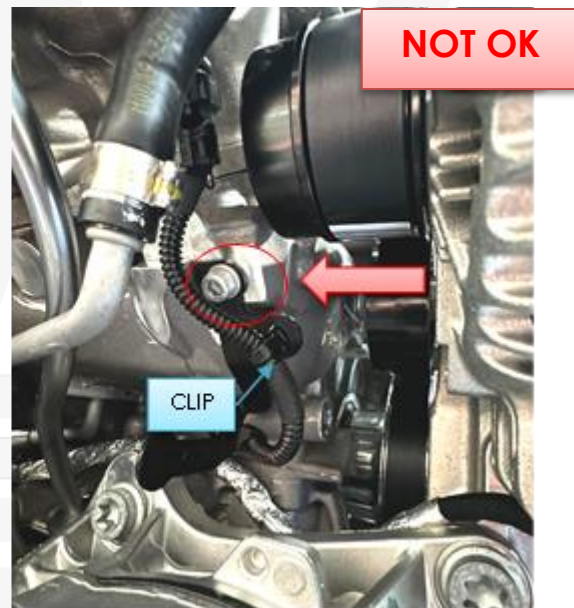
5. Check that the wiring harness is positioned **as far as possible from the alternator pulley** and no excessive slack or deformation is present that could allow contact.

Note: As a reference, locate the bracket screw. The cable must be **routed above the screw, without bends.**

- a. Leave the endoscope in place for visibility.
- b. Reach the harness beneath the retaining clip.
- c. Apply a slight pull to the harness.
- d. Slide the harness into the clip to remove excess slack.
- e. Verify the harness is routed above the bracket screw.
