Service Engineering Operations
Customer Service Division

TO: All U.S. Ford and Lincoln Dealers
SUBJECT: **Customer Satisfaction Program 25N10 – Supplement #1**
Certain 2017-2025 F-450 – F-600 Chassis Cab Upfitted with an Aerial Bucket
Frame Rail Crack
REF: **Customer Satisfaction Program 25N10**
Dated February 11, 2026

CERTAIN 2017-2025 F-450 - F-600 CHASSIS CAB UPFITTED WITH AN AERIAL BUCKET — FRAME RAIL CRACK

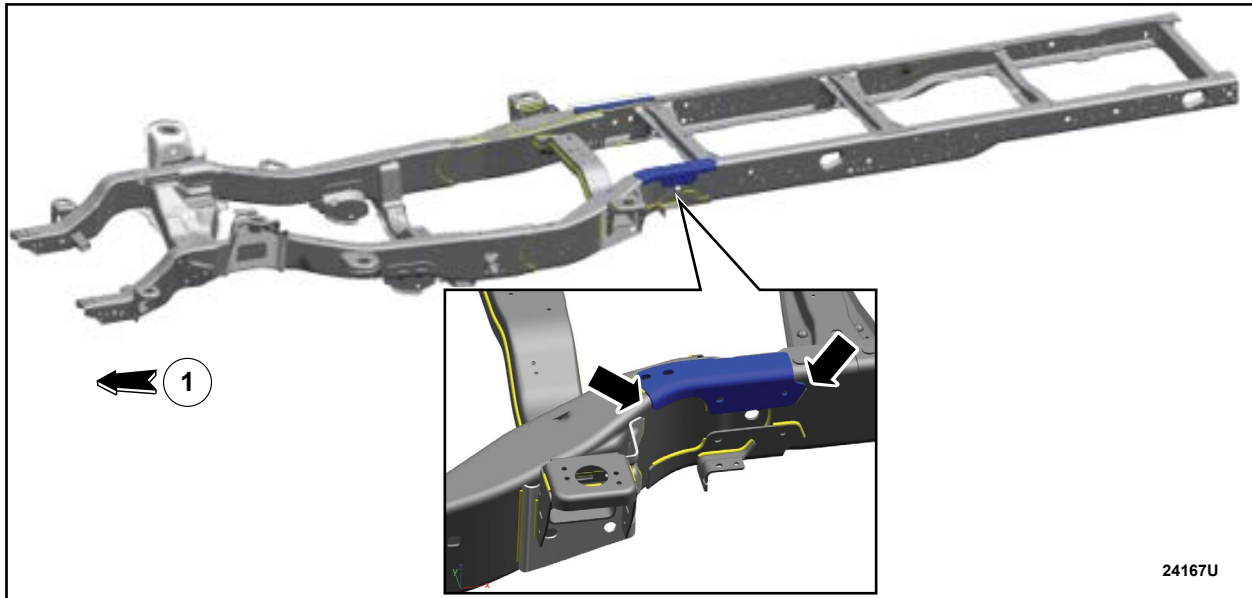
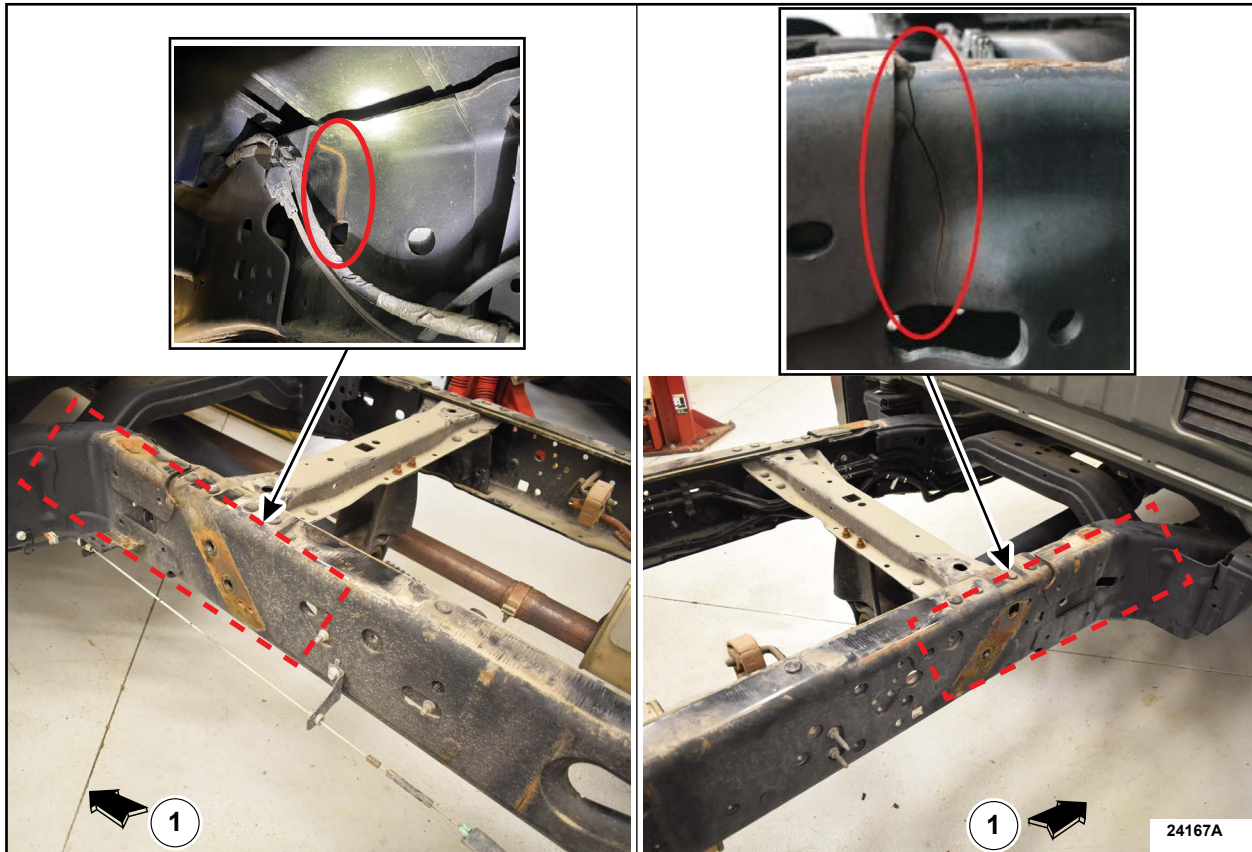
LOCATION 1 - UPPER FRAME RAIL BEHIND CAB - See Figures 1 and 2.

In some of the affected vehicles, the Aerial Bucket Second Unit Body (SUB) upfits could cause stress points on the frame rail. Over time, this stress could cause a crack in the frame rail.

1. Identify and inspect the areas where the frame rail may exhibit signs of stress or a crack. See figures 1 through 6. Using compressed air, clear any debris that may be on the frame rails.

If an affected vehicle exhibits this condition, dealers are to replace the frame assembly at no charge to the vehicle owner. For new vehicle storage guidelines, refer to EFC13033, Storage Guidelines for New Vehicles.

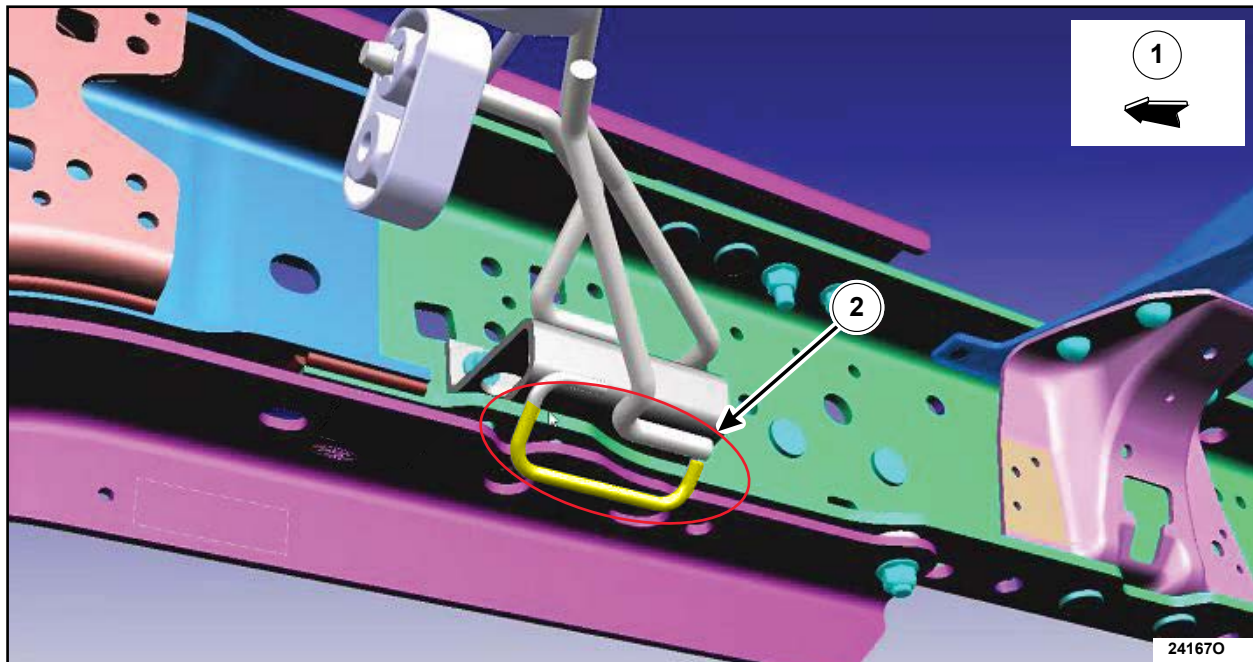
FIGURE 29

1. The right hand side exhaust hanger will interfere with right hand side lower reinforcement bracket.
Figure 29 shows the portion of the exhaust hanger that will be removed in order to obtain the clearance needed.

- (1) Front of Vehicle.
- (2) The portion of exhaust hanger to be removed in yellow.

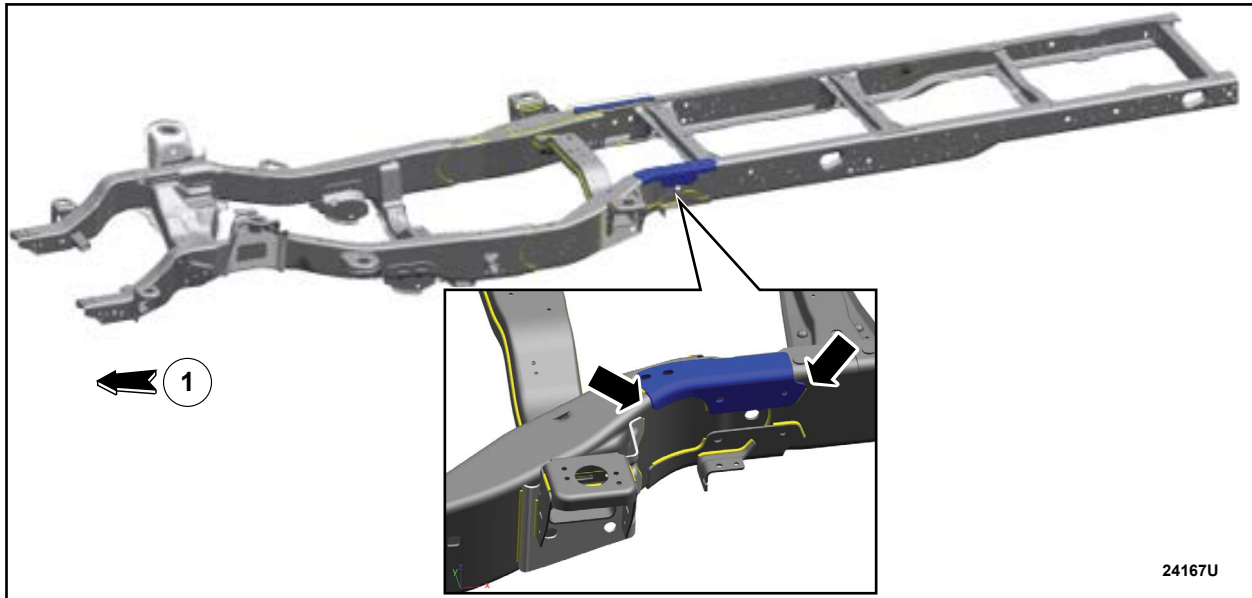
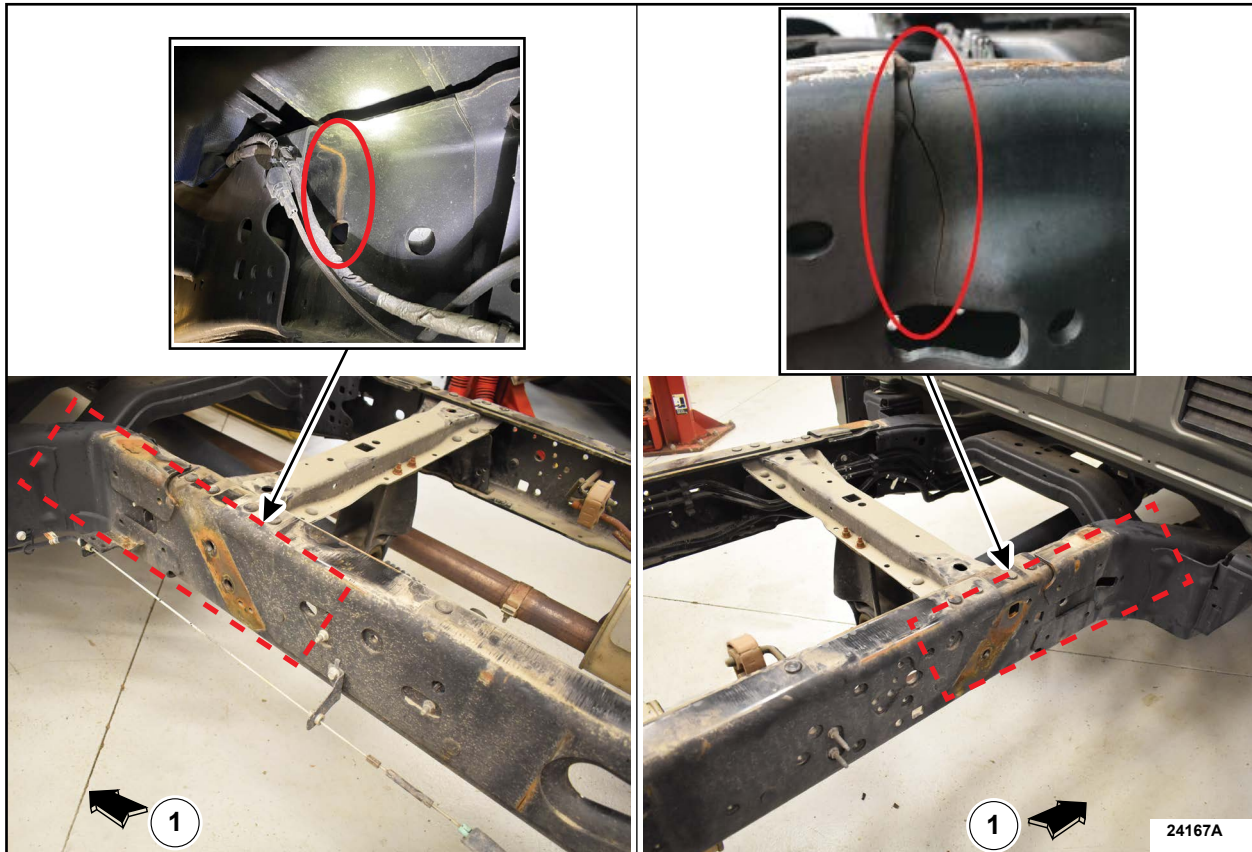
LOCATION 1 - UPPER FRAME RAIL BEHIND CAB - See Figures 1 and 2.

1. Identify and inspect the areas where the frame rail may exhibit signs of stress or a crack. See Figures 1 through 6. Using compressed air, clear any debris that may be on the frame rails.
