2027MY  
Telluride Hybrid  
(LQ2 HEV)

116 (Rev 1, 06/26/2026)

## TECHNICAL SERVICE BULLETIN

SERVICE ACTION: TRANSAXLE ASSEMBLY  
REPLACEMENT (SA648)

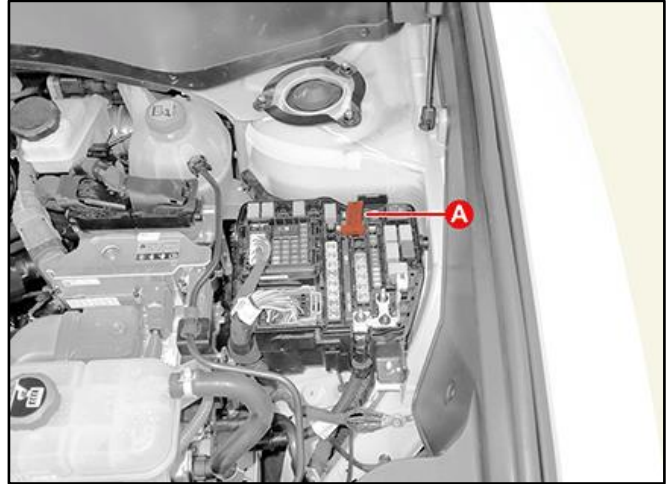
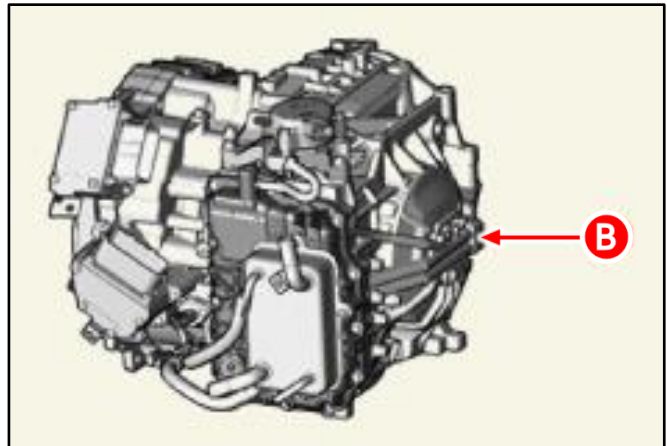
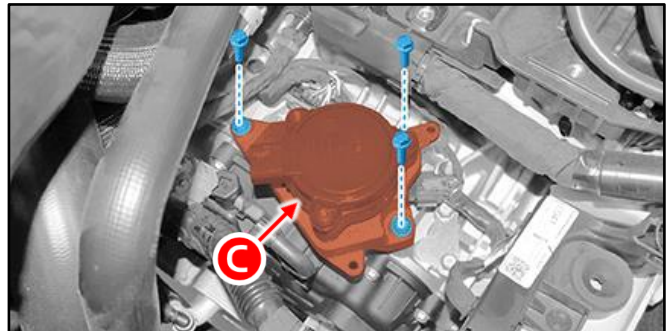
This bulletin provides information to replace the transaxle assembly on certain 2027MY Telluride Hybrid (LQ2 HEV) vehicles produced from February 02, 2026, through March 20, 2026. The affected vehicles may exhibit a rough 3rd → 4th gear upshift and/or 5th → 4th gear downshift accompanied by an illuminated malfunction indicator lamp with DTC P073500 stored. Follow the procedure outlined in this publication to replace the transaxle assembly on the applicable vehicle. Before conducting the procedure, verify that the vehicle is included in the list of affected VINs.

1. Perform the '**High Voltage Shut-Off Procedure**' (A) by referring to "Body Electrical System → High Voltage Shut-Off Procedures → High Voltage Shut-Off Procedures (**Steps 1-4 Only**)" in the applicable Shop Manual on KGIS.

2. **Replace** the automatic transaxle assembly (B) by referring to "Automatic Transaxle System → Automatic Transaxle → Automatic Transaxle → Removal → Installation" in the applicable Shop Manual on KGIS.
3. Reinstall all removed parts in reverse order of removal.

**Note: Transfer the electronic shift actuator (C) to the new transaxle assembly (B).**
