**PRODUCT CAMPAIGN BULLETIN**

**APPLICABILITY:** 2026MY Forester **NUMBER:** WRF-26R

**SUBJECT:** Safety Recall and Stop Sale: Forester **DATE:** 05/28/26

Power Moonroof Glass Adhesion **NHTSA ID:** 26V346

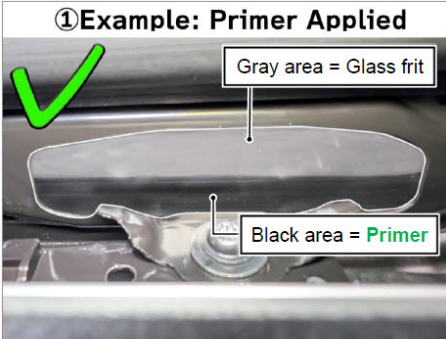
<b>JUDGEMENT CRITERIA</b>	
<b>Is primer applied at all six inspection locations?</b>	
OK (Primer Applied)	NG ( No Primer Applied)
<p><b>① Example: Primer Applied</b></p>

<b>Results</b>	
<b>OK</b>	If any primer is found at all 6 location on the lid assembly-sunroof it is acceptable, reinstall the lid covers. This completes the procedure.
<b>NG</b>	If primer is not applied to one or more of the six inspection locations, the part is considered defective. Proceed to step 2.
<b><u>For additional example see Appendix A</u></b>

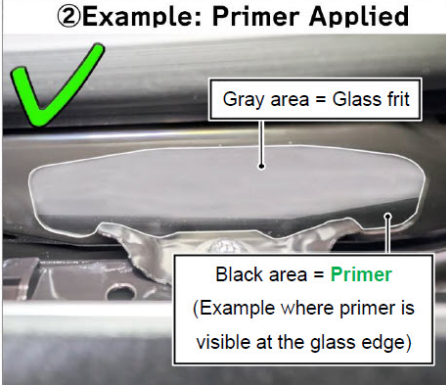
<p><b>② Example: Primer Applied</b></p>

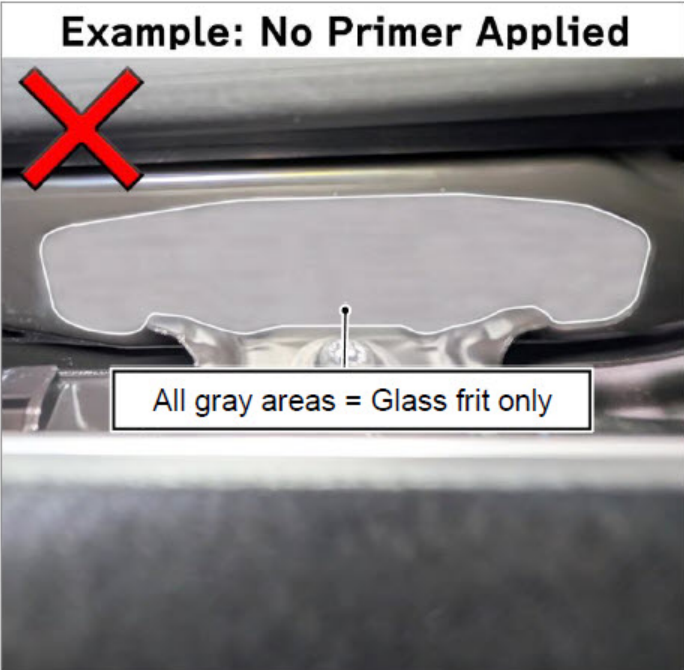
<p><b>Example: No Primer Applied</b></p>

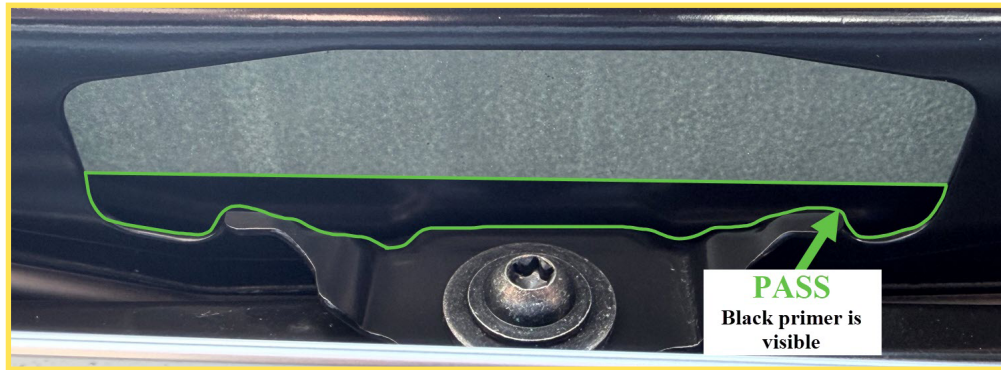
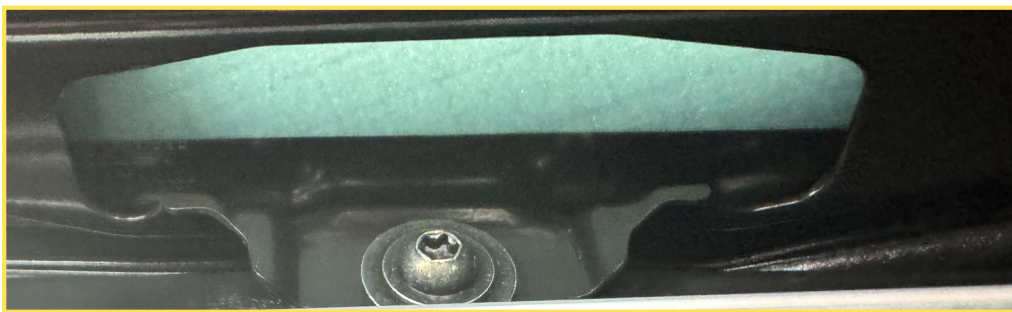
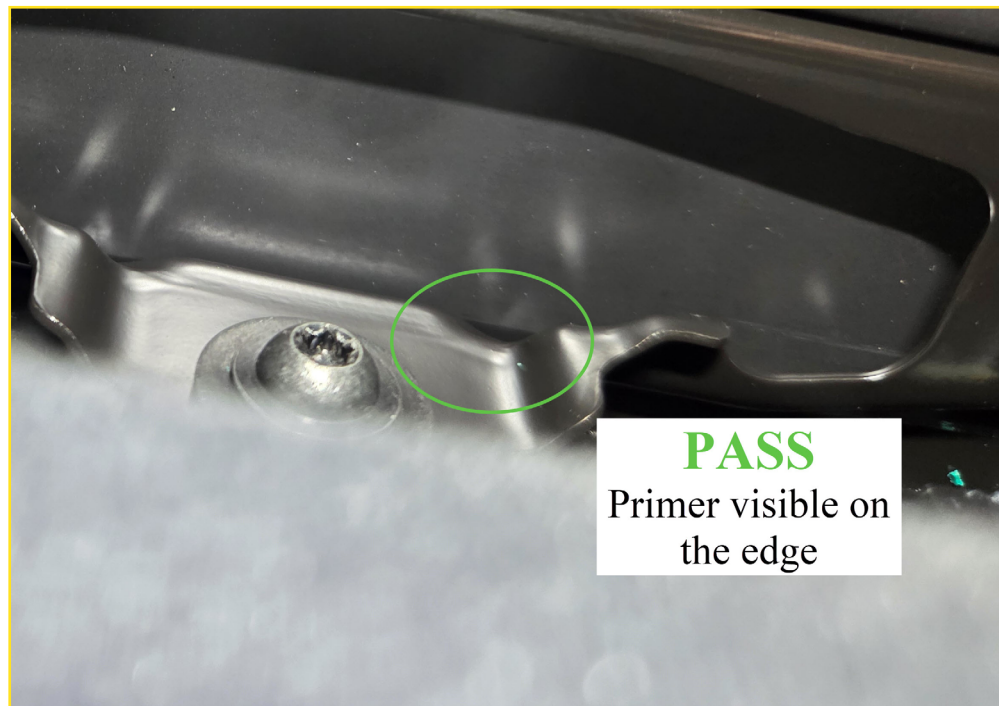
# Appendix A

Additional examples of acceptable primer application on the sunroof lid assembly.

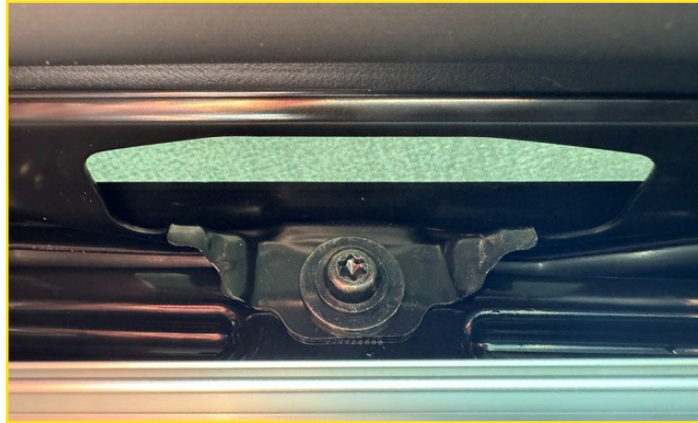
This image was taken outdoors in sunlight with no additional lighting.

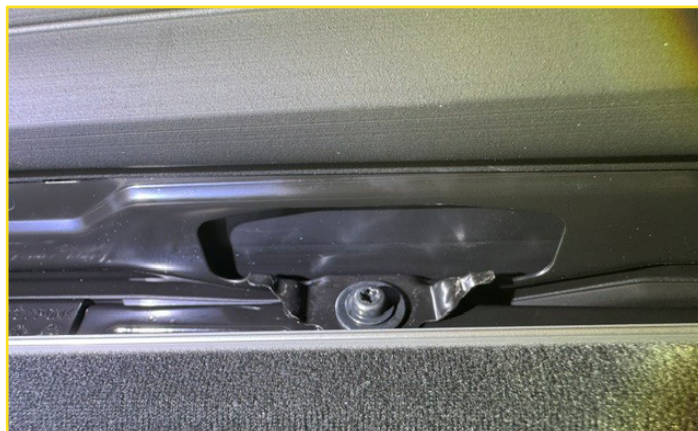
This image was taken indoors with a flashlight positioned inside the vehicle.

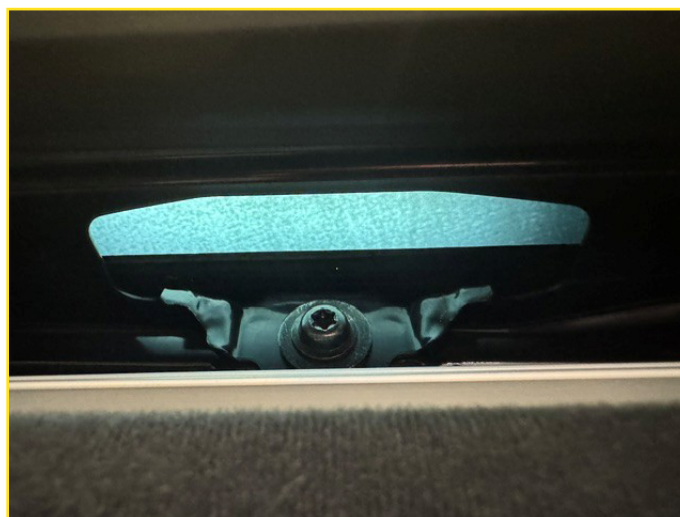
This image was taken indoors with a flashlight positioned outside the vehicle aimed toward the opposite side of the glass.

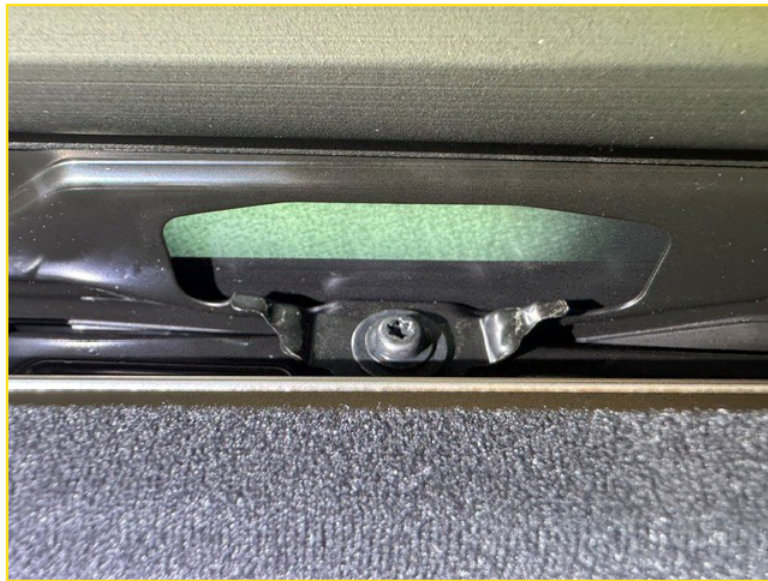
This image was taken indoors with a flashlight positioned outside the vehicle aimed toward the opposite side of the glass and an additional flashlight positioned inside the vehicle.
