SERVICE BULLETIN

APPLICABILITY: 2019-24MY Ascent
2020-24MY Outback & Legacy 2.4L

NUMBER: 09-130-25R

SUBJECT: Exhaust Manifold Flange Nut / Torque & Design Change

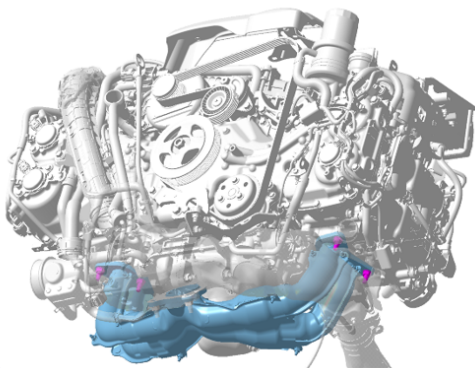
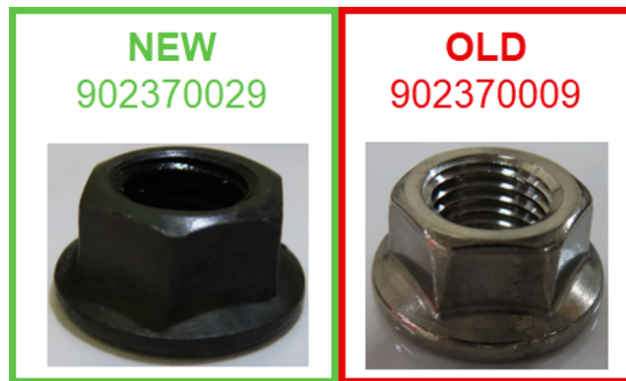
DESCRIPTION OF DESIGN CHANGE:

This bulletin announces the design change made to the exhaust manifold flange nuts. The material has been changed from **stainless steel** to **medium carbon steel**. This change also necessitates a revised tightening torque specification. When replacement of the flange nuts is required, follow the part and service procedure information outlined in this bulletin.

NOTE: The new and old flange nuts should not be interchanged and always replaced as a set.

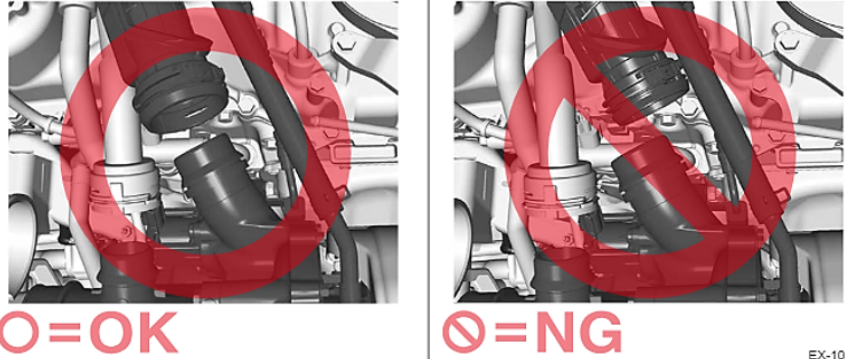
EX-10383

O=OK **X=NG**

The torque procedure has been changed from a one-time torque of 65 Nm (6.6 kgf-m, 47.9 ft-lbs) to a two-step procedure with an initial torque of 55 Nm (5.6 kgf-m, 40.6 ft-lbs) then a final torque of 65 Nm (6.6 kgf-m, 47.9 ft-lbs). A section of the Service Manual is pictured below. The added service procedure (4.) has been outlined in **RED** and will be added to the applicable Service Manual in the future.
