SERVICE INFORMATION BULLETIN

APPLICABILITY: 2026+ Outback 2.5L
 2026+ Impreza & Crosstrek 2.5L
 2026+ Forester

NUMBER: 18-243-26
DATE: 06/10/26

SUBJECT: FB2.5 Oil Spacer / Service Manual Correction

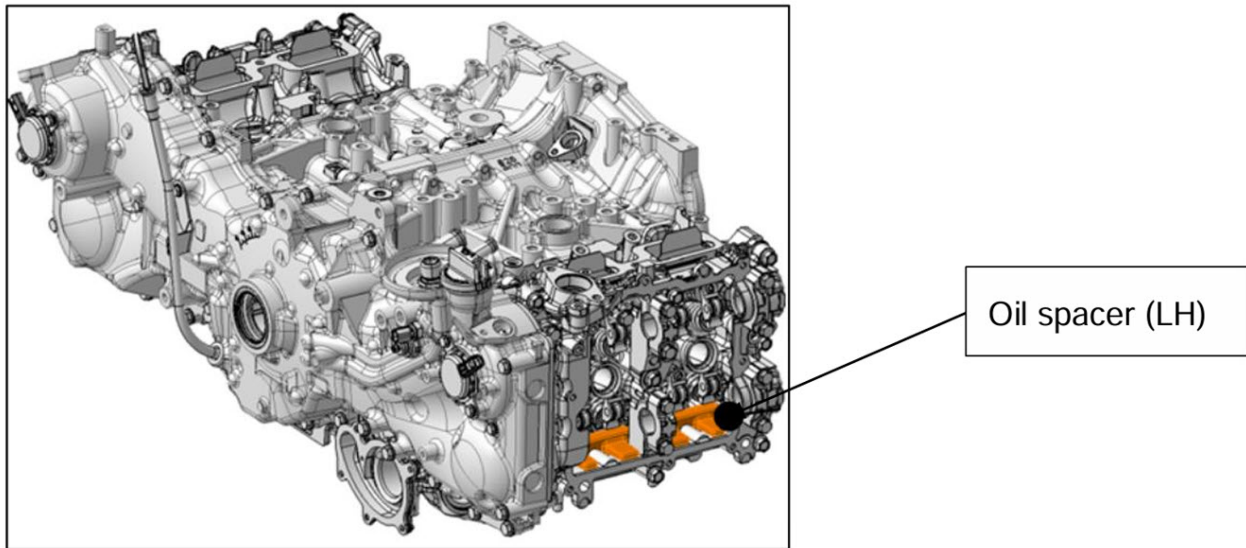
This service information bulletin announces the elimination of oil spacers from both left- and right-side camshaft carriers on FB2.5 engines. Oil spacers and related hardware were removed during some production stages. This update does not affect performance and will be added to the Service Manual in the future.

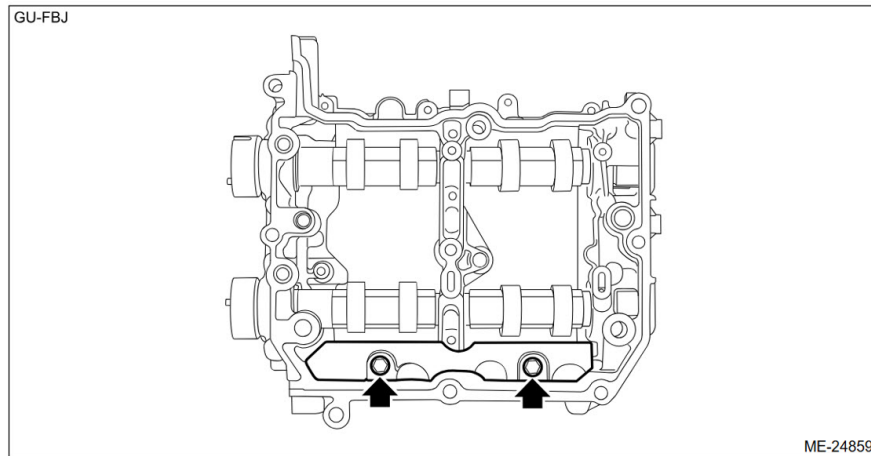
4. Install the oil spacer to the cam carrier

Some FB2.5 engines removed oil spacers from production. If oil spacers are missing during camshaft carrier servicing, there is no need to install new ones. If the engine has oil spacers and they are removed during servicing, reinstall them as per the applicable Service Manual.

Tightening torque:

6.4 N·m (0.7 kgf-m, 4.7 ft-lb)
