SERVICE BULLETIN

APPLICABILITY: 2018-2021MY Crosstrek 2.0L DI & PHEV
 2017-2021MY Impreza 2.0L DI
 2021MY Crosstrek 2.5L DI
 2019-21MY Forester 2.5L DI
 2020-22MY Legacy & Outback 2.5L DI

NUMBER: 09-81-21R

SUBJECT: Fuel Injector- Design Change
 Misfire DTC P030* / Engine Knocking / DTC P219C-D-E-F

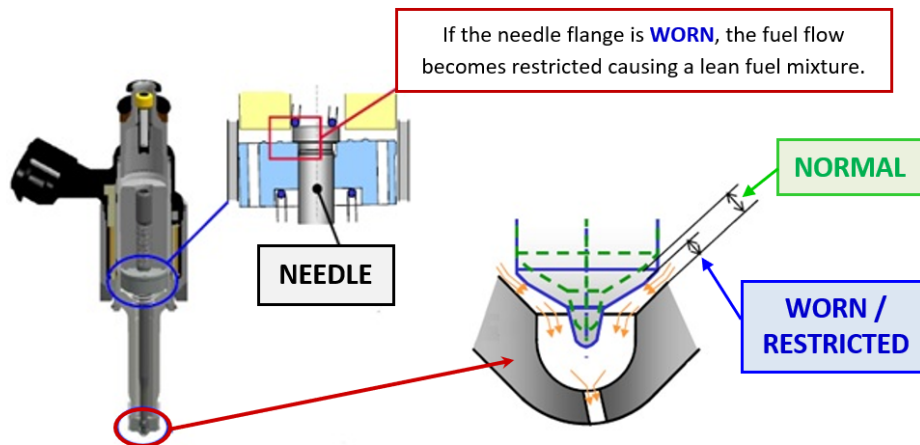
FUEL INJECTORS: The new fuel injector tips have changed from 3 holes to 6 holes to reduce the fuel pulsation.

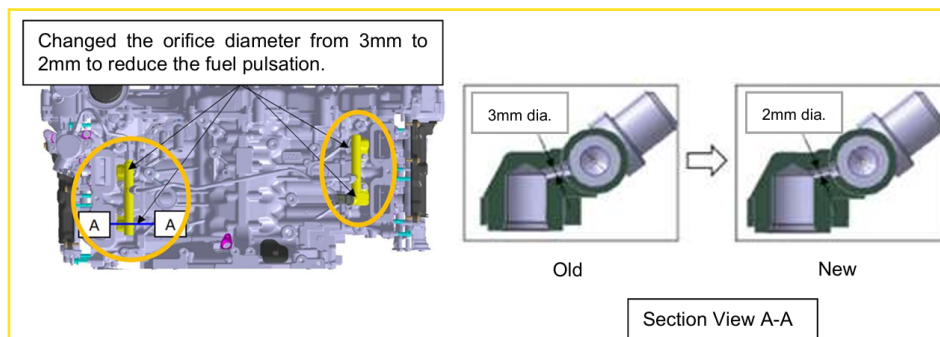
FUEL PIPES (Impreza/Crosstrek w 2.0L ONLY): The fuel pipe orifice diameter has changed from 3mm to 2mm to reduce fuel pulsation.
