**SERVICE BULLETIN**

**APPLICABILITY:** 26MY Outback Models including Wilderness models

**NUMBER:** 15-336-25R

**SUBJECT:** FOTA (Firmware Over-The-Air) Reprogramming for DENSO Gen 5 CP25 Audio Navigation Infotainment Systems via DCM

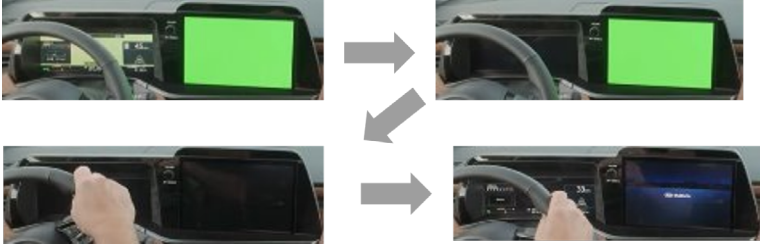
No	Category	Symptom
1	Launch Navigation	<p>The CID display becomes unstable, and then the meter and CID restart.</p>

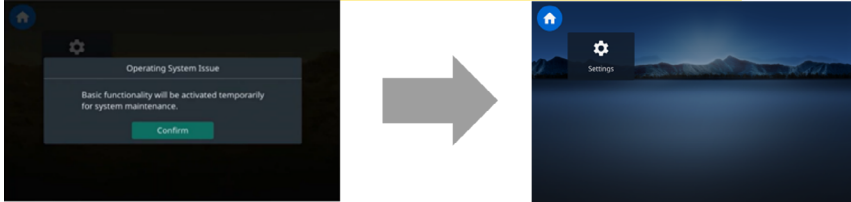
2	Launch Navigation	<p>After navigation startup, an “OS System Issue” pop-up appears.</p>
