**SERVICE BULLETIN**

**APPLICABILITY:** 2020+ Outback 2.4L  
 2020-25MY Legacy 2.4L  
 2019+ Ascent  
 2022+ WRX

**NUMBER:** 02-196-26  
**DATE:** 06/22/26

**SUBJECT:** White Exhaust Smoke /  
 Diagnostic and Repair Procedure

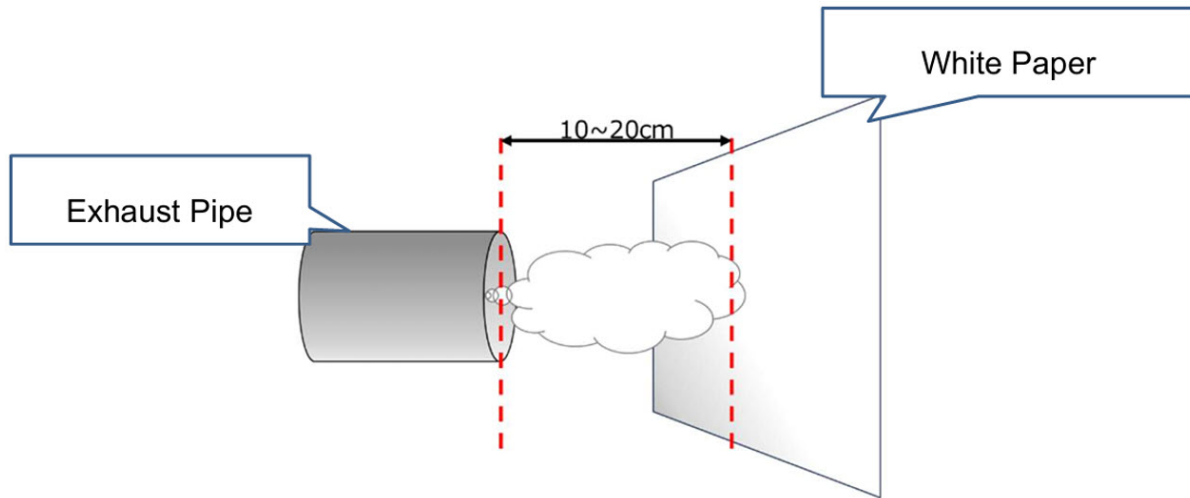
**Step 2:** Determine whether white smoke or vapor is being emitted from the exhaust. Mount a paper towel 4-8 inches (10-20cm) from the exhaust. Start the engine and let it idle for 30 seconds. Turn the engine off and wait for the paper towel to dry.

If yellow or brown stains appear on the paper towel, continue to the next diagnostic step. If no stains are present on the paper towel, only vapor was emitted from the tailpipe.

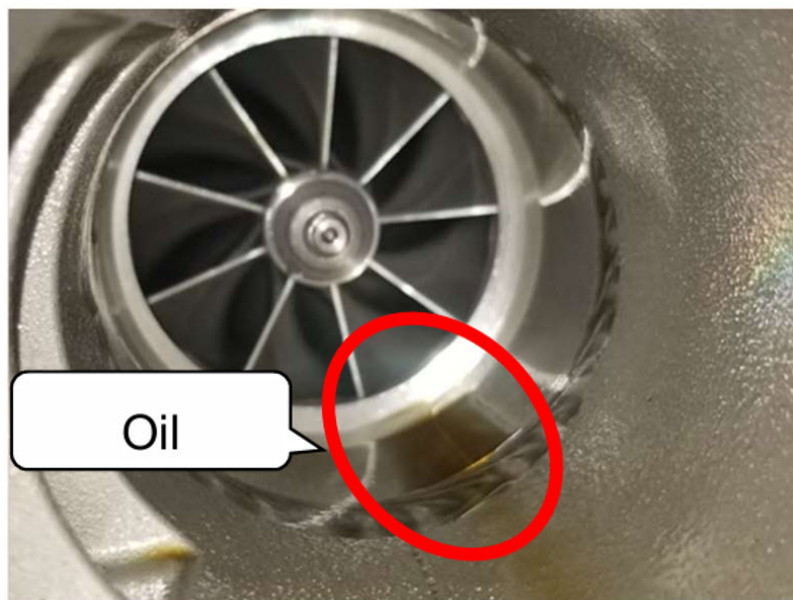
**Step 4:** Check the turbo inlet for oil. See examples below:

If oil is found, then proceed to step 5.

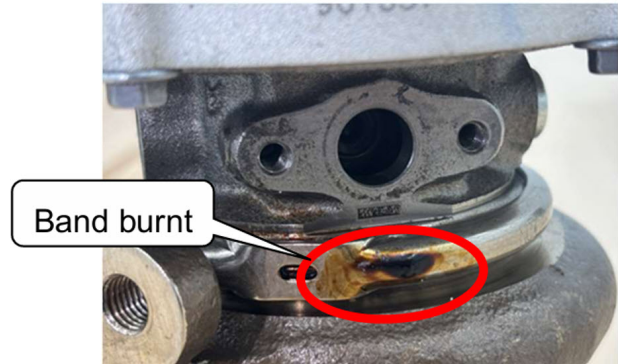
**Step 5:** Inspect the turbo V-band clamp for discoloration. See example below:

If the band is discolored, proceed to step 6

If the band is not discolored, replace the turbo.  
Then repeat step 2 to confirm the concern has been corrected before moving forward.

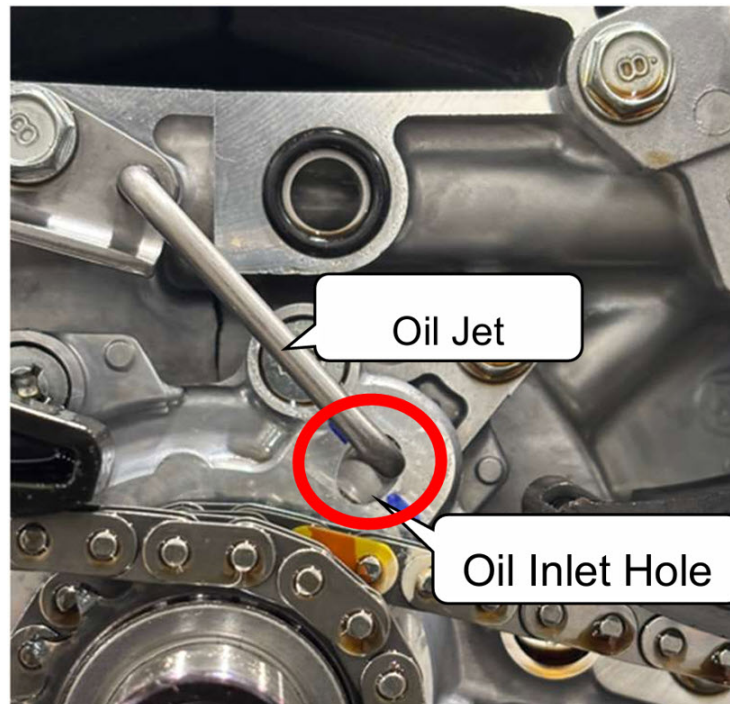
**Step 6:** Remove the timing cover and inspect the oil jet alignment.

If the oil jet is directed at the lower half of the oil inlet hole, loosen the bolt securing the oil jet and adjust it so it is directed toward the upper half of the scavenge pump oil inlet, as shown below. Torque the jet bolt while supporting the jet tip in the correct position. Replace the timing cover and any one-time-use parts with new ones.

If the oil jet is already directed toward the upper half of the scavenge pump oil inlet, replace the scavenge pump and timing cover, along with any one-time-use parts.

**[CAUTION: Do not bend the oil jet, as this will cause damage.]**

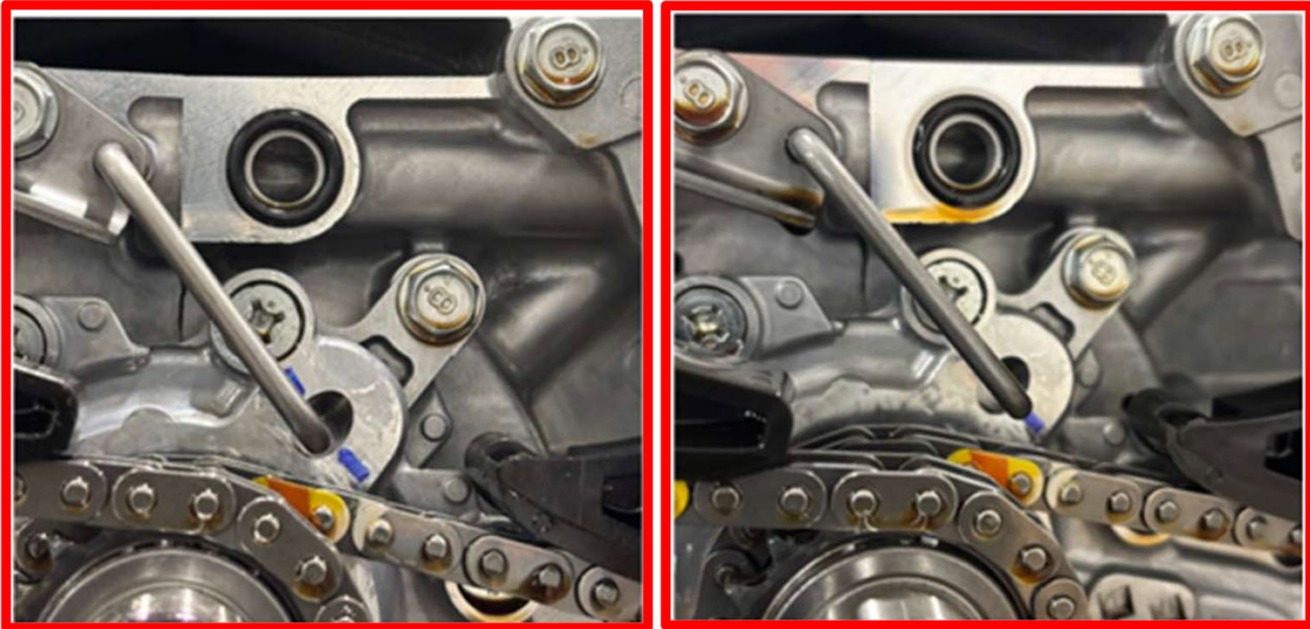
### Examples of misaligned jets:

**Note:** If replacement of the scavenging pump is necessary, ensure the oil jet remains directed at the upper half of the scavenging pump. Failure to do so will cause white smoke.
