SERVICE BULLETIN

APPLICABILITY: 2026MY Outback **NUMBER:** 15-339-26
SUBJECT: Gen4 DCM FOTA Reprogramming **DATE:** 06/22/26

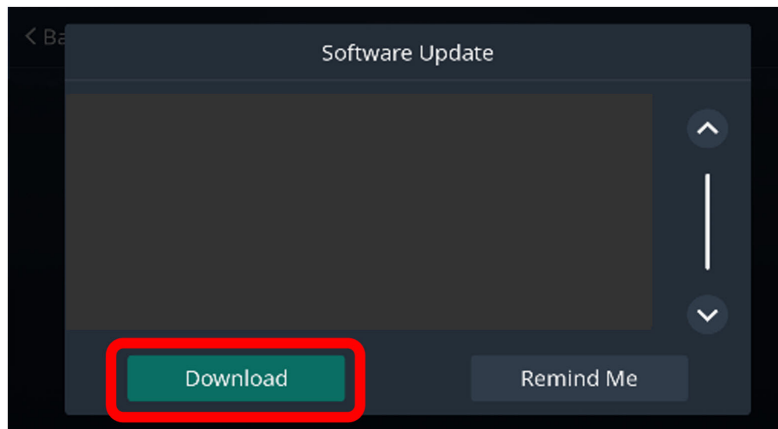
Step 3A: A download notification pop-up appears automatically when the ignition switch is in the ON position. Select “Download.”

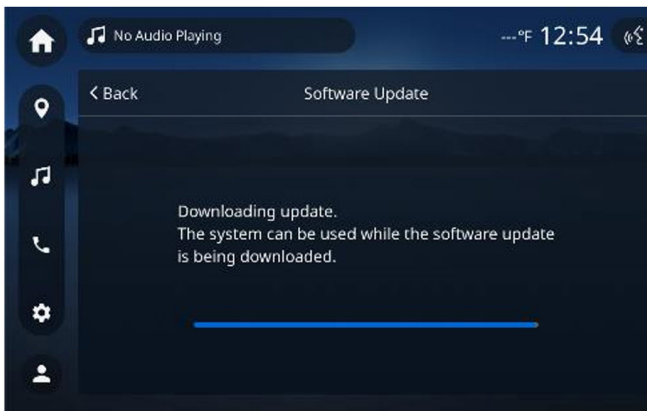
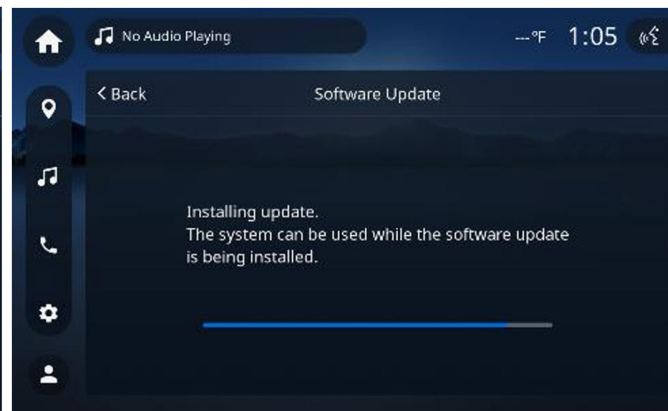
Step 4: The download will start and display a download progress bar. Once the update is downloaded it will automatically start to install.

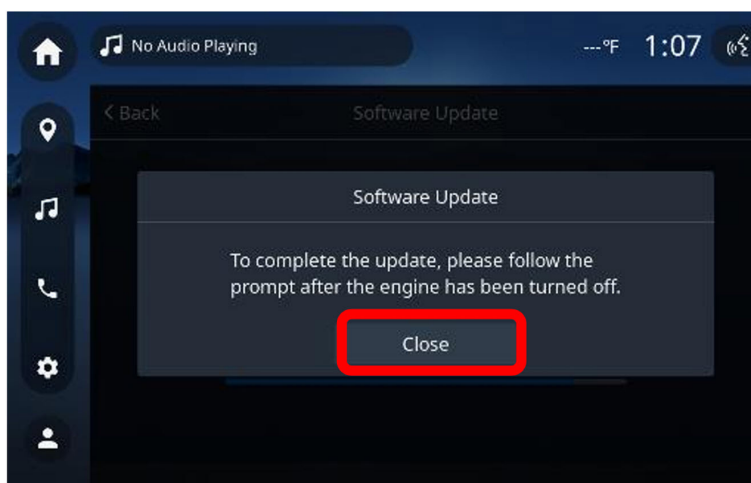
Step 5: Once the installation is complete, select “Close.”

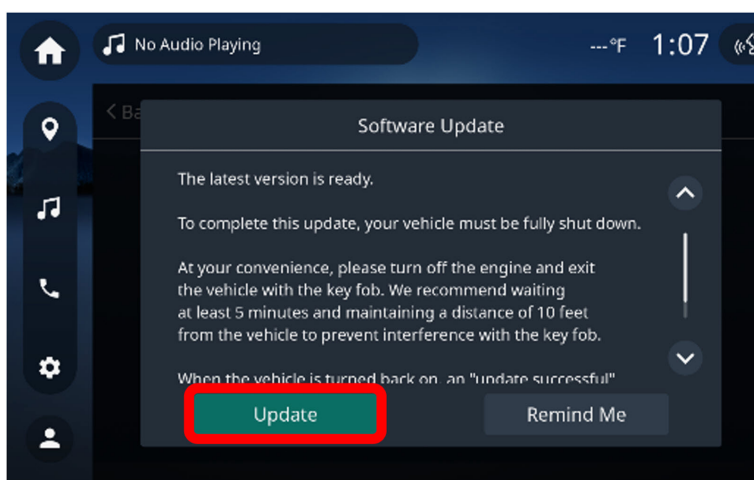
Step 6: Turn off the ignition, follow prompts on screen, and select “Update.”

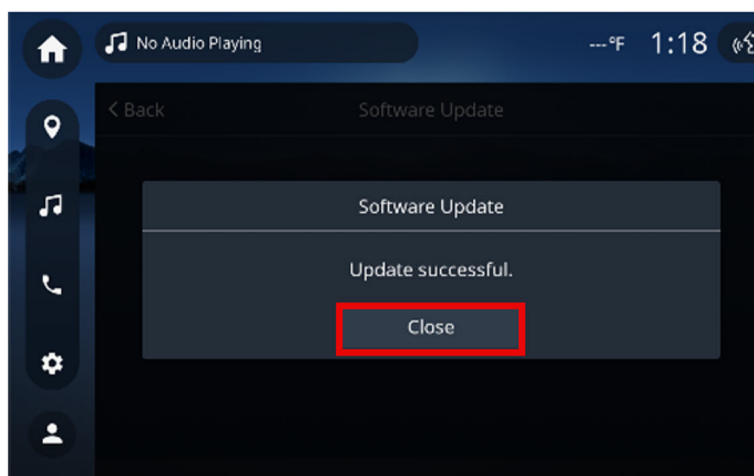
Step 8: Enter the vehicle, turn the ignition on, and select “Close” on the Update successful screen.

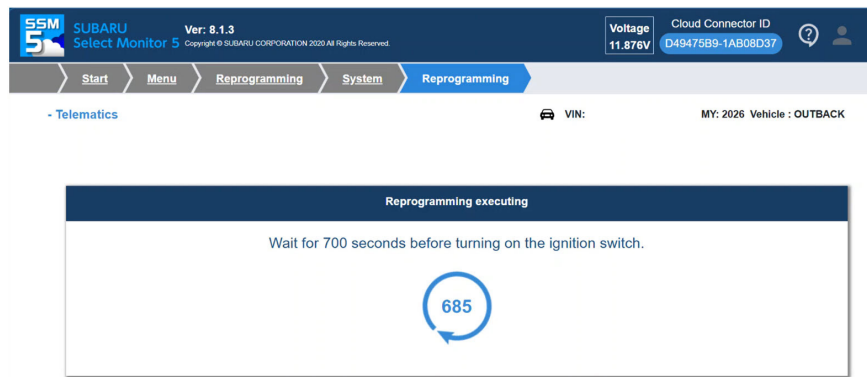
Step 5: When prompted to turn the ignition switch off, shift the vehicle into Park, turn the ignition switch off, then wait 700 seconds before turning the ignition switch on.

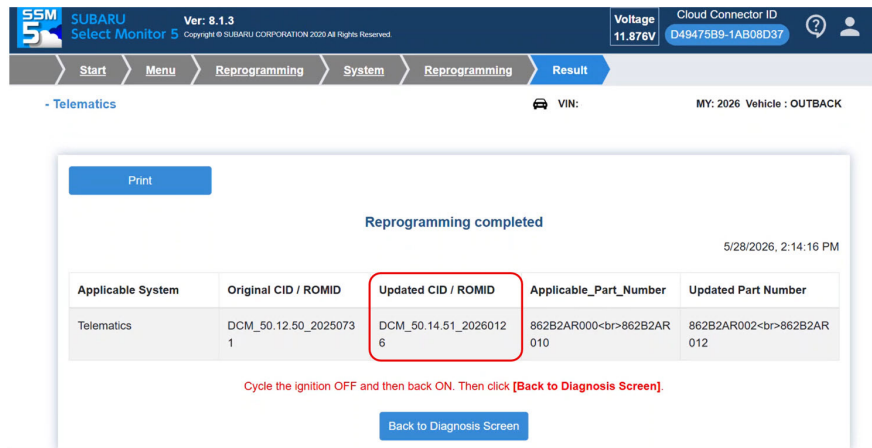
Step 6: Confirm software number is **DCM_50.14.51_20260 126**.
