**PRODUCT CAMPAIGN BULLETIN**

**APPLICABILITY:** 2026MY Solterra **NUMBER:** WRG-26R

**SUBJECT:** Battery ECU Reprogramming **DATE:** 06/23/26

**NHTSA ID:** 26V-393

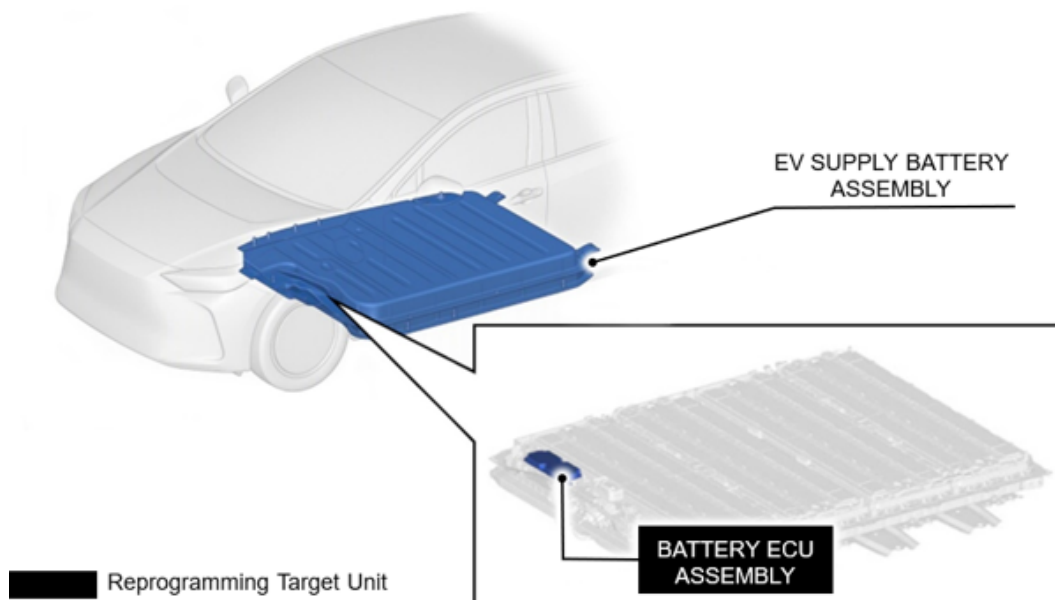
## BATTERY ECU ASSEMBLY LOCATION:

The subject battery electric vehicles (BEV) are equipped with a battery that supplies electricity to the drivetrain. This battery is controlled by an onboard ECU that contains two integrated circuits where one could immediately overwrite data in the same memory address location that the other had just written to. If this occurs, the memory can fail an operational check. If there are multiple failed attempts, an “EV System Malfunction” warning message will be displayed, and multiple malfunction indicator lamps for different systems will illuminate. While power steering and power assisted braking continue to operate, the electric drive system will shut down. This can cause a loss of motive power while driving at a higher speed, increasing the risk of a crash.

Subaru retailers will update the software of the battery ECU at no cost to the customer.

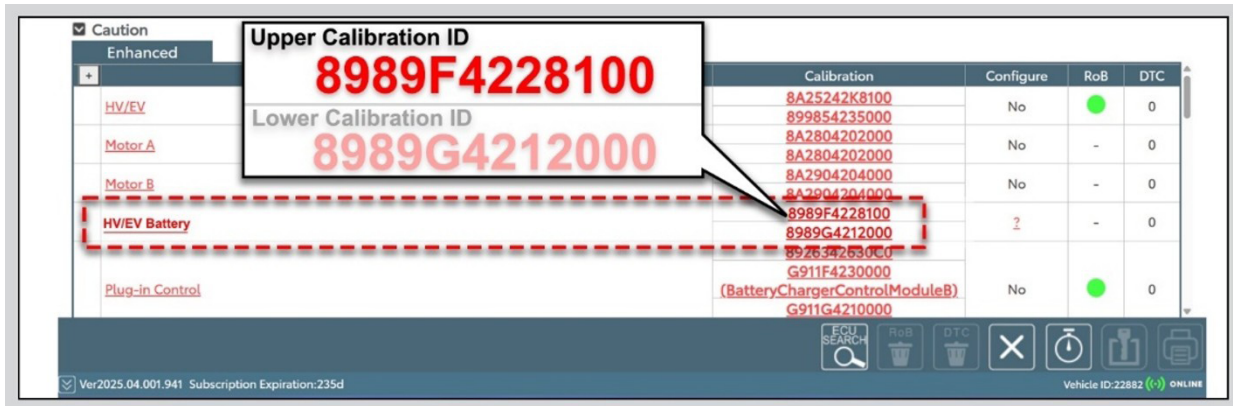
8989F422 “**8100**”: [Reprogramming required.](#)

8989F422 “**8200**” / “**8300**”: [Reprogramming NOT required](#) (updated software already applied).

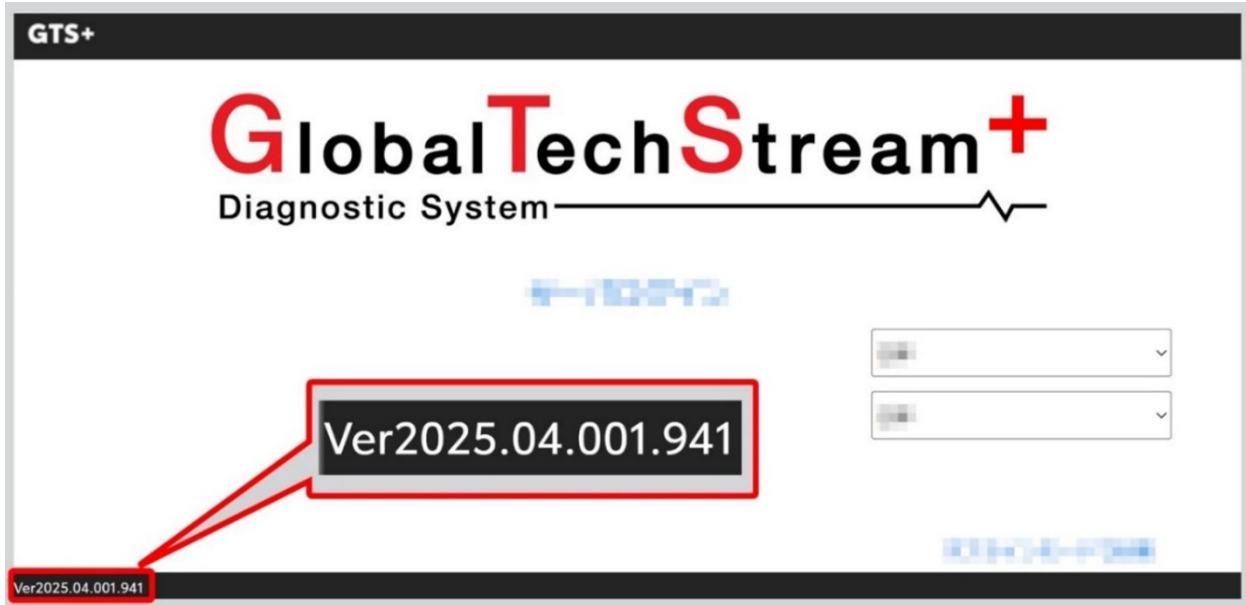
**STEP 1:** Confirm the GTS+ software version is up to date with version Ver2025.04.001.941 or later. The software version is displayed at the bottom left of the GTS+ screen.

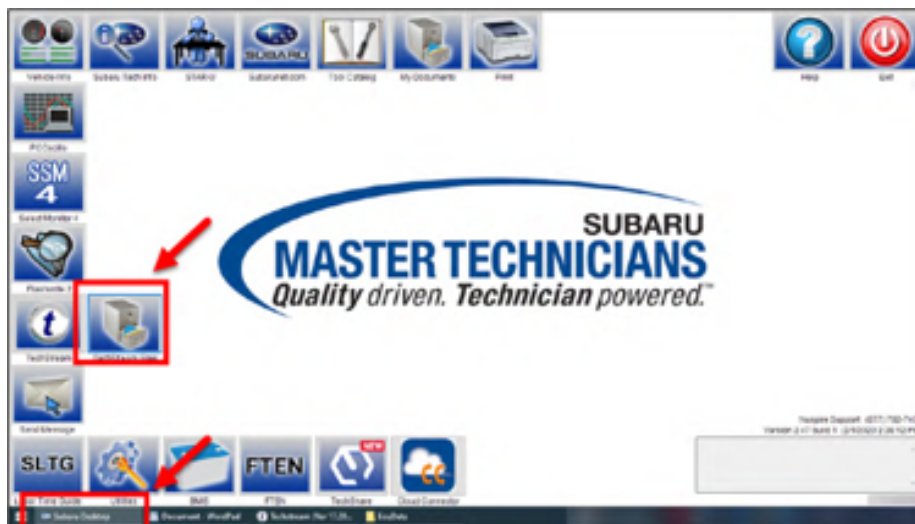
**STEP 4:** Prepare the reprogramming file by selecting the Subaru Desktop lower taskbar. Select the TechStream Files icon and open the EcuData folder. Locate and open the folder titled “WRG-26 BECM reprogramming on certain 2026 Solterra”.

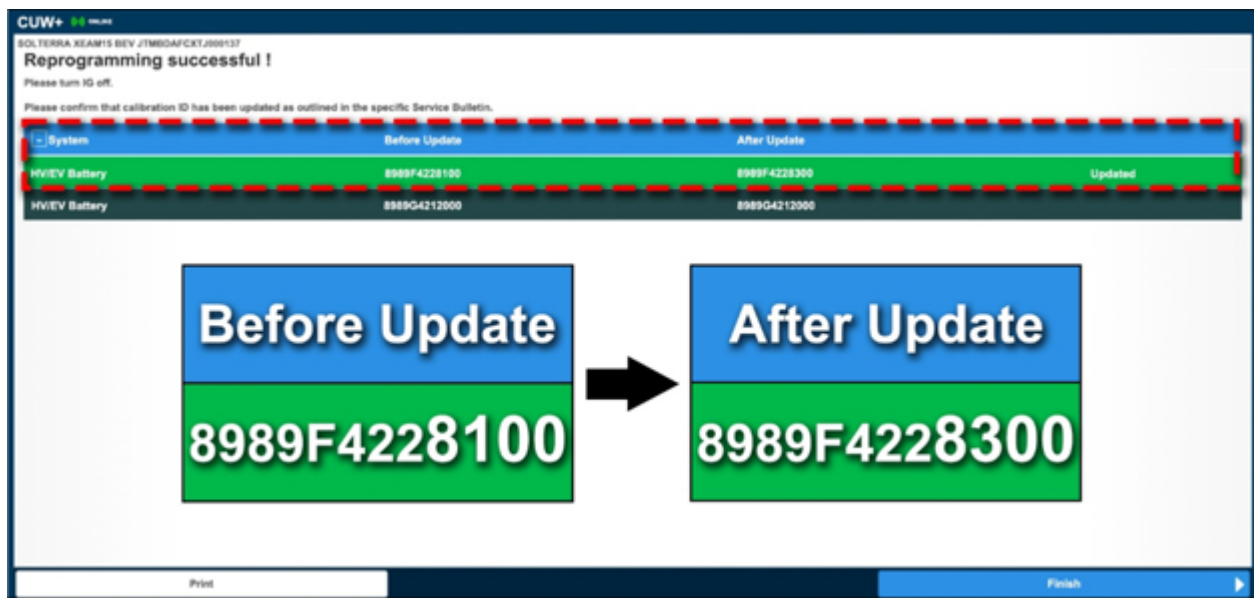
**STEP 6:** After the reprogramming procedure is completed, confirm the Calibration ID has been updated by comparing the “Before Update” and “After Update” values.

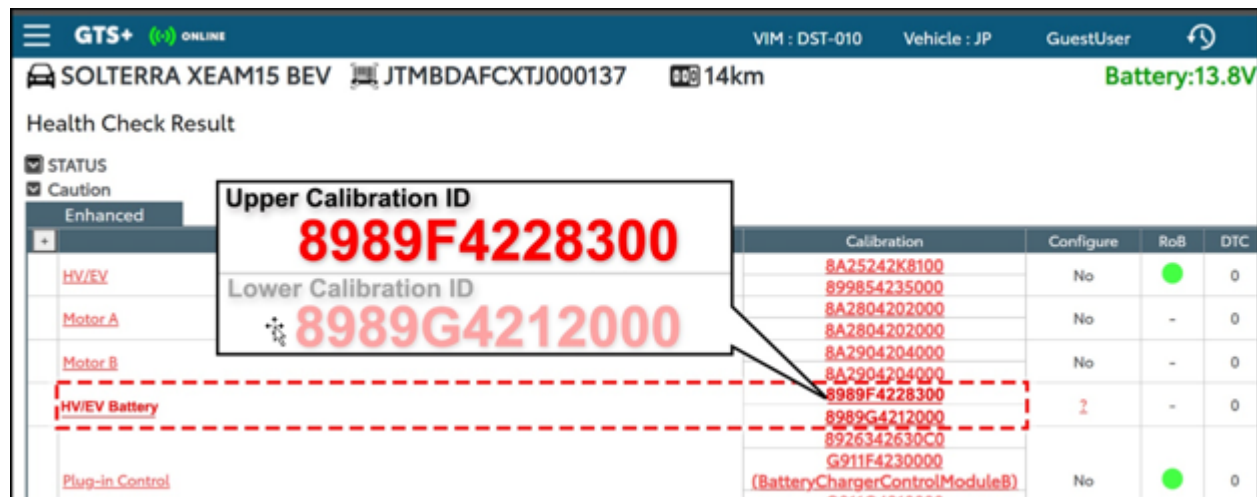
**STEP 7:** Perform a Health Check and clear any DTCs acquired during reprogramming. View the Health Check result screen and confirm the upper Calibration ID of the “HV/EV Battery System” has been updated to “8989F4228300”.
