SERVICE BULLETIN

APPLICABILITY: 2020+ MY Legacy & Outback
 2022+ MY WRX (A/T Only)
 2019+ MY Ascent

NUMBER: 16-151-24R

SUBJECT: TR690 Chain Slip, Judder, Shudder, & Hesitation Concerns

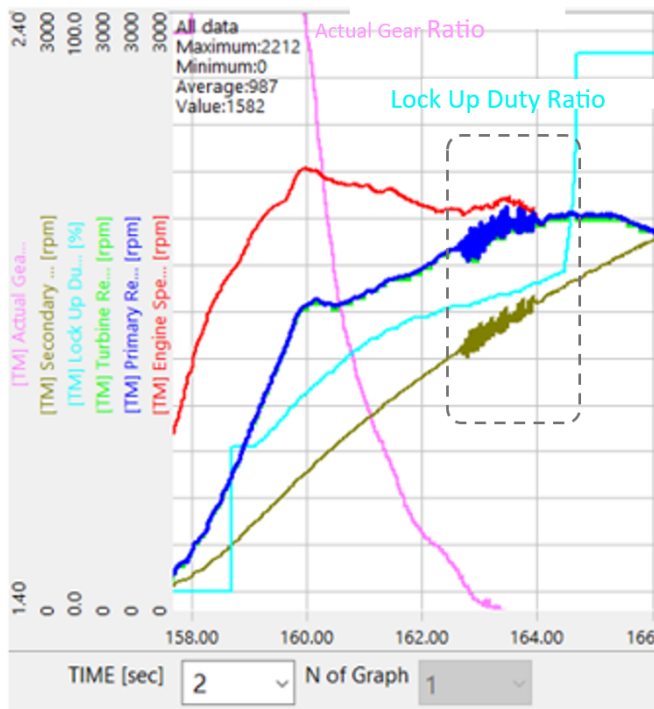
Example Graph for Lockup Judder Type A:

Lockup Judder Type A Diagnosis Procedure.

After the test drive has been completed with replication of the symptom, refer to the judgement criteria and example graph below to determine if the condition matches Lockup Judder Type A. If replication has not been completed, refer to the replication steps below.

Lockup Judder Type A & B: Torque Convertor (p.n. 31100AB460) replacement, CVT Fluid (p.n. 31333AA160) replacement, and TCM software reprogramming (newest software available).

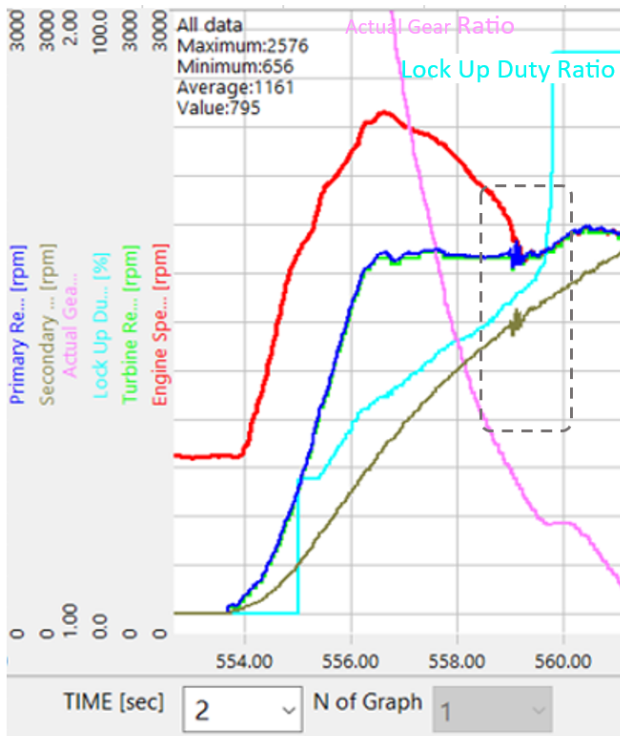
Example Graph for Lockup Judder Type B:

Lockup Judder Type B Diagnosis Procedure:

Judgement Criteria

- There are fluctuations in Turbine Revolution and Primary Rev Speed:

Peak to Peak > 50 rpm

Duration < 1 second

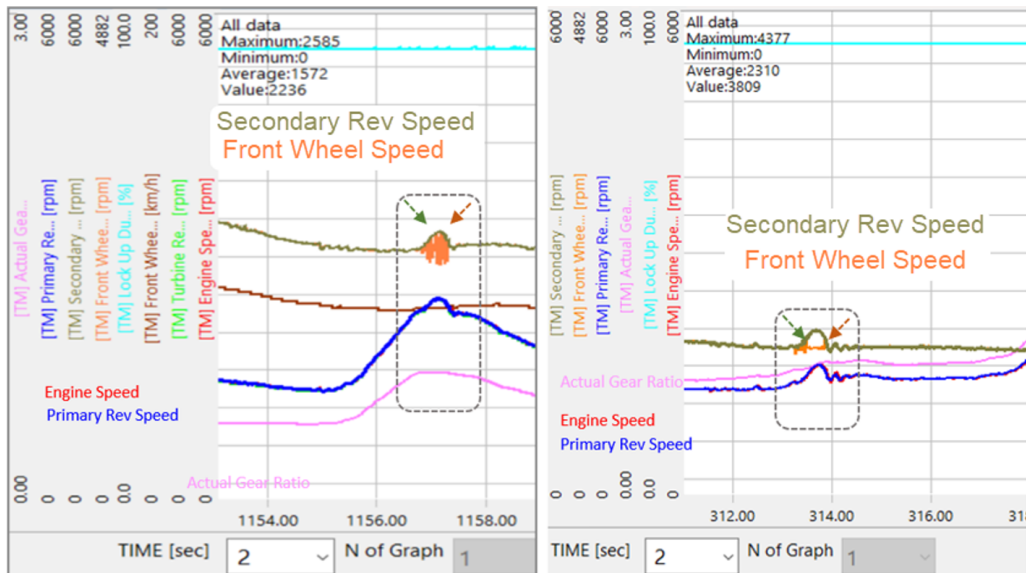
Examples Graph for Forward Clutch Judder:

Forward Clutch Judder Diagnosis Procedure:

The rotational speeds of the upstream and downstream sides of the forward clutch do not synchronize during driving.

Upstream side of the forward clutch: Secondary Rev Speed

Downstream side of the forward clutch: Front Wheel Speed

Forward Clutch Judder: CVT Fluid (p.n. 31333AA160) replacement and TCM software reprogramming (newest software available).

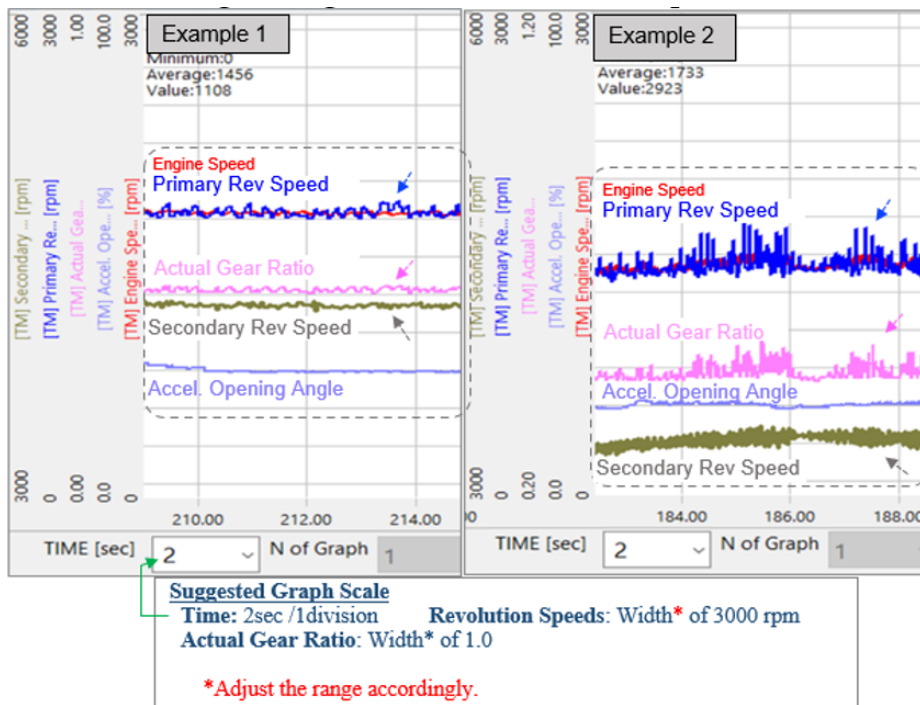
Examples of the data monitoring during Continuous Micro-Slip:

1. Continuous Micro-Slip

During a continuous micro-slip, while the Accelerator Opening Angle monitor displays a stable value for more than one second, there are fluctuations in the Actual Gear Ratio monitor:

Peak to Peak > 0.02

Frequency > 3 cycles per 1 second

There are fluctuations in the Primary Rev Speed and/or Secondary Rev Speed monitor:

Peak to Peak > 50 rpm

Using Subaru Select Monitor (SSM), check and record data monitors and compare to the three examples listed below. If the recorded data from the vehicle matches the examples below, the CVT will require replacement. The SSM data will be required for claim submission. A QMR containing the same information will also be required.

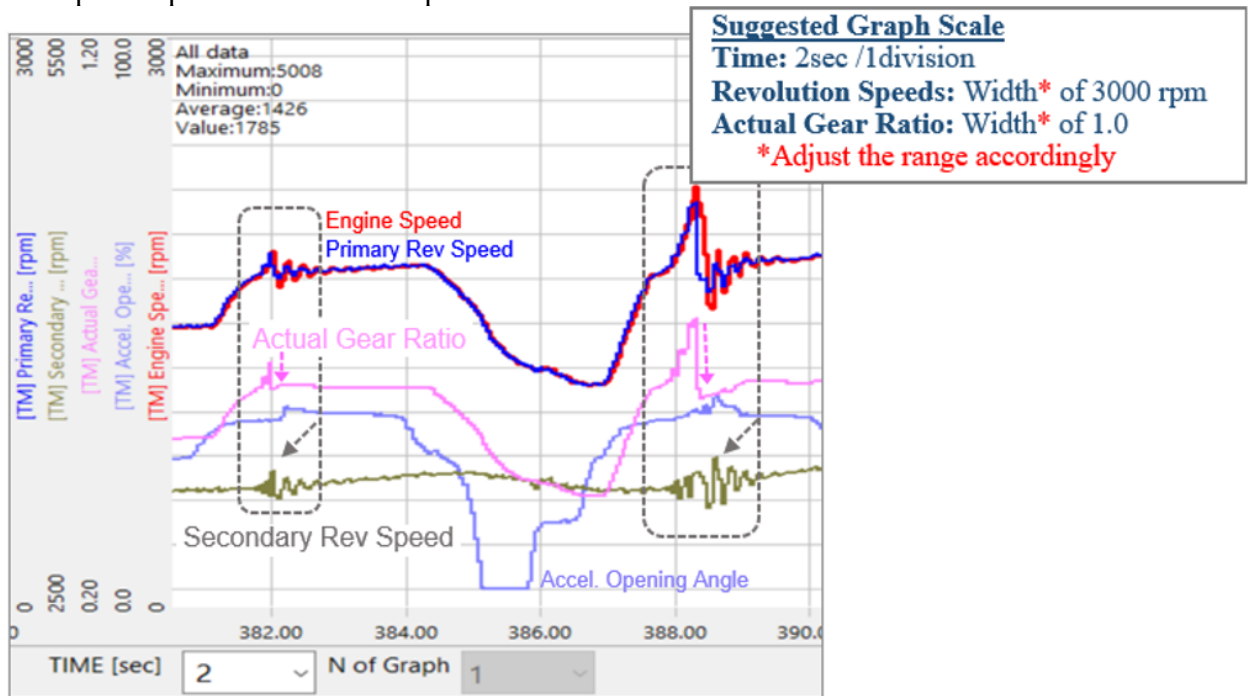
Example Graph of Short Time Slip:

2. Short-Time Slip

When a short-time slip occurs, the changes in the Actual Gear Ratio monitor will be larger than 0.1 per 0.1 second. After the Actual Gear Ratio monitor resumes to stable conditions, distinct fluctuations in revolution speed continues.

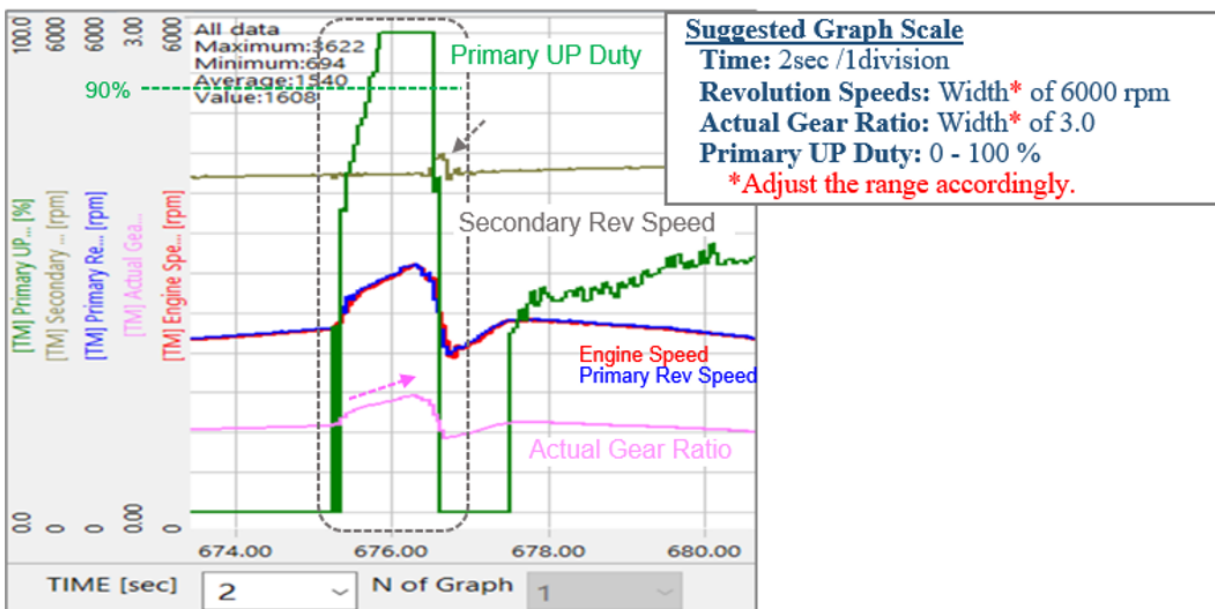
3. Long-Time Slip

When a long-time slip occurs, the Primary UP Duty monitor will be larger than 90% and the Actual Pulley Ratio monitor lowers for a duration of 0.5 seconds or more. Even after the Actual Gear Ratio monitor resumes to stable conditions, distinct fluctuations in revolution speed continues.

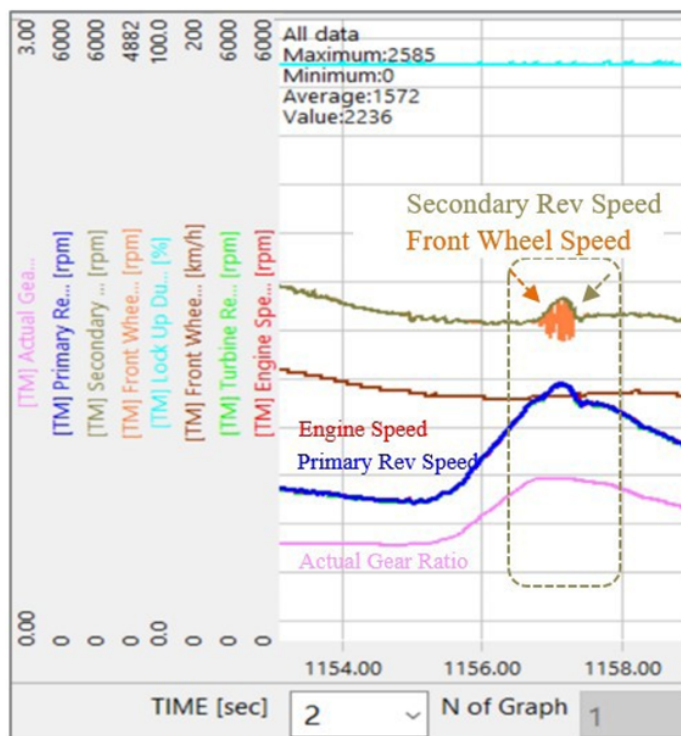
1. Forward Clutch Slip Shock

The rotation speeds for the upstream and downstream sides of the forward clutch do not synchronize when driving.

Upstream side of the forward clutch-
Secondary Rev Speed

Downstream side of the forward clutch-
Front Wheel Speed

This shock can occur when the forward clutch slips. If this situation is reported, reprogram the TCM with the newest software available.
