Tesla, Inc. Service Bulletin		<h1>Rework Spoiler Outer Panel</h1>	
SB-25-11-007 June 12, 2026		R1	
Classification Repair Bulletin		Section/Group 11 - Closures	Mobile Service Can Perform (where permitted)
Model Model Y		Model Year 2025	Country/Region Europe, North America
		Build Location Fremont, Giga Berlin, Giga Texas	
<small>The model(s) and model year(s) listed are a general approximation of the affected VIN list. Refer to the VIN/Bulletin Tracker or Customer/Vehicle profile to determine applicability of this bulletin for a particular vehicle.</small>

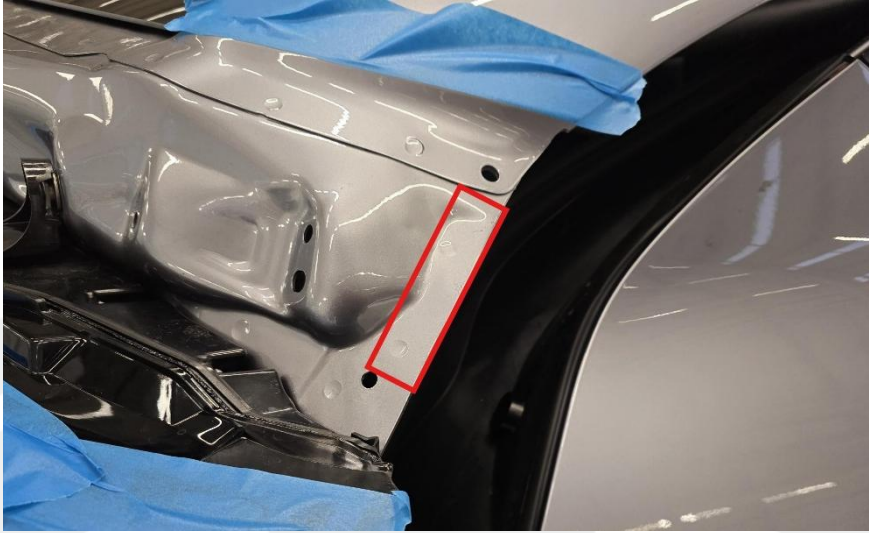
Figure 1 – RH shown, LH similar.

On certain Model Y vehicles, a gap between the liftgate and the spoiler outer panel may produce a whistling sound if the vehicle is driven at high speed.

1. Remove the spoiler outer panel (refer to Service Manual procedure [1133050502](#)).
2. Clean the LH and RH edges of the liftgate with IPA wipes, and then allow 1 minute to dry (Figure 1).
