Tesla, Inc.
Service Bulletin

Inspect and Rework Front Seat Cushion(s)

SB-26-13-005
June 4, 2026

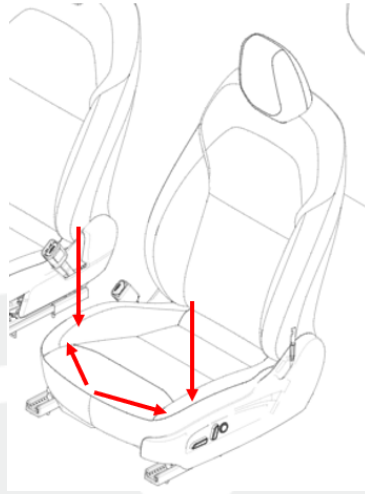
Figure 1

On some vehicles, degraded or excessive glue under the front seat cushion(s) may cause creaking noises during cornering or when pressing on the seat cushion(s).

1. Sit in the reported seat and shift weight around, and then press the seat cushion according to the red arrows (Figure 1) to verify if there is a creaking noise from the cushion area.

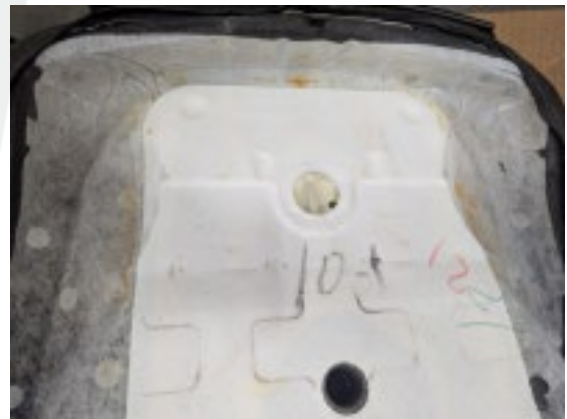
Figure 3 – Residue and Friction Marks

3. Apply felt tape to the outlined area to cover the adhesive residue or friction marks (Figure 2 and 3).

**NOTE:** Overlap the tape if necessary.
