Document ID: IK1201506

Title: A26 Turbochargers remanufactured by SRC between 05/01/2023 and 02/01/2025

Applies To: Vehicles with A26 engine

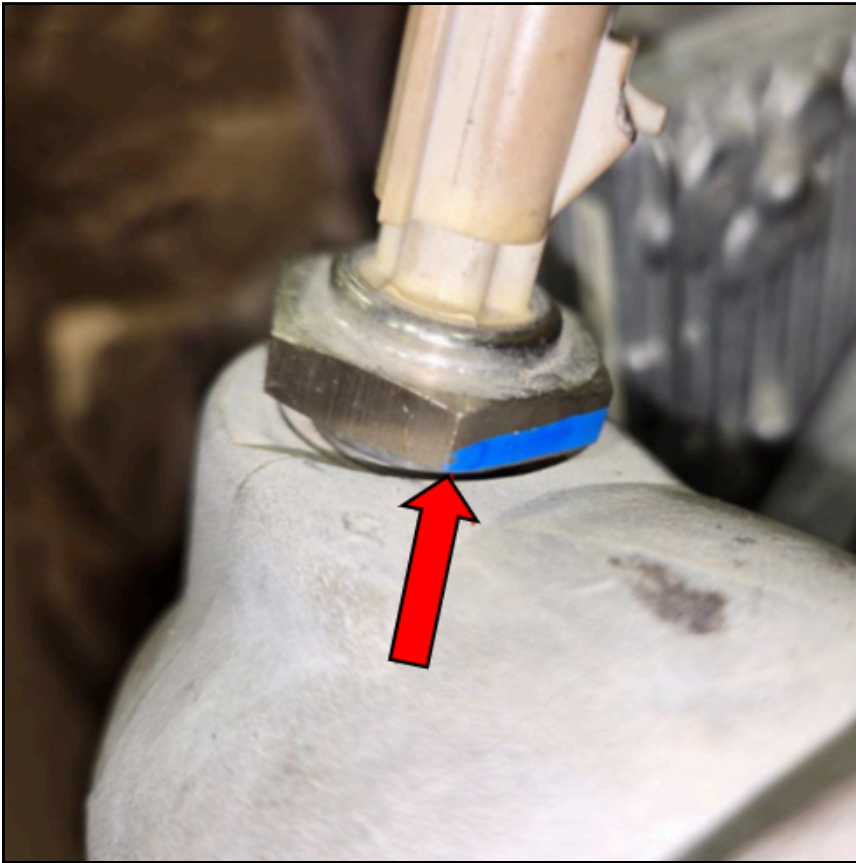
Figure 1. TCOCT Sensor Interference

SRC Turbochargers assembled with new compressor housings may have a defect that prevents the TCOT sensor (**Part# 1845988C1, Sensor, Exhaust Gas Temp**) from being installed correctly.

6. See Figure 1, if the sensor exhibits the same condition (contact with the turbo compressor housing), refer to the SRC Technical Service Bulletin at the provided PDF link for additional details /service_kb/DocTool/Documents/Published/IK1201506/Files/TSB-02-13-25_A26_Turbocharger - file.pdf.
7. Remove wheel chocks.
8. Once repairs are completed, perform a road test to verify proper vehicle functionality and confirm normal system operation.
