STAR ONLINE PUBLICATION

Case Number: S2609000009

Symptom/Vehicle Issue: Check Engine Light (CEL) Illuminated with Diagnostic Trouble Code (DTC) P0106 Manifold Absolute Pressure Sensor Performance Setting In The Powertrain Control Module (PCM)

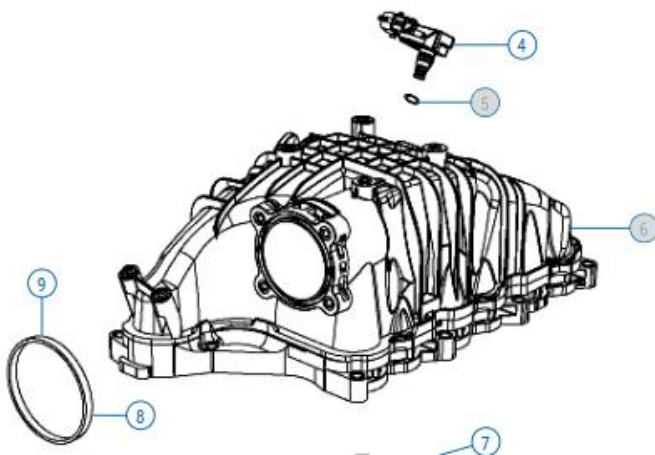
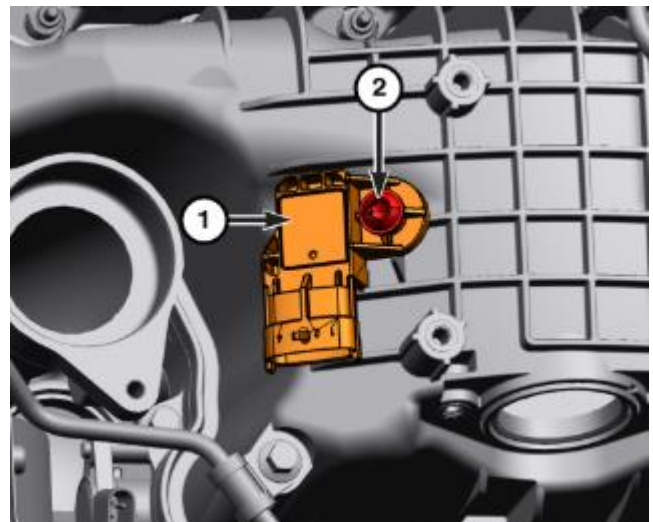
Owner Complaint/Technician Observation: Technician may find that DTC P0106 is setting after replacing the intake manifold. At this time the Manifold Absolute Pressure (MAP) sensor that is installed on the new manifold is incorrect and will need to be replaced with the correct MAP sensor for your application or transfer the MAP sensor from the original intake manifold.
