STAR ONLINE PUBLICATION

Case Number: S2608000029

Symptom/Vehicle Issue: No Start, Multiple Warning Lamps on, Relay Clicking Noise

2025-2026 Ram Promaster (VF)

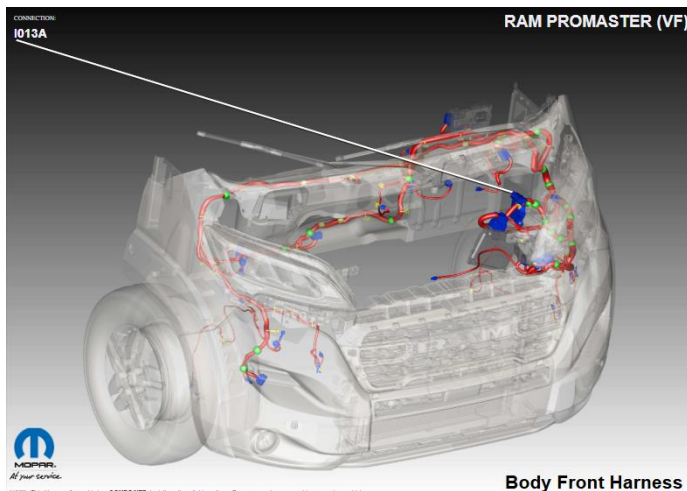
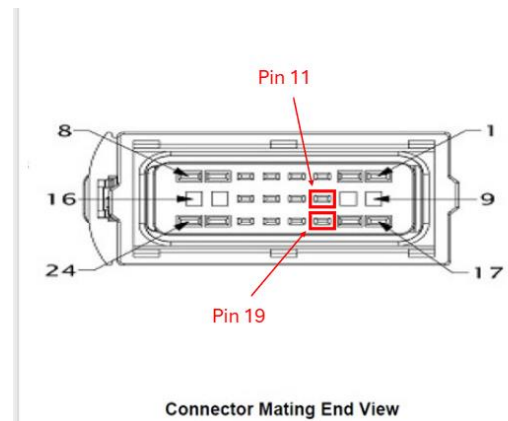
Owner Complaint/Technician Observation: The owner complains the vehicle does not start and the Instrument Panel Cluster (IPC) has multiple warning lamps on. Technicians may or may not have Diagnostic Trouble Codes (DTCs), technician may hear a relay clicking noise when attempting to start.

Discussion: Inspect the inline harness connector i013A, gray 24-way pin 11 and 19. Inspect the connector for excessive grease and for any potential bent or spread terminals. Clean excessive grease, repair suspect terminals and secure the connector as needed.
