REFERENCE:	TSB: 08-250-26 GROUP: 08 - Electrical	Date:	June 27, 2026	REVISION:	—
VEHICLES AFFECTED:	2026 (RU) Chrysler Pacifica / Voyager This bulletin applies to vehicles built on or after January 19, 2026 (MDH 0119XX) and on or before March 09, 2026 (MDH 0309XX) equipped with 7" Full Color TFT Display (Sales Code JAJ), 120 MPH Primary Speedometer (Sales Code JCB), Instrument Panel Parts Module II (Sales Code X8C), and without PHEV Adaptation Components (Sales Code XDQ).			MARKET APPLICABILITY: <input checked="" type="checkbox"/> NA <input type="checkbox"/> MEA <input type="checkbox"/> SA <input type="checkbox"/> IAP <input type="checkbox"/> EE <input type="checkbox"/> CH NOTE: This bulletin applies to the North America market.	
CUSTOMER SYMPTOM:	Customers may experience one or more of the following: <ul style="list-style-type: none"> • Speed limit warning chimes while driving. • IPC display message speed warning exceeded. • Speed limit appears on US IPC. Fig. 1

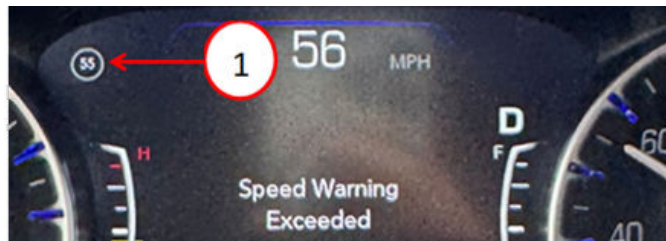
Fig. 1
IPC Display

CAUSE:	IPC Configuration

1 - Speed Limit Indicator

This bulletin involves reprogramming the IPC configuration.
