STAR ONLINE PUBLICATION

Case Number: S2523000066 Rev. A

Symptom/Vehicle Issue: Driver Side Window Switch Buttons Stuck Or Inoperative.
Rev A.

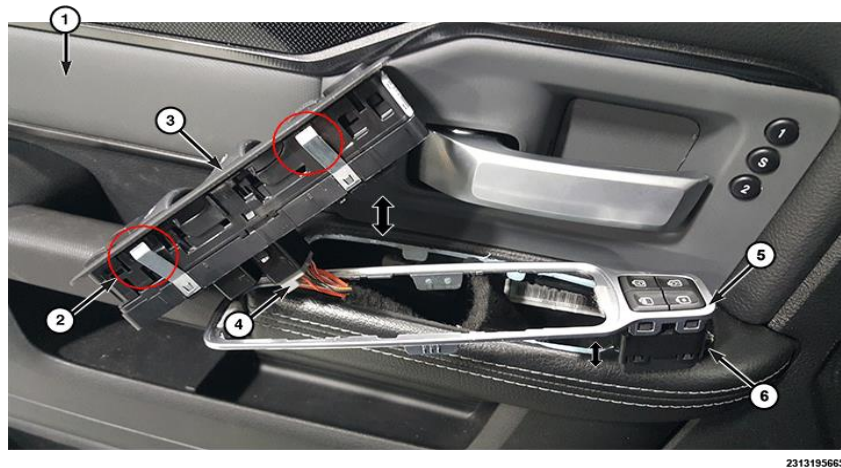
Removal of Lock Switch Assembly (early design)

Condition 1. Mis-install (excessive force on switch top surface) could cause misalignment of the buttons within the switch housing. The stuck button would be visible, and operating the button would not activate the function. Review procedure 1. below

- A. Press the switch back plate assembly firmly to the bezel housing, and ensure all snap tabs are engaged. Press side walls to and visually confirm that all the snap tabs are inside the slots.
- B. Reconnect the wiring connector and snap fit the switch assembly into the armrest opening.

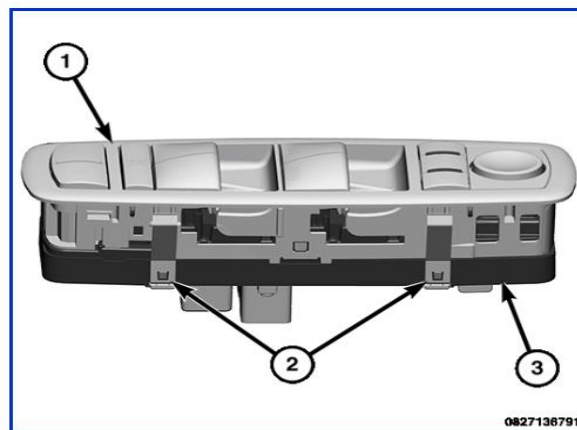
- 1 - Switch Bezel
- 2 - Switch Bezel Retaining Clips
- 3 - Switch Bank

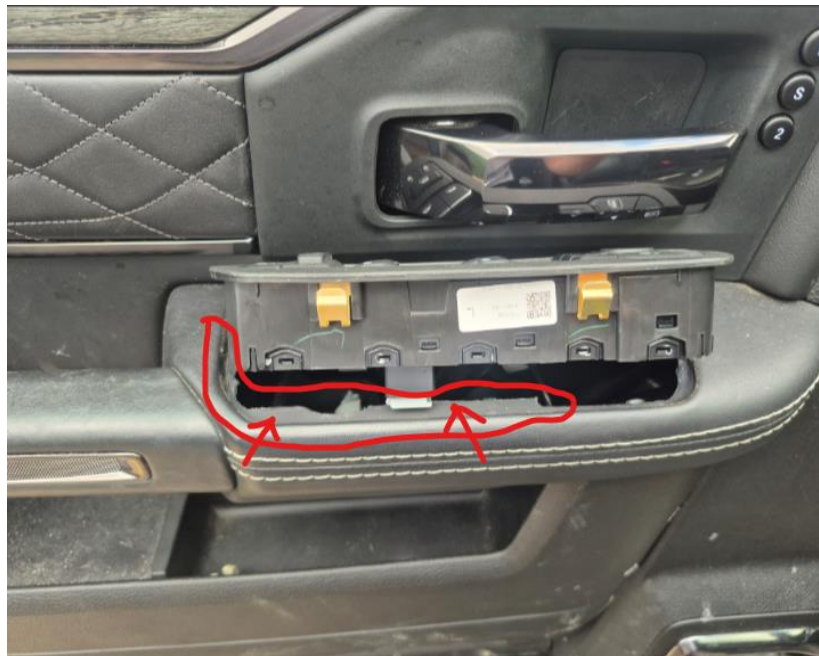
Condition 2. Bezel mounted mirror switches binding or stuck due to excess door panel cover material in switch opening.

Example Of Excess Material To Be Trimmed. Condition 2

- A. With switch and bezel removed, inspect the switch mounting opening for excessive door panel cover material causing binding. If necessary, using a sharp hobby knife, carefully trim excess material from the opening. Do not cut material where it will be visible to the owner with the switch installed.
- B. Install the switch and bezel to check fit and switch operation. Repeat step A as needed to remove the fabric binding condition.
