## STAR ONLINE PUBLICATION

**Case Number:** S2102000004 REV. D

**Models Affected:** 2021-2026 Jeep Grand Cherokee (WL)

**Symptom/Vehicle Issue:** WL Front Control Arm Bushing - Handling Link Has Loose Rubber Appearance

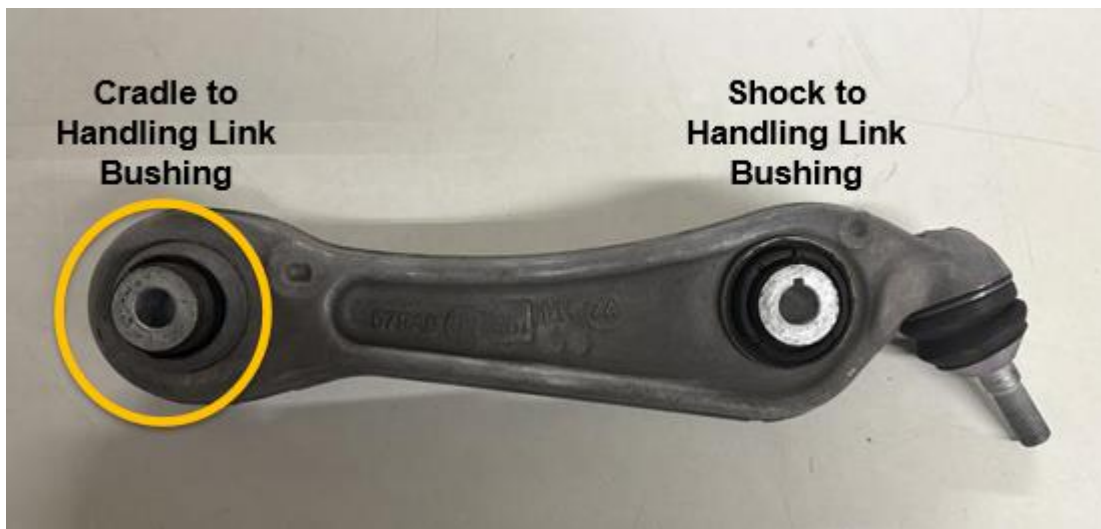
#1

**Customer Complaint/Technician Observation:** During a vehicle inspection or other repair work it may be noticed the front control arm handling link bushing may have what appears to be rubber separating or coming off the bushing. No issues with vehicle handling or operating the vehicle with this condition.

**Discussion:** The outer bushing sleeve has a rubber layer as part of the manufacturing process and is not an "active" part of the bushing. If the rubber from this outer surface has separated it does not require a control arm replacement. The condition does not cause noise, nor affect the bushing operation or vehicle handling. See images 1 and #2 below.
