Check engine light with reduced power with fault codes P300A6D, P300974, P300DFB, or P300DE8

Topic number	LI09.40-N-079144
Version	6
Function group	09.40 - Turbocharger
Date	6/29/26
Validity	Model 907 with OM654
Reason for change	Remedy Update

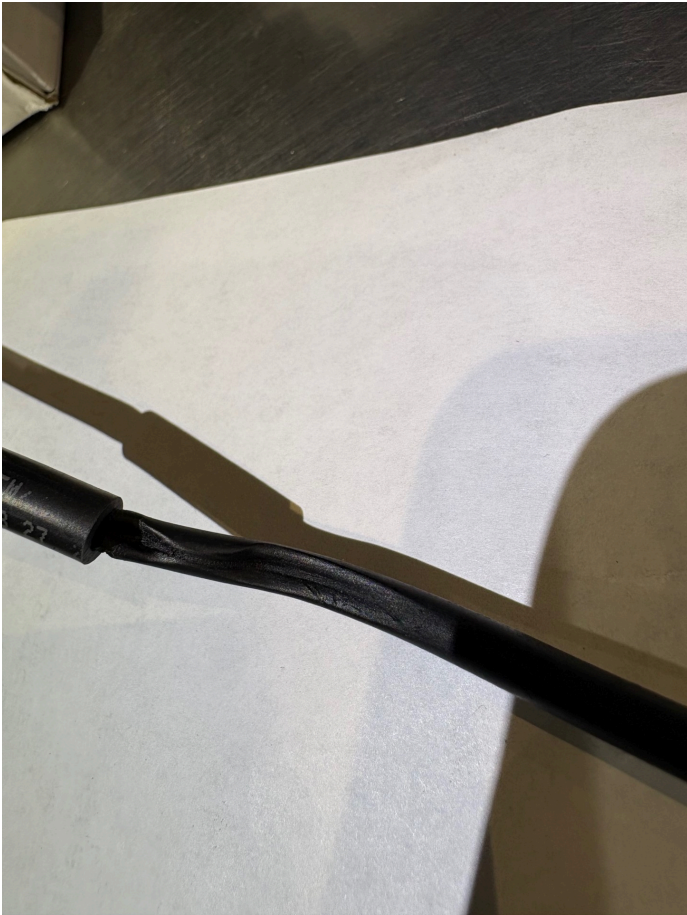
Attachments	
File	Description
OM654 Vacuum Diagram.pdf	OM654 Vacuum Diagram
Melted line.jpg	Vacuum Line melted under Low Pressure EGR Cooler

- Check the vacuum at all vacuum components (such as the Wastegate and Boost Pressure Control Y77, Y100/2) while driving, and compare it to the source vacuum.
- Thoroughly inspect all vacuum lines and connections for signs of wear, cracks, or disconnections.
- Refer to the Attachments for the OM654 Vacuum diagram.

- Ensure each component holds a vacuum when actuated.
- Replace any failed component and retest.

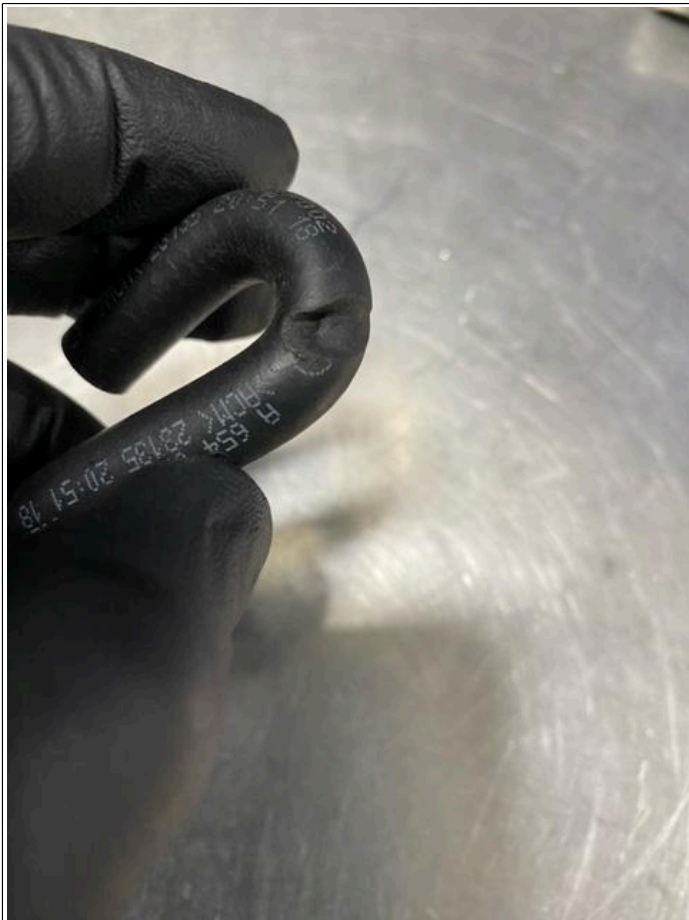
Vacuum Line A654 070 23 32.jpeg	Vacuum Line at High Pressure EGR Cooler Bypass Valve

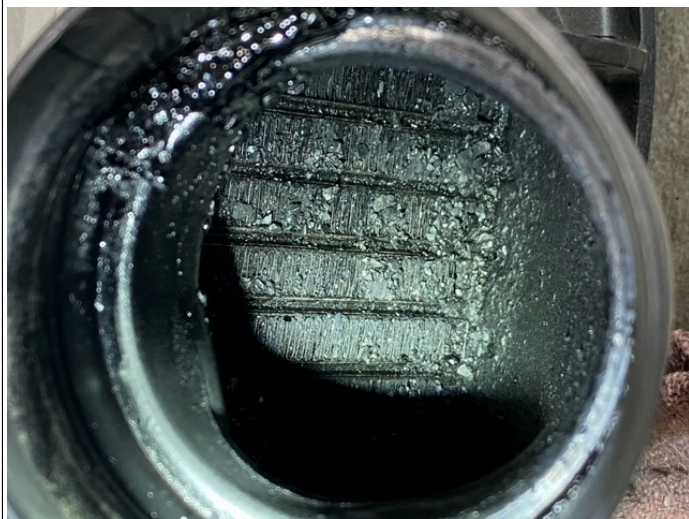
[Inlet Side Of Charge Air Cooler.jpeg](#)

Debris within the Charge Air Cooler

- Check the outlet of the turbocharger (high-pressure side), the charge air pipe at the back of the engine, and the charge air cooler inlet near the firewall for any debris or blockages.
- If oil, debris, or sludge is found in the Charge Air System, Turbocharger Outlet, or Charge Air Cooler Inlet, follow LI09.41-N-080666 for the required repair procedure.

Note: If it is determined that the Charge Air Cooler is obstructed by debris, please use damage code 50301 B2 when submitting your warranty repair claims.

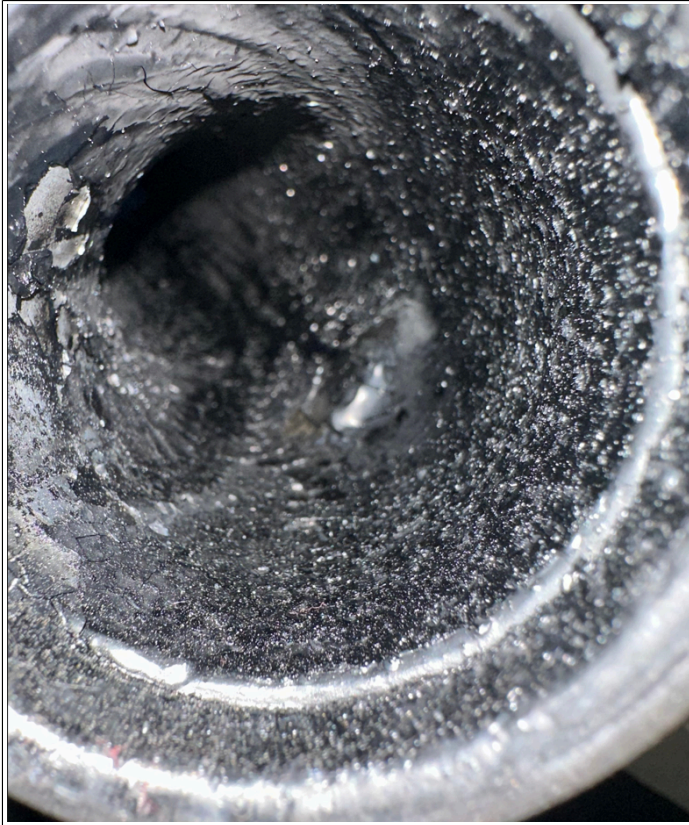
[Charge Air Pipe.png](#)

Debris within the Charge Air Pipe
