Check engine light with reduced power with fault codes P300A6D, P300974, P300DFB, or P300DE8

Topic number	LI09.40-N-079144
Version	5
Function group	09.40 - Turbocharger
Date	6/3/26
Validity	Model 907 with OM654
Reason for change	Remedy Update

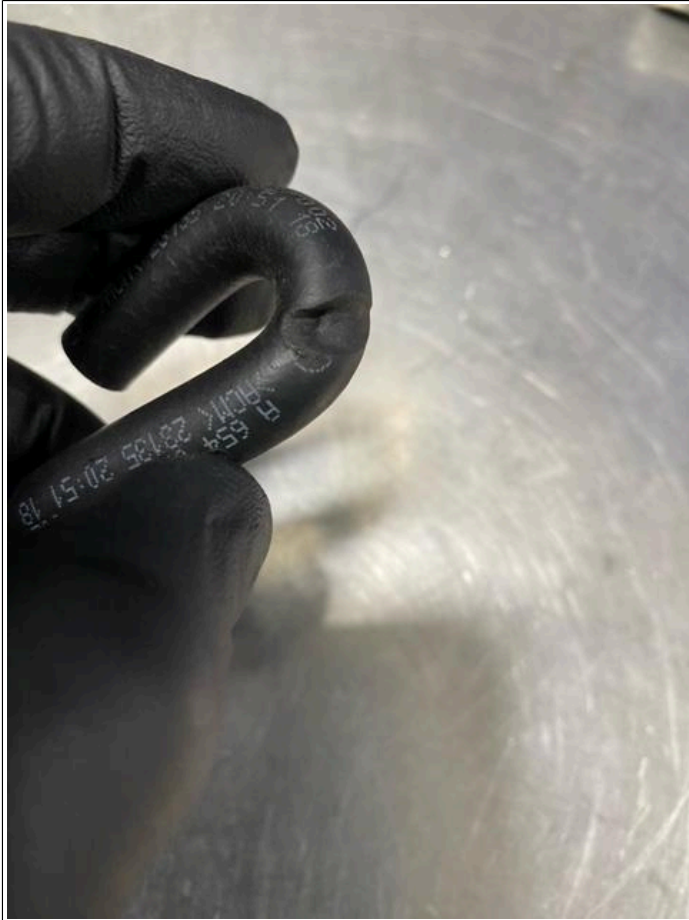
Vacuum Line A654 070 23 32.jpeg	Vacuum Line at High Pressure EGR Cooler Bypass Valve

- Check the vacuum at all vacuum components (such as the Wastegate and Boost Pressure Control Y77, Y100/2) while driving, and compare it to the source vacuum.
- Thoroughly inspect all vacuum lines and connections for signs of wear, cracks, or disconnections.
- Refer to the Attachments for the OM654 Vacuum diagram.

- Ensure each component holds a vacuum when actuated.
- Replace any failed component and retest.

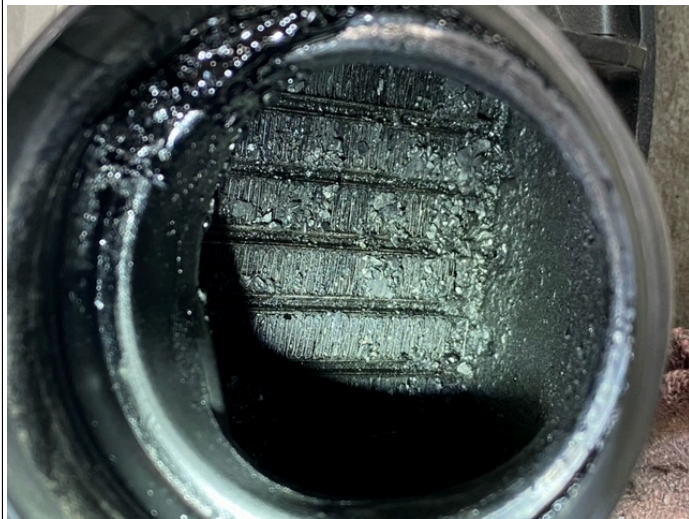
[Inlet Side Of Charge Air Cooler.jpeg](#)

Debris within the Charge Air Cooler

- Check the outlet of the turbocharger (high-pressure side), the charge air pipe at the back of the engine, and the charge air cooler inlet near the firewall for any debris or blockages.
- If oil, debris, or sludge is found in the Charge Air System, Turbocharger Outlet, or Charge Air Cooler Inlet, follow LI09.41-N-080666 for the required repair procedure.

Note: If it is determined that the Charge Air Cooler is obstructed by debris, please use damage code 50301 B2 when submitting your warranty repair claims.
