## Check engine light with reduced power – P300A6D due to charge air system contamination

Topic number	LI09.41-N-080666
Version	1
Function group	09.41 - Charge air pipe/charge air cooling
Date	6/3/26
Validity	Model 907 with OM654
Reason for change

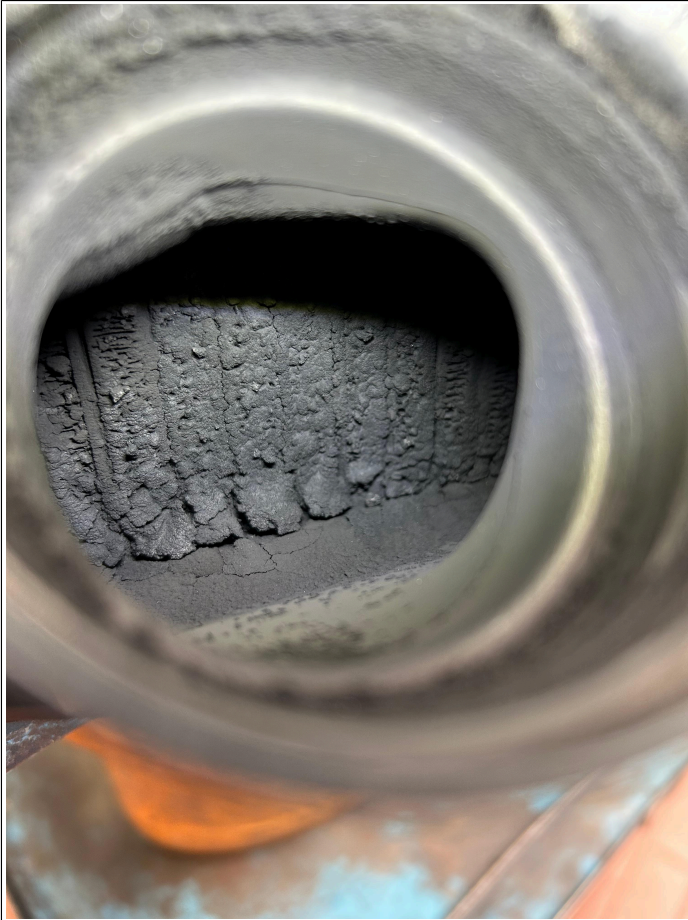
Attachments	
File	Description
<a href="#">Charge Air Cooler 2.jpg</a>

- Oil mist from the crankcase ventilation system can enter the intake tract and deposit within the charge air system
- Under high thermal load and with soot-laden or aged engine oil, these deposits may carbonize
- Carbonized deposits can loosen and accumulate in the charge air cooler and related components
- This can result in partial or complete restriction of the charge air cooler, leading to underboost conditions and fault codes such as P300A6D

1. Replace the following components as a set:

- Charge air cooler
- Exhaust turbocharger
- Charge air pipe upstream of the charge air cooler
