## OM642 DPF Filter Cracked or Broken

Topic number	LI49.10-N-080528
Version	1
Function group	49.10 - Exhaust pipes, mufflers
Date	6/3/26
Validity	906 with OM642 engine
Reason for change

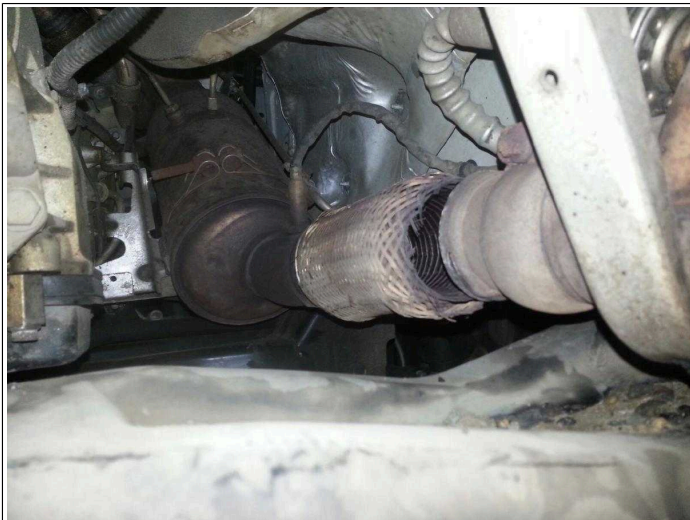
The DPF filter is cracked, broken, or leaking, allowing hot exhaust gas to escape from the exhaust system.

Attachments	
File	Description
<a href="#">Exhaust2_compressed.jpg</a>	Example of Broken DPF

Inspect the DPF assembly for cracks, separation, or leakage.

If any damage is found, replace the DPF filter assembly.

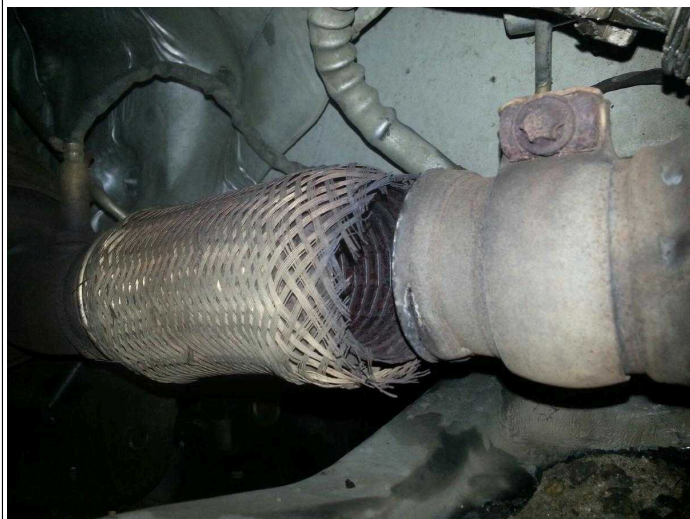
[Exhaust\\_compressed.jpg](#)

Close up of Broken DPF assembly in vehicle

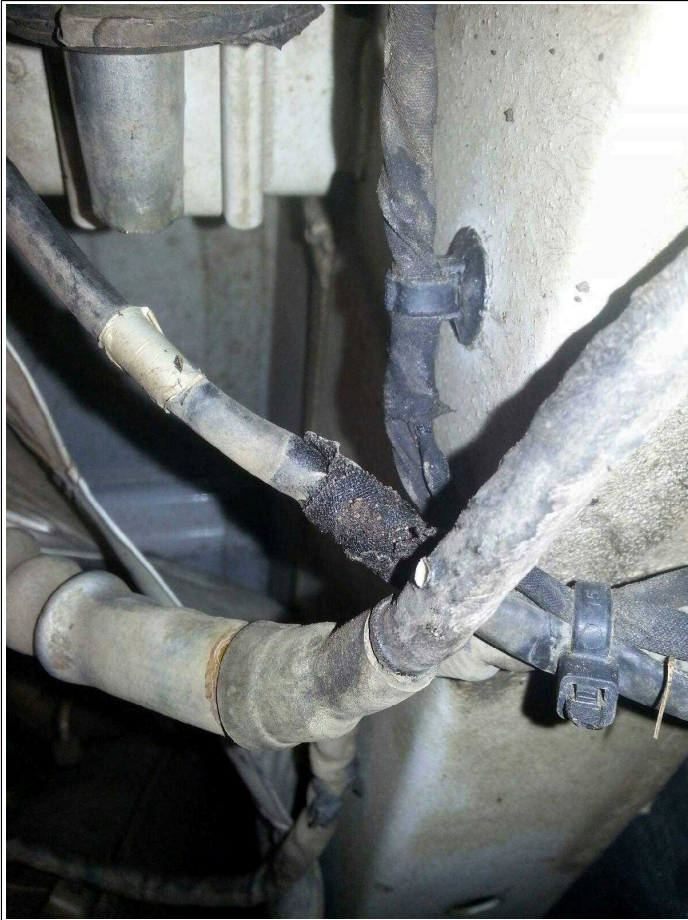
[melted harness 1\\_compressed.jpg](#)

Damage to the wiring harness may not be visible externally, as the outer tape can remain intact while the internal wires are melted and fused together.

Main Harness before removing outer tape

The wiring harness must be opened in any area exposed to the exhaust leak to visually inspect the individual wires. External inspection alone is not sufficient to determine harness condition.

Repair or replace any damaged wiring in accordance with approved repair procedures. Replace any dosing system components that show signs of heat damage.

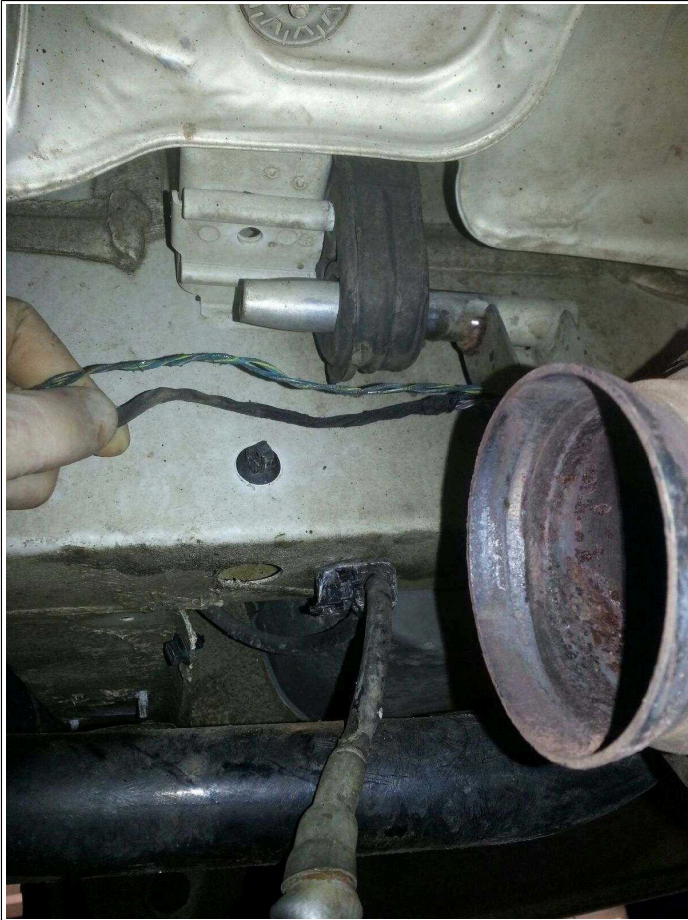
[Melted harness 2\\_compressed.jpg](#)

- Internal melting of wiring insulation within the harness
- Short to ground conditions and loss of communication between control units
- Damage to the dosing valve and/or heated AdBlue line

Main harness after outer tape is removed and melted wiring found

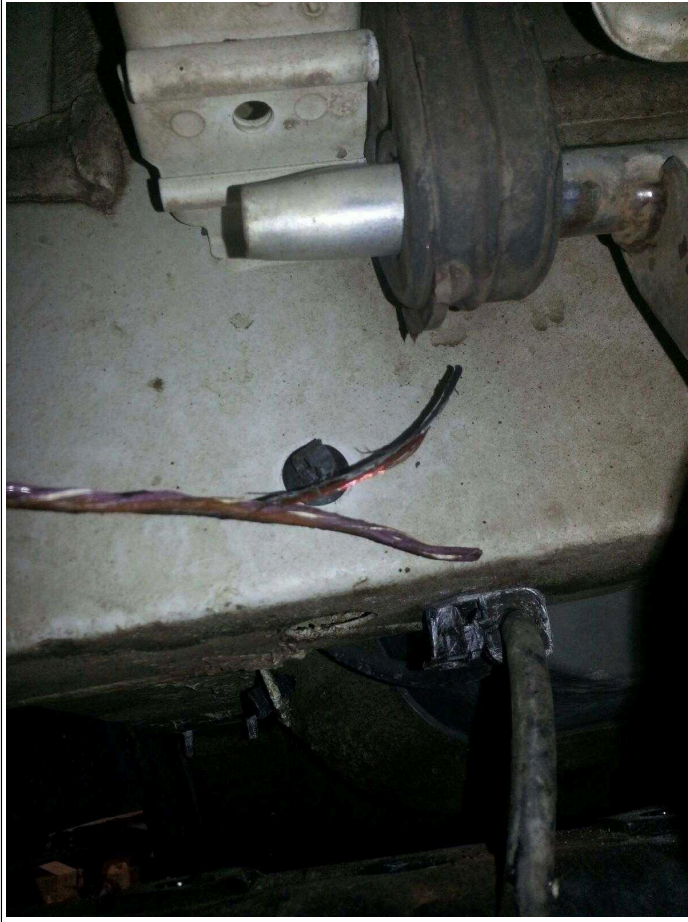
[Melted harness 3\\_compressed.jpg](#)

Main harness close up of melted wiring
