## Technical product information

| <b>Topic</b> | Window Drop Glass Operation Continental GT/GTC 25-26MY |
| <b>Transaction No.</b> | 2080372/3 |

Window Drop Glass Operation | Continental GT/GTC | 25-26MY

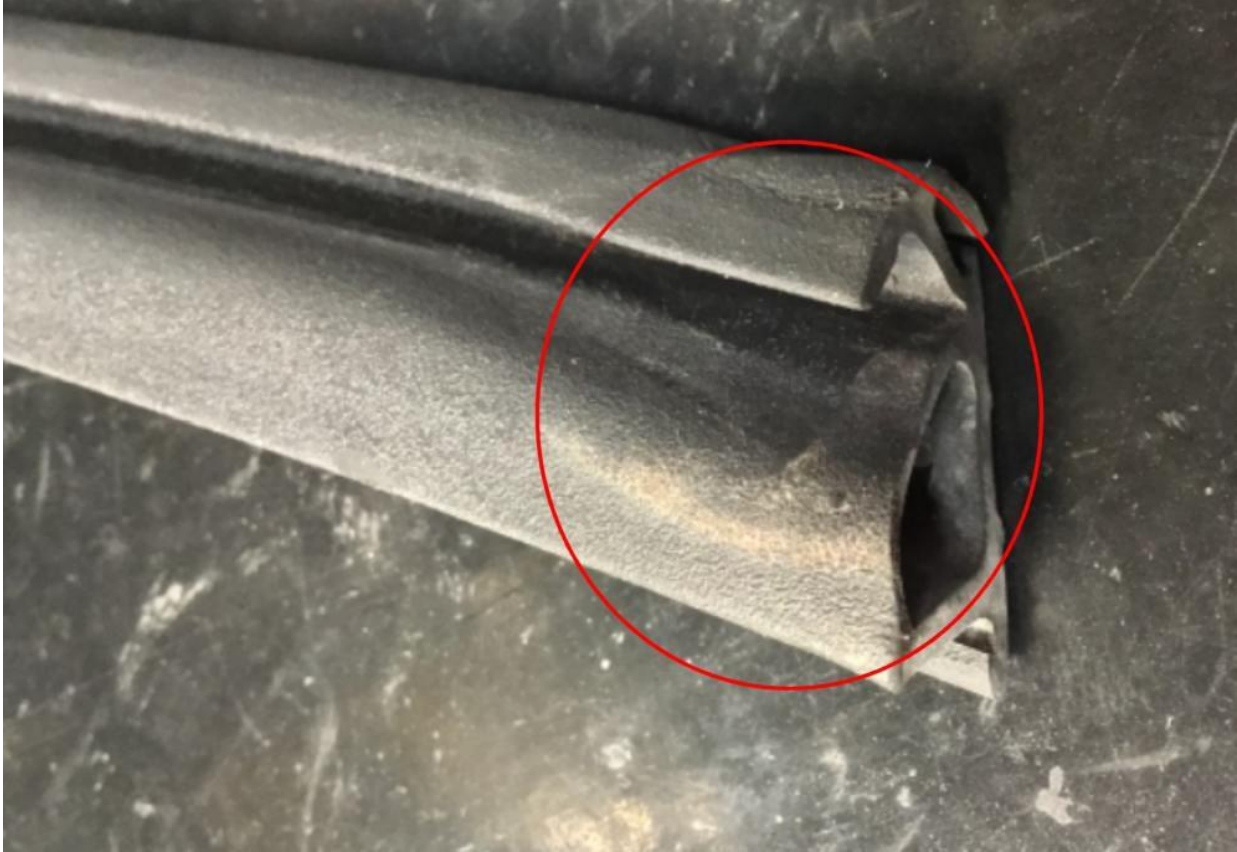
Figure 1

- Damage
- Splits
- Tears
- Misalignment
- Incorrectly fitted / located
- Drop glass seal deformation (see Figures 1 and 2 as examples)

**NOTE:** Any issues found with the window seals must be rectified before conducting the remaining steps

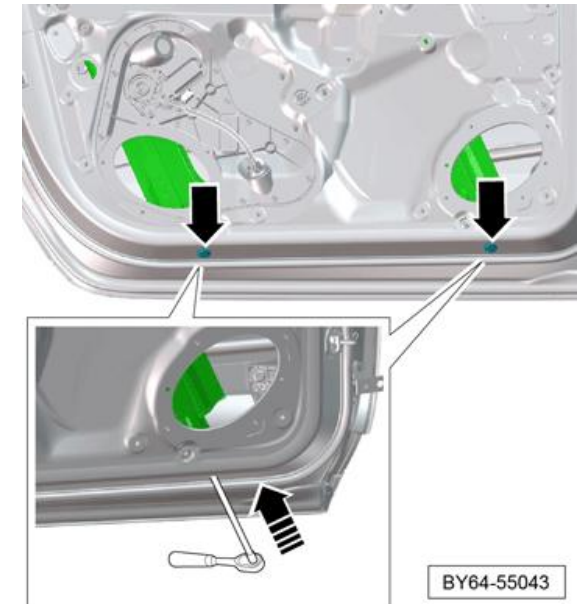
Figure 4

**NOTE:** If the 971 mm  $\pm$  1mm specification shown on the previous slide is incorrect, these bolts must be loosened to adjust the glass forward or backward as needed to meet the correct specification.

Loosen bolts -3- & -4- to ensure the glass sits in mounting position in its lowest position. Then resecure the bolts.
