Technical Service Bulletin

Subject: SCRATCH ON SEAT BACK BAR GARNISH FROM CONTACT WITH CONVERTIBLE TOP	Bulletin No.: 09-020/26
	Last Issued : 06/17/2026

2016-2026 MX-5

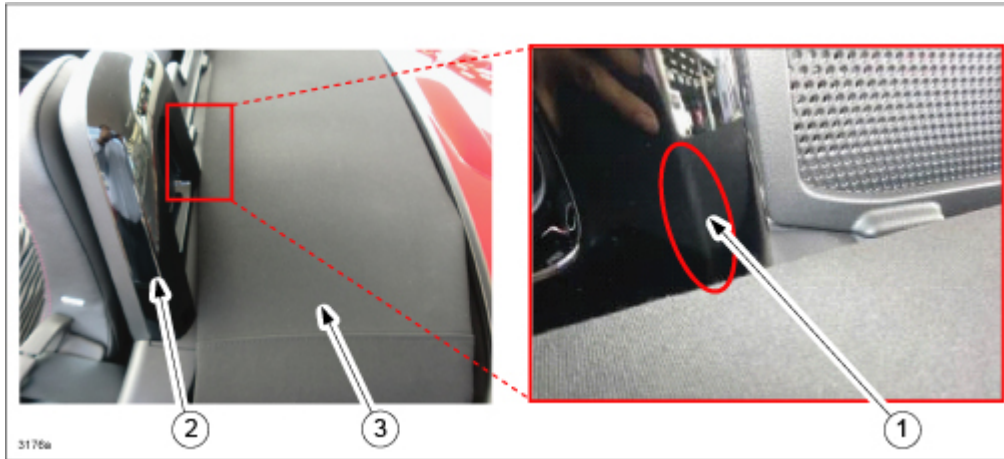
Some vehicles may exhibit scratches (1) on the rear of the seat back bar garnish (2) from contact with the convertible top (3).

NOTE: If the seat back bar garnish(s) is scratched, replace it with a new one.

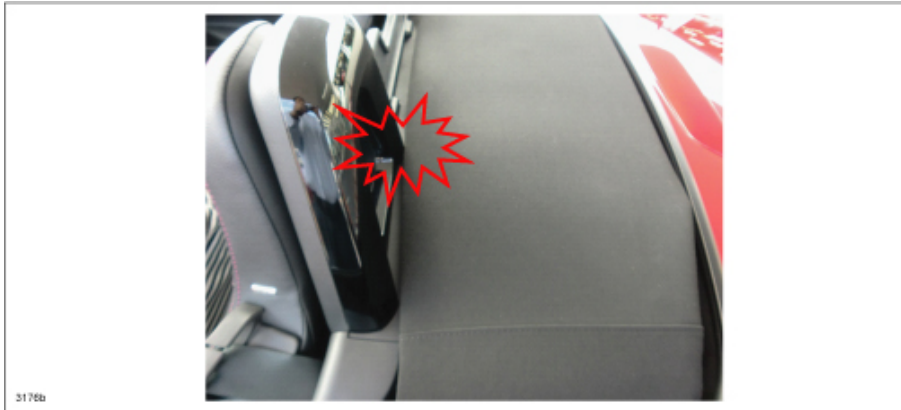
Due to assembly variations, the clearance between the seat back bar garnish and the convertible top is too small on some vehicles.

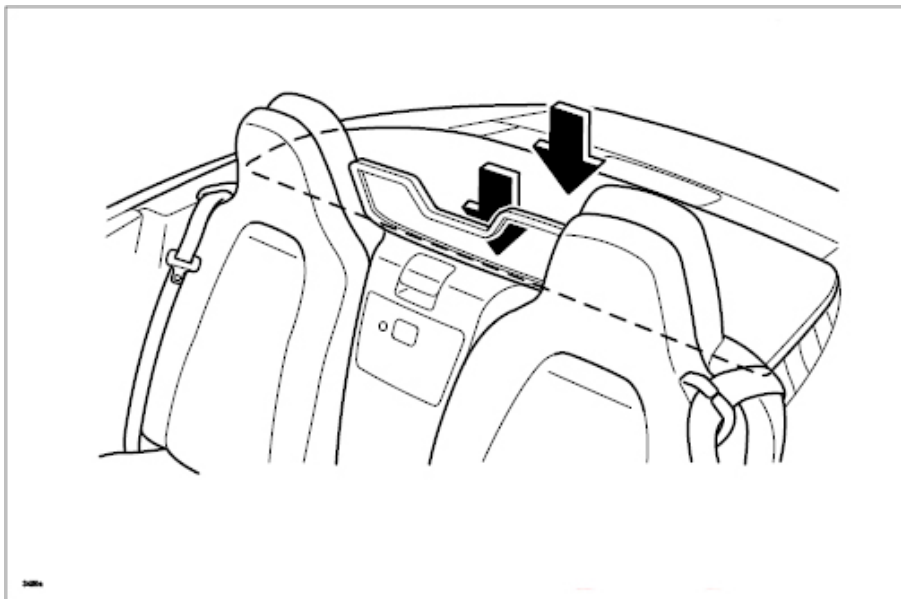
On later 2016 models (starting with VINs JM1ND*****117681), the link stopper of the convertible top has been changed to adjust the opening angle and folding position of the convertible top. This increased the gap between the seat back bar garnish and the convertible top when folded down. On these later models, the issue seems to occur if the customer does not completely lock the convertible top down when lowered.

NOTE: Make the customer aware that the top needs to be completely locked down when lowered to prevent this from happening. With the convertible top lowered, press down on both the front and rear areas of the top (as shown with the arrows) until a latch sound is heard and the top does not pop up.

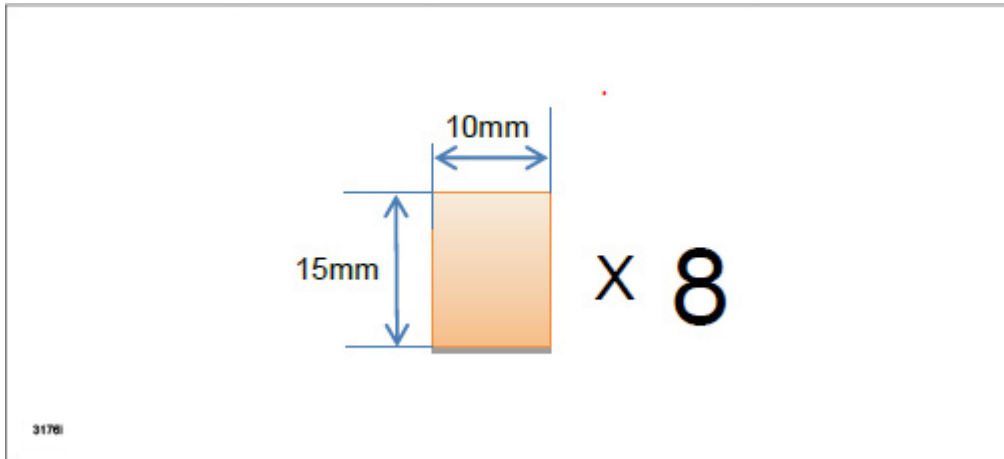
NOTE: The holes may be damaged when removing the metal fasteners of the back trim from the square holes of the seat back crossmember. A loose fit of these fasteners could cause a creak noise.

5. Attach 8 pieces of fabric sheet to the 4 square holes of the seat back crossmember to prevent a creak noise.

a. Select a 0.25 mm thickness fabric sheet from the "Noise Repair Kit" (TA01-76-100) and cut out 8 equal squares 15mm x 10mm.
