Subject: MYMAZDA APP CONNECTED VEHICLE ERROR CODE DESCRIPTION AND RECOVERY INFORMATION	Service Alert No.: SA-040/26
	Last Issued : 06/15/2026

DESCRIPTION

Some customers may experience a Connected Vehicle failure. The MyMazda App may display an Error Code. This document provides Error Code description and recovery information to assist with repairs.

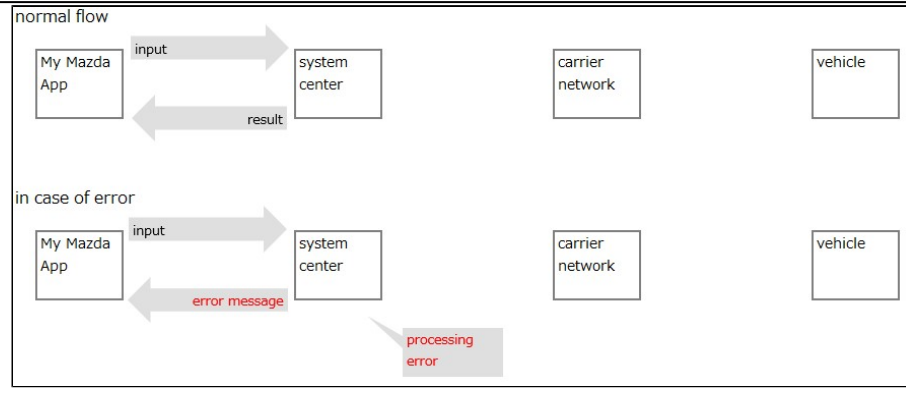
400C01

Description	It occurs when customer's input contains invalid value or there is blank at required items.	
MyMazda App Message	<p>Please check the input and try again. (400C01)</p>

Confirmation/ Recovery	Customer	Wait several minutes and try again. Review the input data and try again.
	Dealer	If the error continues to occur, there may be a problem with the system center -> Go to " Troubleshooting Instructions ".

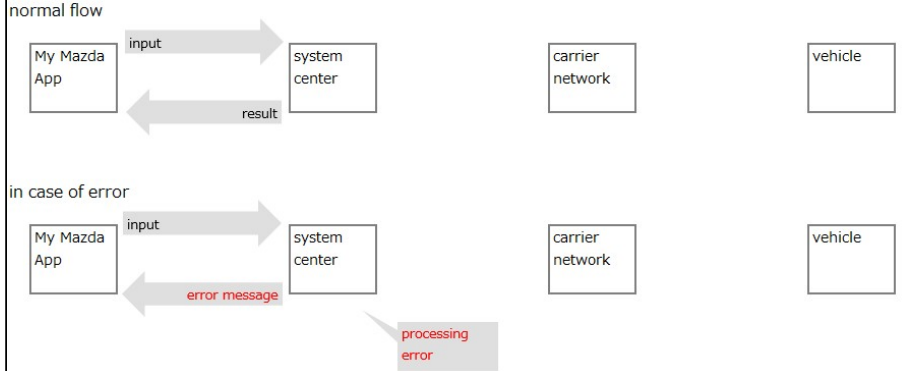
<p>MyMazda App Message</p>	<p>Please check the input and try again. (400C06)</p>

<p>Confirmation/ Recovery</p>	<p>Customer</p>	<p>Review the input data and try again. Wait about 5 minutes and try the operation again.</p>
	<p>Dealer</p>	<p>If there are no abnormalities in the input values, there may be a problem with the system center -> Go to "Troubleshooting Instructions".</p>

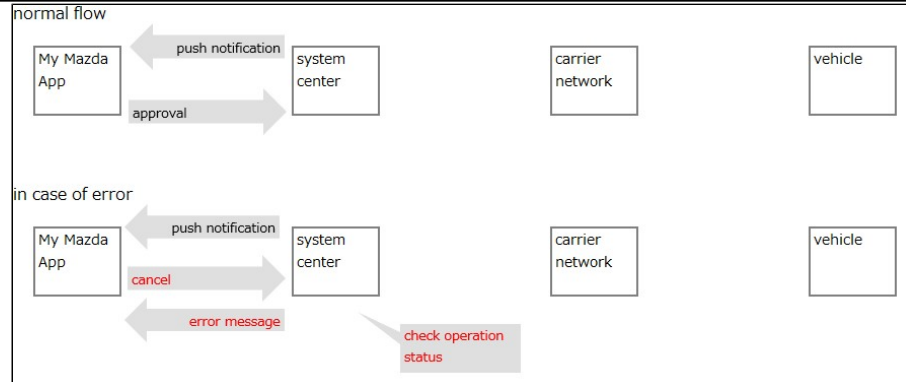
400S00

<p>Description</p>	<p>This occurs because "Cancel" was selected in response to a push notification for an approval request.</p>	
<p>MyMazda App Message</p>	<p>Please wait for a while and try again. If the error error continues, please contact the call center. [400S00]</p>	
<p>Process Flow</p>

<p>Confirmation/ Recovery</p>	<p>Customer</p>	<p>Retry the operation again.</p>
	<p>Dealer</p>	<p>This is a system error and may or may not be resolved by repeated retries. If the error continues to occur, there may be a problem with the system</p>

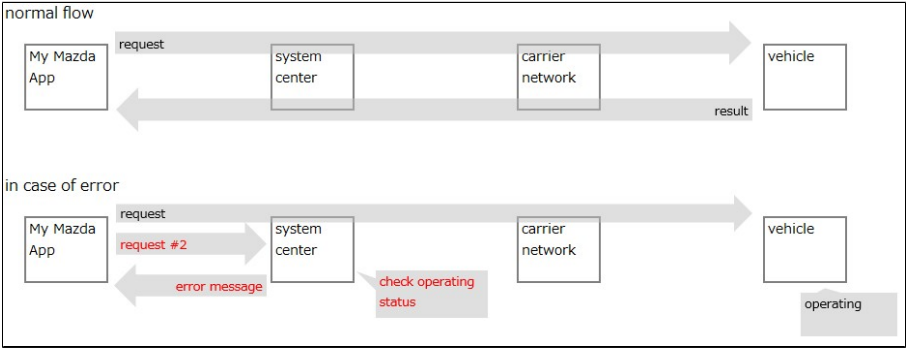
400S01

<p>Description</p>	<p>Occurs when the next remote operation is performed before the previous remote operation request has completed. In addition, it occurs in the following cases; All steps were not completed when replacing the TCU, and keys could not be exchanged.</p>	
<p>MyMazda App Message</p>	<p>Remote operation is in progress. Please wait for a while and try again. (400S01)</p>

<p>Only one remote request can be completed per 60-second period.</p>	
<p>Cause</p>	<p>Multiple execution of remote control.</p>	
<p>Process Flow</p>

<p>Confirmation/ Recovery</p>	<p>Customer</p>	<p>Wait for a response to the previous request, or wait 5 minutes and try again. Make sure that the vehicle keys are not left inside the vehicle. → If it remains, it cannot be executed. Check to see if any operations, such as opening a door, are being performed between the time the operation is performed and the response is received from the vehicle. → Cannot be executed if there is an operation. Turn on IG-on, check the reception strength icon at the bottom right of the center display.</p>

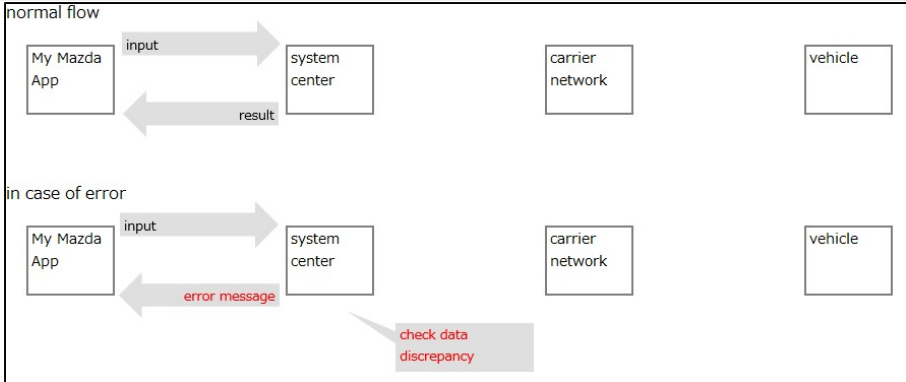
400S03

Description	This occurs when the data in question does not exist, has already been deleted, or the input data is incorrect when deleting a user.	
MyMazda App Message	Target data is not available. This data has already been deleted or is incorrect. [400S03]	
Cause	Because there are cases where conditions are not met, and where even if conditions are met, it may be deleted depending on the timing of processing.	
Process Flow

Confirmation/ Recovery	Customer	Review the input data and try again.
	Dealer	If the error continues to occur, there may be a problem with the system center -> Go to " Troubleshooting Instructions ".

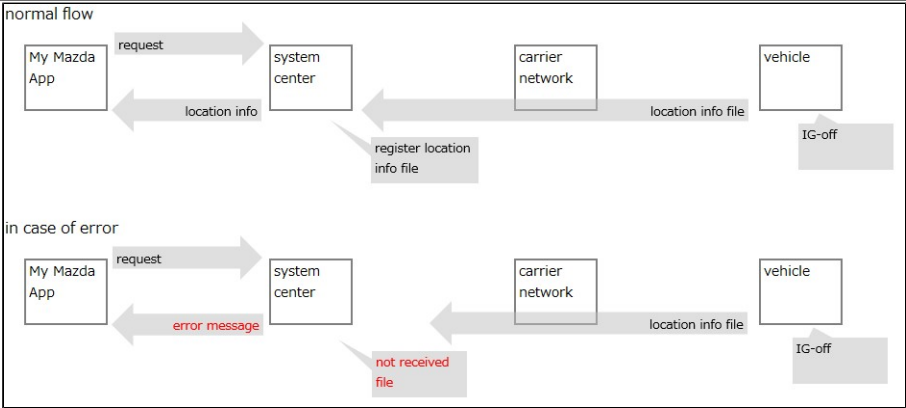
400S06

Description	<p>This occurs when location information cannot be obtained when logging in, performing a service that obtains location information, such as displaying a map or Vehicle Finder. Main factorsThe signal condition at the parking place is poor.</p>	
MyMazda App Message	The location data is not available. [400S06]	
Cause	<p>The signal condition at the parking place is poor. Occurs in the case of specific conditions of in-vehicle data.</p>	
Process Flow

Confirmation/ Recovery	Customer	<p>Turn on IG-on, check the reception strength icon at the bottom right of the center display.

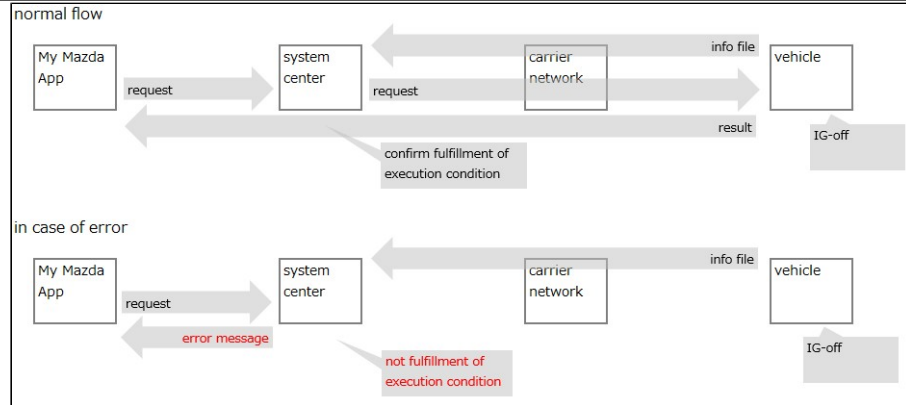
<p>MyMazda App Message</p>	<p>Remote Engine Start can only be executed two consecutive times in a row. (400S11)</p>

<p>If Remote Engine Start is used, the engine will stop running automatically after 15 minutes for safety, security and emissions. Remote Engine Start can only be used 2 consecutive times while the vehicle is not driven. After the vehicle has been driven, the use count is reset.</p>	
<p>Cause</p>	<p>Exceeded the number of times the remote engine start.</p>	
<p>Process Flow</p>

<p>Confirmation/ Recovery</p>	<p>Customer</p>	<p>Check whether the request operation has been performed more than 3 times. Check whether the following conditions (required conditions for execution) are met.</p> <ul style="list-style-type: none"> • The vehicle has stopped after driving for more than 100 meters. • 24 hours have passed since the last execution <p>Turn on IG-on, check the reception strength icon at the bottom right of the center display.</p>

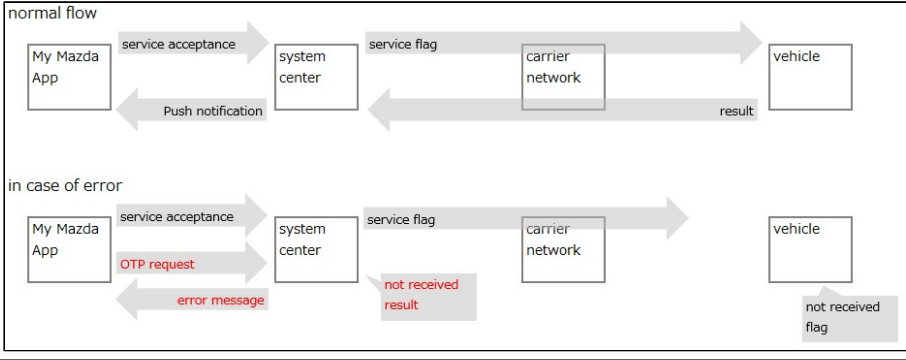
400S19

<p>Description</p>	<p>This occurs when an OTP display request is made when the vehicle is not ready for OTP display (opening process/blocking process/blockage error). *OTP = one time passcode Main factors:</p> <ul style="list-style-type: none"> • TCU exchange is being performed while the usage start process is being executed. • The WiFi contract (In-Car WiFi) is interfering and line operation is failing. 	
<p>MyMazda App Message</p>	<p>The Authorization Code could not be sent because vehicle connectivity has not been established yet. Please try again after connectivity is established. (400S19)</p>

<p>18PF OPENING COMMUNICATION LINE HAS NOT BEEN COMPLETED (OTP request before line opening completed)</p>	
<p>Cause</p>	<p>TCU replacement during OTP process In-Vehicle WiFi Contract interference</p>	
<p>Process Flow</p>

<p>Confirmation/ Recovery</p>	<p>Customer</p>	<p>Wait a few hours (up to 12 hours) and after receiving a push notification that OTP display is possible, execute the OTP request again. Processing is only performed between 6:00 a.m. and 10:00 p.m. Eastern time, so it may take more than 12 hours. Turn on IG-on, check the reception strength icon at the bottom right of the center display.</p>

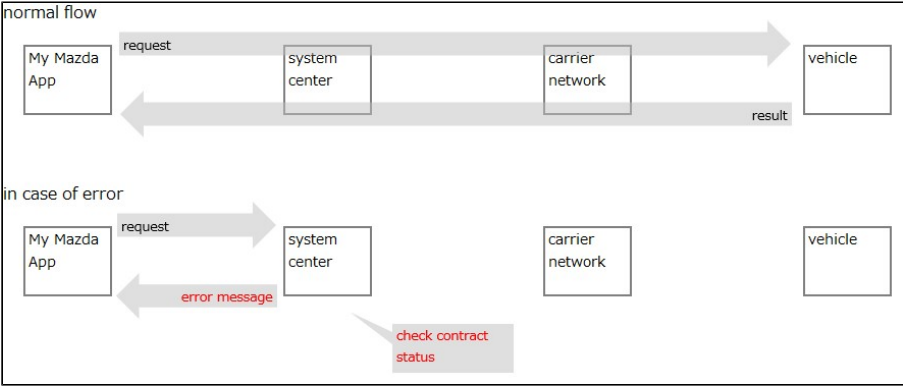
400S20

Description	This occurs if not subscribed to the base plan.	
MyMazda App Message	Connected Services cannot be executed at this time because {base plan} has not been purchased. Please purchase {base plan} from the subscription website and try again. [400S20]	
Process Flow

Confirmation/ Recovery	Customer	Perform the operation again after subscribing to the base plan..
	Dealer	If the error continues even after subscribing to the base plan -> Go to " Troubleshooting Instructions ".

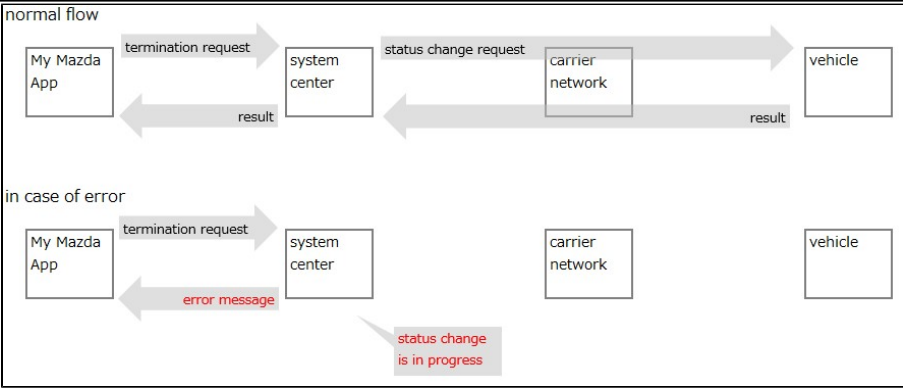
400S21

Description	<p>This occurs when the connected contract cancellation process is executed while the line is being opened or blocked. Main factors</p> <ul style="list-style-type: none"> • The TCU was replaced during the start of use. • The WiFi contract (In-Car WiFi) is interfering and line operation is failing.
MyMazda App	Please wait for a while and try again. If the error continues, please contact the call center. (400S21)

<p>Message</p>	<div style="border: 1px solid black; padding: 5px;"> <p>Error</p> <p>Please wait for a while and try again. If the error error continues, please contact the call center. (400S21)</p> <div style="text-align: center; background-color: black; color: white; width: 100px; margin: 10px auto; padding: 5px;">OK</div> </div> <p>CV cancelation has failed. Update TCU to the latest software.</p>	
<p>Cause</p>	<p>TCU replaced during TCU cancellation process Acitve In-Car WiFi contract</p>	
<p>Process Flow</p>

<p>Confirmation/ Recovery</p>	<p>Customer</p>	<p>Wait several hours (up to 12 hours) and perform the CV cancellation process again. Processing is only performed between 6:00 a.m. and 10:00 p.m. Eastern time, so it may take more than 12 hours. Turn on IG-on, check the reception strength icon at the bottom right of the center display.</p>

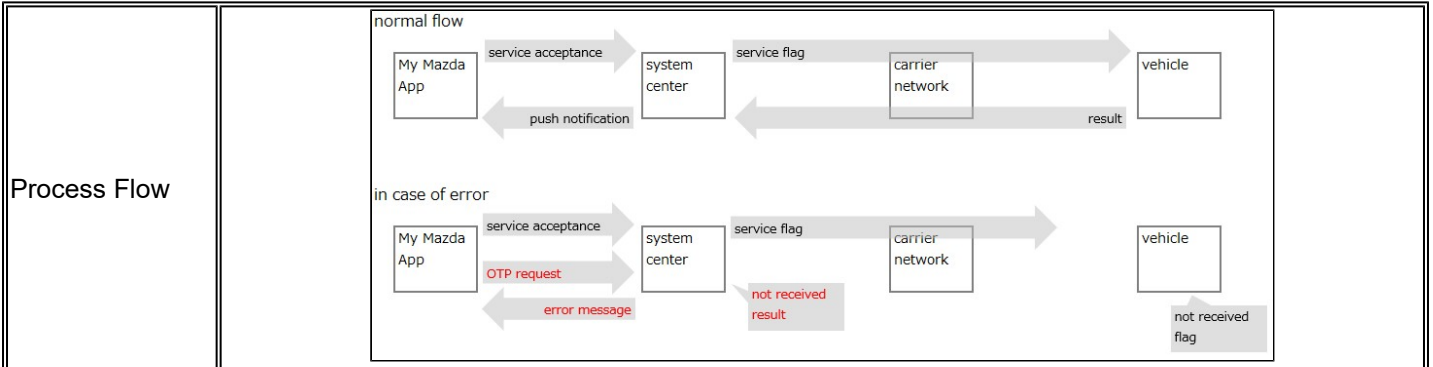
Description	<p>Occurs when an OTP display request is made when the vehicle is not ready for OTP display (before push notification is sent). *OTP = one time passcode Main factors;</p> <ul style="list-style-type: none"> • OTP display on vehicle side is not ready (takes up to 12 hours) • Service flag download failed 	
MyMazda App Message	<p>Authorization Code Request is processing. This may take up to 12 hours to complete. You will be notified when the process is completed.(400S25)</p> <p>User will receive push notification to continue with OTP request.</p>	
Cause	TCU is not in "Open" status

Confirmation/ Recovery	Customer	<p>Wait a few hours (up to 12 hours) and after receiving a push notification that OTP display is possible, execute the OTP request again. Turn on IG-on, check the reception strength icon at the bottom right of the center display.</p>

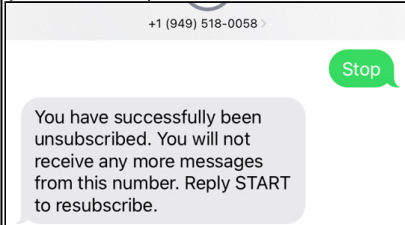
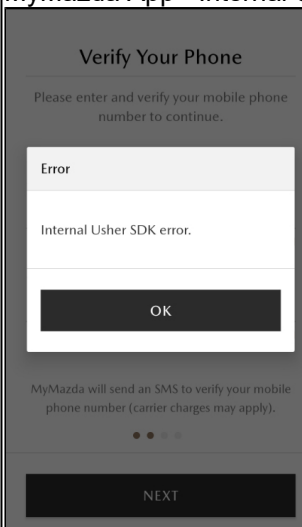
Internal User SDK error

Description	<p>Customer inadvertently texted "Stop" to 1-949 518-0058 (Twilio SMS)</p>

MyMazda App Message	<p>MyMazda App - Internal Usher SDK error.</p>

Customer	<p>1. Text "Start" to 1-949 518-0058 (Twilio SMS) 2. Retry to create a MyMazda account. Note: USA and Canada only</p>

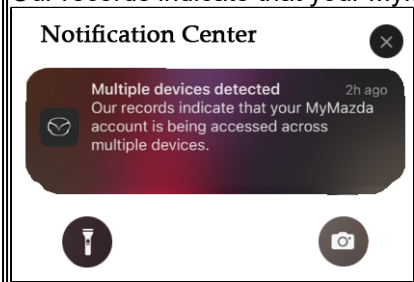
Description	Usually occurs if the same login credentials were used on different devices. Example, iPhone and Android.
MyMazda App Message	<p>Notification Center Multiple devices detected Our records indicate that your MyMazda account is being accessed across multiple devices.</p>

Customer	No action needed

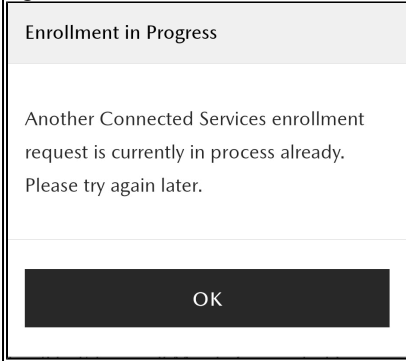
Description	Enrollment in Progress
MyMazda App Message	<p>Another Connected Services enrollment request is currently in process already. Please try again later.</p>

Dealer	CV cancelation has failed. Update TCU to the latest software.
