Subject: ELECTRICAL CONCERN AND/OR MULTIPLE DTC'S DUE TO AFTERMARKET DEVICE	Service Alert No.: SA-041/26
	Last Issued : 06/18/2026

APPLICABLE MODEL(S)/VINS:

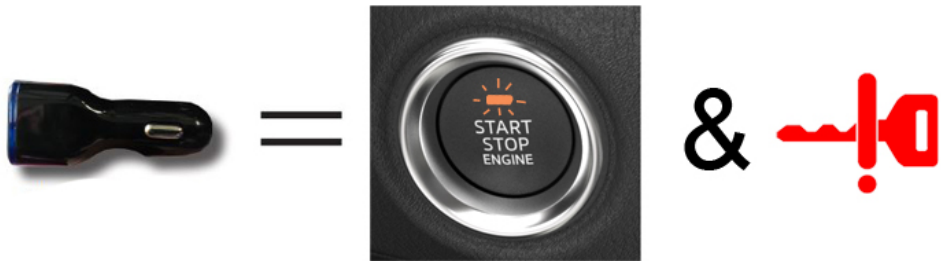
Some aftermarket cell phone chargers, accessories connected to the 12V outlet or key fob proximity to a cell phone may cause issues with the START/STOP button or rear view camera.

- Intermittent engine no start or unable to turn off
- Instrument cluster red security indicator light ON
- Engine Start/Start Button Amber indicator light flashing
- Battery discharge
- Electrical relay buzzing noise
- DTC B13D3:94 stored (Communication error with remote transmitter)
- DTC P1260:00 stored (Immobilizer system problem)
- Rear View Monitor Display is Blurry

Aftermarket Cell Phone Charger/Accessory connected to 12V outlet	Engine Start/Stop Button Amber Indicator Light Flashing	Key Warning Light (red)

For concerns where the vehicle power supply cannot be controlled adequately, such as an engine no start condition or the engine cannot be turned off, explain to the customer as follows: Due to the reverse power supply from electronic devices with internal batteries connected through the vehicle's accessory socket, the vehicle system may not be able to determine the vehicle electronic status. As a result, the vehicle power supply control fails. To overcome this situation, remove the electronic device with internal batteries from the accessory socket.

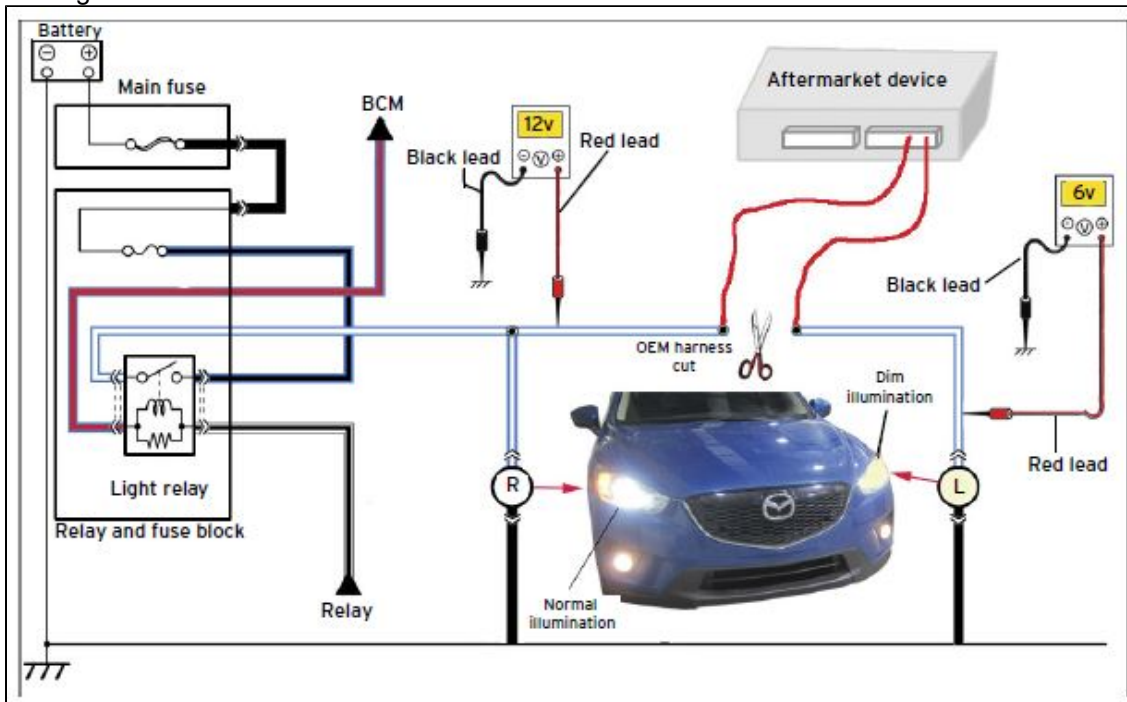
Below is an example of a dim headlight. The aftermarket device changed the headlight circuit resistance, causing a dim headlight.

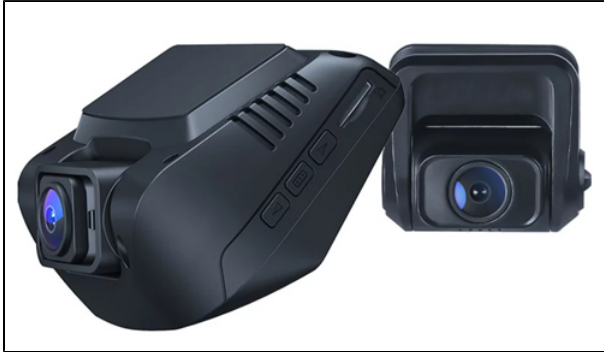
DTC B119F:01 (TEL antenna No.1 malfunction) stored. This may be caused by an aftermarket dash cam, radar detector and/or FasTrak device.

The aftermarket device may cause electrical noise disturbing the reception of GPS signals.

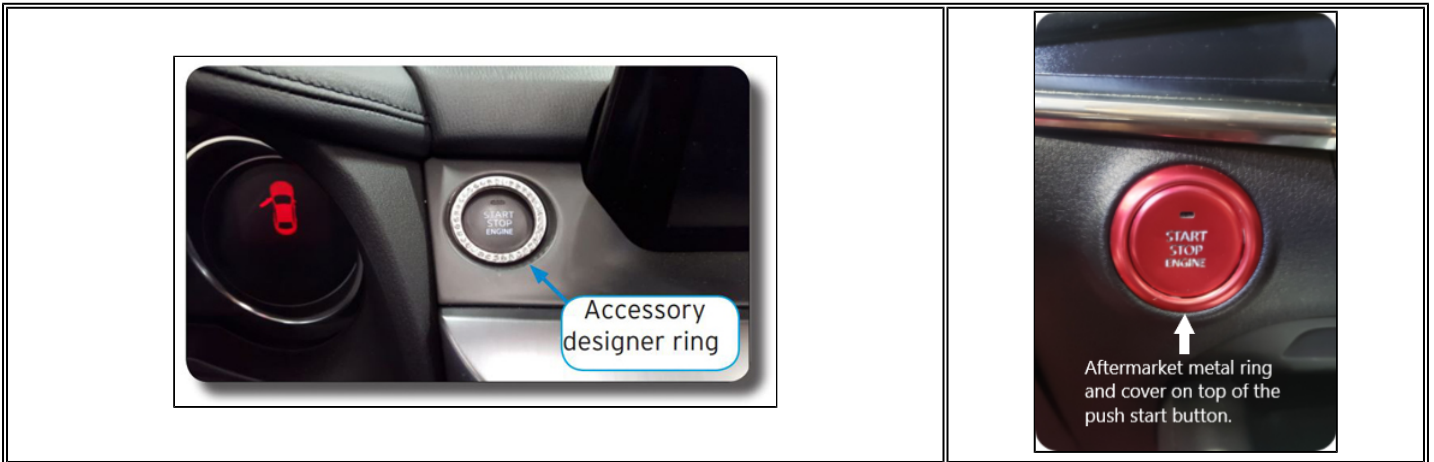
When programming a key or installing a Genuine Mazda Accessory Remote Engine Start system, you may encounter programming difficulty. This may be caused by a customer installed aftermarket decorative trim and/or cover on the START/STOP ENGINE button. The aftermarket accessory may create electrical interference, which may interfere with programming.
