SIB 33 01 24

PROPER REPAIR PROCEDURE FOR REAR AXLE FAILURE (BEV)

2026-06-05

G26 i4 Gran Coupe Battery Electric Vehicle (BEV) With HEAT 220LR	G60 i5 Sedan (BEV)	G70 i7 Sedan (BEV)	i20 iX Sports Activity Vehicle (SAV BEV)
---	--------------------	--------------------	---

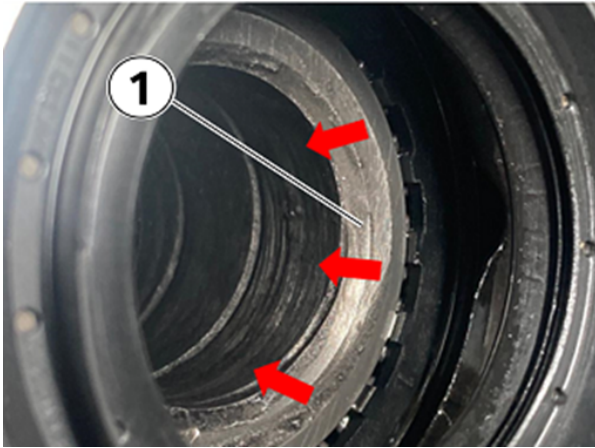
- Visually check the parallel key spline in the differential of the electric drive unit for damage (on the side where the driven shaft is broken)
- Visually check whether fragments of the driven shaft have remained in the differential
- Check the surfaces of the plain bearing seats (on both sides of the differential) for

discoloration due to high heat, chips, and seizing marks (1)

If damage is found at the points listed above, the electric drive unit must be replaced.

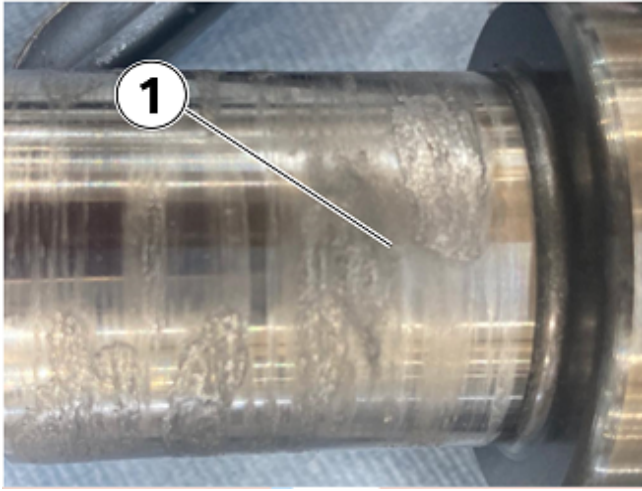
- Check the surface of the plain bearing seats of both driven shafts for discoloration due to high heat, chips, and seizing marks (1)
