SIB 41 01 26

DELIVERY STOP: TAIL PANEL PLUG

2026-06-16

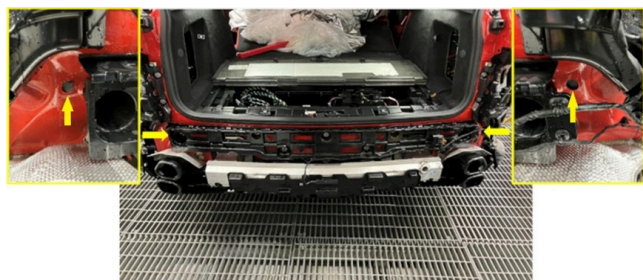
The plug for the rear finish plate was not mounted in the factory.

Possible water ingress into the luggage compartment.

Retrofit the plug (arrows) for the rear end panel on the left and/or right from inside of trunk area.
