### SIB 51 12 25

## GROANING SOUND FROM THE TAILGATE

2026-06-11

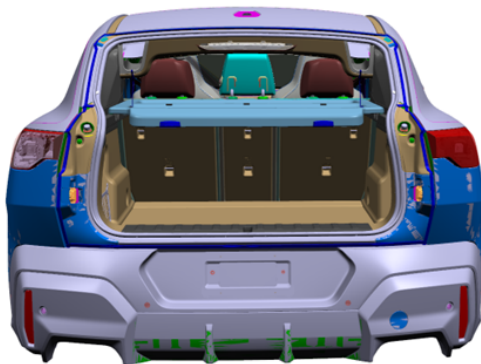
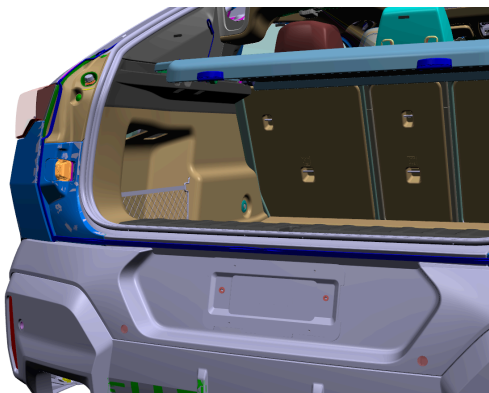
A “groaning” noise is heard from the tailgate when driving on rough roads.

Frictional vibration of the tailgate wedging elements (**highlighted in orange at arrows**).\_

Adjust the tailgate.

1. Verify the customer's concern.
2. Adjust the tailgate following repair instructions listed in ISTA/AIR 41 62 014.
3. Reassemble the vehicle and verify the repair.
