SIB 51 20 22

CRACKING SOUND IN THE HEADLINER AREA

2026-06-29

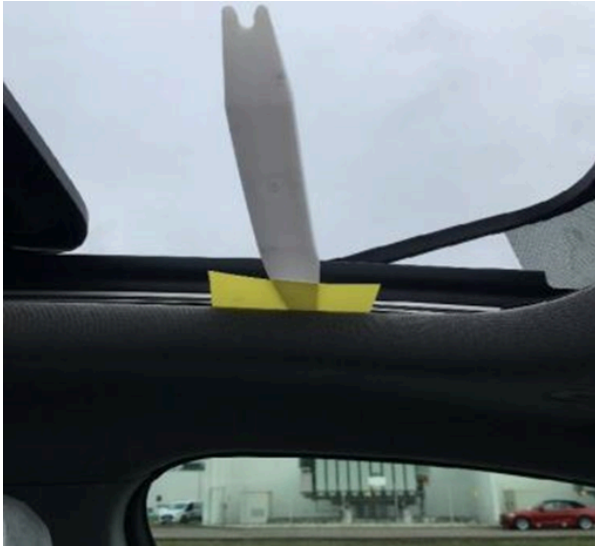
Cause 1:

1. The metal frame of the panorama roof cutout on the headliner is contacting the panorama roof.
2. Movement of the headliner holding clips.
3. The metal frame of the panorama roof cutout separates from the headliner.

1. Using a clip lifter, pry open the contact area to increase the gap to eliminate the contact. Make sure that the metal frame is not deformed in this visible area. If it is deformed, replacement is necessary (Reference the Cause 3 replacement repair instruction)

2. Reassemble the vehicle and verify repair.

3. If the noise is still present after performing this repair, proceed to Cause 2.
