SIB 52 01 20

GROANING NOISE FROM TRIM APERTURE ON THE FRONT SEAT

2026-06-26

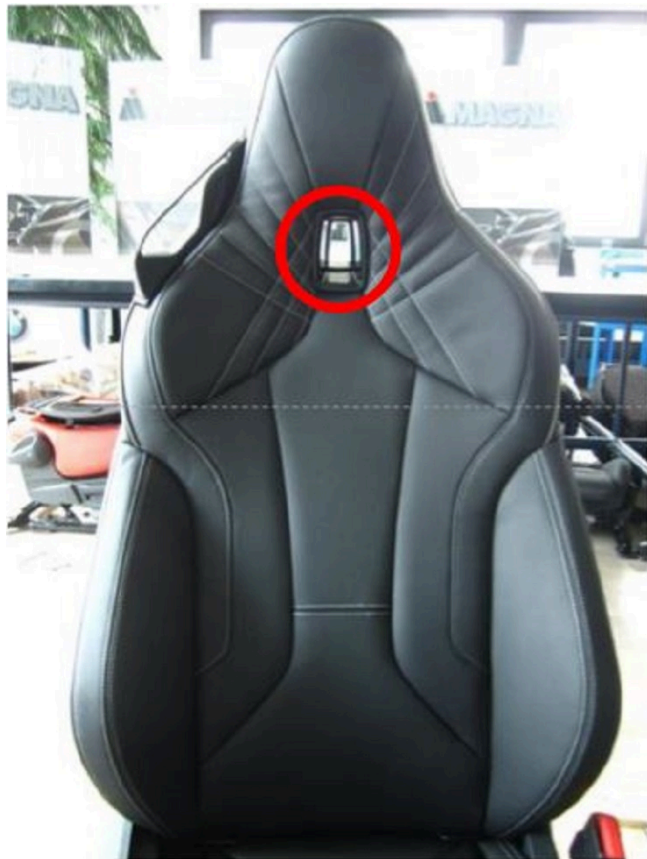
When getting in or out of the vehicle, a groaning noise can be heard from the opening (aperture) in the seat backrest. The noise may be heard from one or both of the front seats.

The trim aperture in the front seat is insufficiently lubricated. The front and rear halves of the trim can contact each other, causing friction noise.

Lubricate the trim aperture (circled).

- mating edges of the front and rear half of the trim
- inner edges of the trim aperture
