SIB 52 07 25

M5 HEAD RESTRAINT GROANING NOISE

2026-06-03

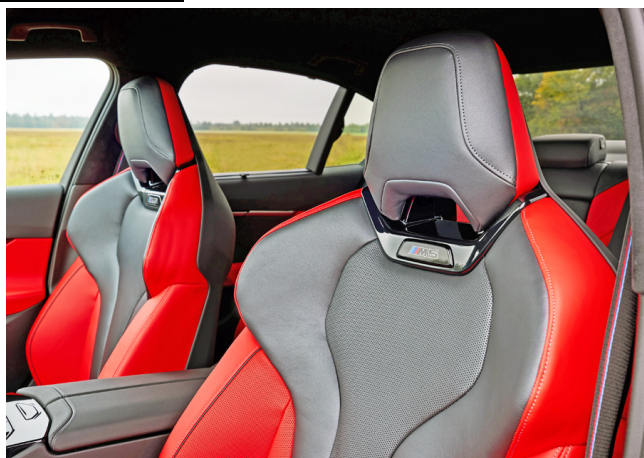
The decorative trims on the head restraints of the driver's seat and front passenger seat cause groaning noises on any route, at any temperature, even in a slightly reclined position.

The edge of the aperture trim rubs against the seat leather upholstery at the point of contact.

Replace the aperture trim on both seats in case of a noise concern with revised part number 52 10 7885235.

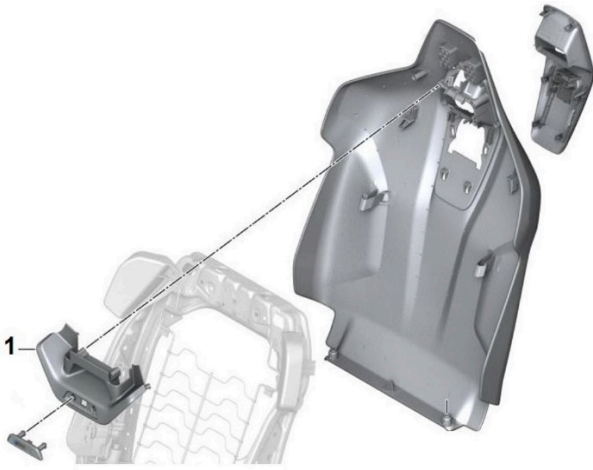
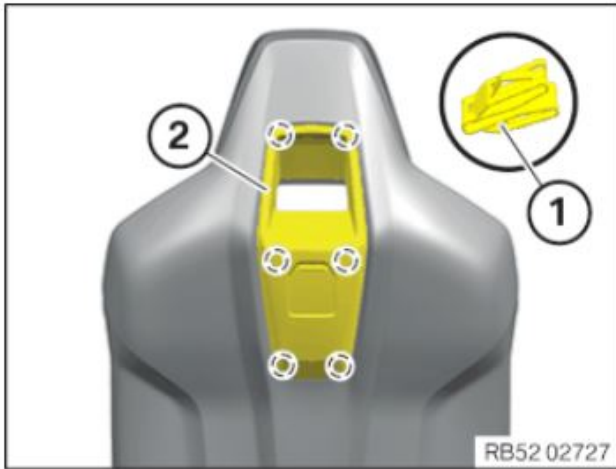
If the decorative trim causes groaning noises, **replace the decorative seat aperture trim (1) with an improved part.**

To remove the front decorative seat aperture trim, you must first remove the trim (2) from the rear of the seat. There are 6 retainer clips (1).

Follow Repair Instruction REP-TAT-P-5217-01

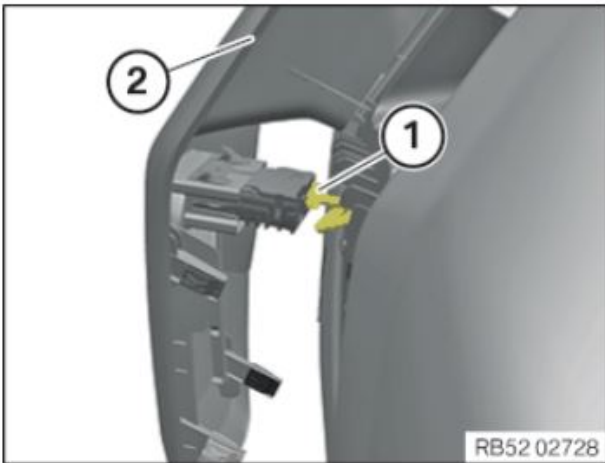
Disconnect the electrical connector for the trim M light (1).

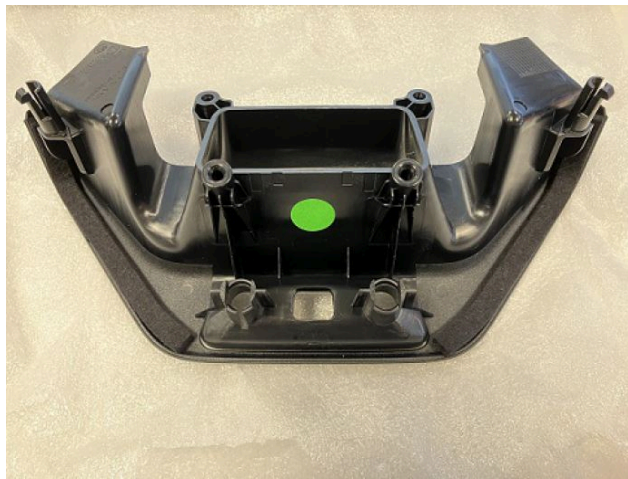
The revised front aperture trim can be identified by a green dot sticker.

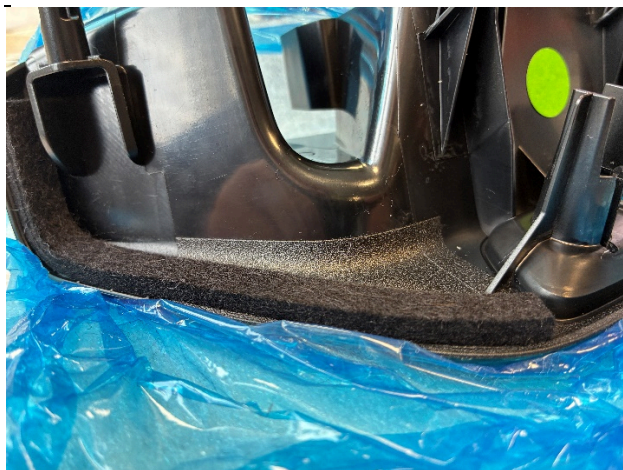
The improved part with the green dot sticker has strips of felt attached.
Do not install the part if the felt is missing.
