SIB 61 06 26

BEV HV CHARGING NOT POSSIBLE, CHARGING SOCKET WHITE LED ON, NO FAULTS STORED

2026-06-04

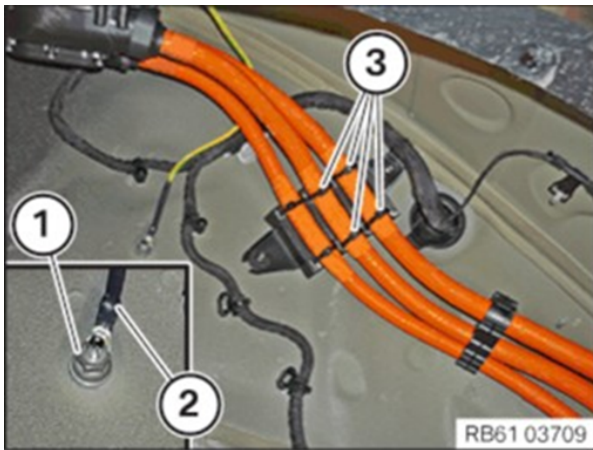
1. Unfavorable high-voltage charging socket PE (Protective Earth = protective ground) pin grounding wire connection at vehicle body contact point.
2. Unfavorable Control Pilot (CP) or Proximity Pilot (PP) low voltage signal connection.
3. Worn contact pins in the charging socket or charging station charging plug.
4. Charging plug is not correctly connected to the vehicle.

Right rear fender well view of HV charging socket wiring - PE grounding wire connection point to body (1 and 2) highlighted.

1. Gain access to the high-voltage charging socket grounding point under the right rear inner fenderwell – **(BEV) REP-REP-P-5171041**.
2. Disconnect the PE grounding wire connection point from the high-voltage charging socket on the vehicle body (see items 1 and 2 in the example illustration).
3. Clean the M6 bolt and grounding point body contact surface, as well as the M6 nut and wire terminal contact surface with a suitable wire brush or similar (e.g. abrasive pad).
4. Reassemble the PE grounding wire to the clean grounding point.
5. Torque the M6 nut to 8 Nm (class A threaded connection).
6. Follow the “four-eyes” work verification principle, the grounding point must be checked by a high voltage trained technician. See **Form for potential equalization screw connections REH-HIN-P-0001-1 - V.3**
7. Perform a charging test at a high-power charging station / DC charging station.

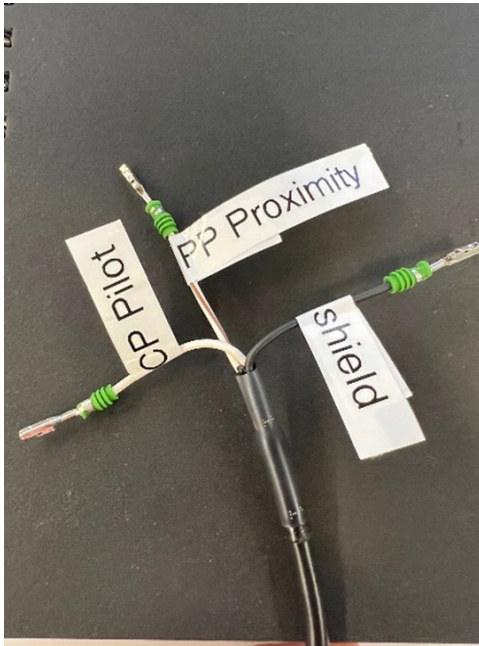
Photo shows CP/PP harness view from the Charging Socket 12 V connector

The Control Pilot (LD_CP), Proximity Pilot (LD_PP) signals and shielding wire (are bundled together in the CP/PP harness). The shield wire has a connection to body ground.

Make sure the harness is not pinched, frayed or the shrink tubing at both ends damaged in any way.

Note: These signals should NOT be shorted to each other or to ground through the shielding wire of the CP/PP harness or to the vehicle body or the signal will be lost.

Test for signal lines integrity, there should be uninterrupted continuity from Charging Socket to CCU.

- Pin 4 to 18 should be 0 Ohms
- Pin 9 to 19 should be 0 Ohms
- Pin 8 to 31 should be 0 Ohms

- Pin 18 to 31 should be OL
- Pin 19 to 31 should be OL
- Pin 18 to 19 should be OL

- Pin 4 to 8 should be OL
- Pin 4 to 9 should be OL
- Pin 8 to 9 should be OL
