SIB 63 04 26

FRONT INTERIOR READING LIGHTS RANDOMLY TURN ON AND OFF AFTER PREVIOUS REMOVAL

2026-06-30

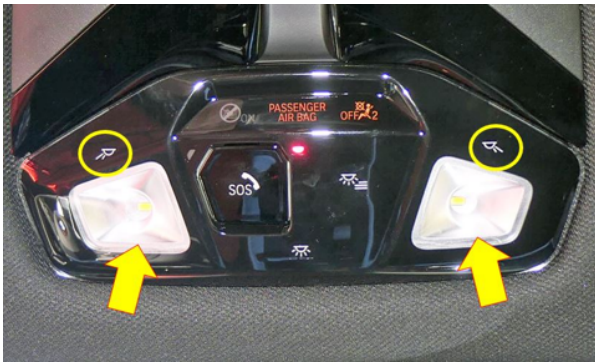
The front interior reading light(s) (arrows) will randomly turn ON and OFF while driving.

The reading lights are normally activated by touching the small icons (circled).

During the previous removal process of the front interior light, damage was caused due to the use of incorrect resistance points, or excessive pressure during installation of the light into the headliner.

Replace the affected front reading light assembly.
